Safety Alert

ALERT 12 – 10

LOSS OF BALANCE RESULTS IN LACERATION TO LEG FROM GRINDER

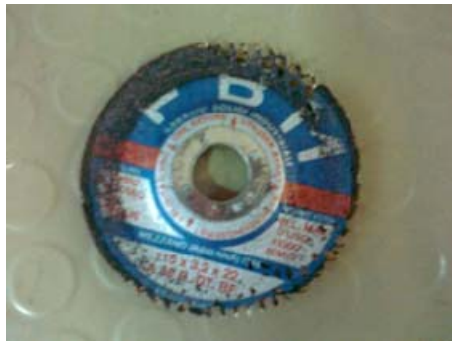
Wheel after incident

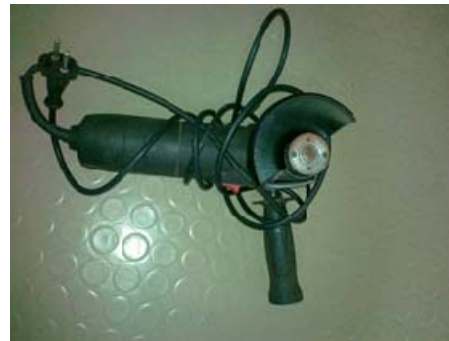
Grinder involved

- The grinder had no emergency stop system in place. Therefore the grinder continued its rotational movement once it was not under the control of the AB Seaman. This rotation resulted in cutting the seafarer and the wood deck;

- Conducted an inventory of the portable power tools available onboard all vessels and replaced the ones without an emergency stop system;
- Issued an instruction/circular aimed to control certain non-urgent maintenance activities on deck in particular circumstances (e.g. potential vessel instability/unpredictable movements);
- Reinforced instruction to personnel regarding the Stop the Job Authority;
- Reinforced instruction to personnel about the importance of Permit To Work, Risk Assessment and Toolbox Talk system to identify risk so as to become aware and reduce them;
- Issued instruction/circular aimed to limit the use of electrical tools under particular circumstances and to reinforce the proper use of support equipment (e.g. Ladder to be secured).

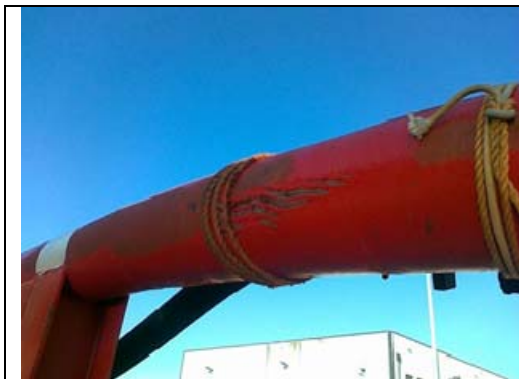
Work area

- Improper position to perform the activity (on top of a ladder) and ladder was not properly secured;
- Deck space was not sufficient to perform the maintenance activity and was reported as being slippery;
- The condition of the crash-bar and this planned activity did not justify the urgency to perform this specific maintenance activity during the stand-by position at an offshore platform.

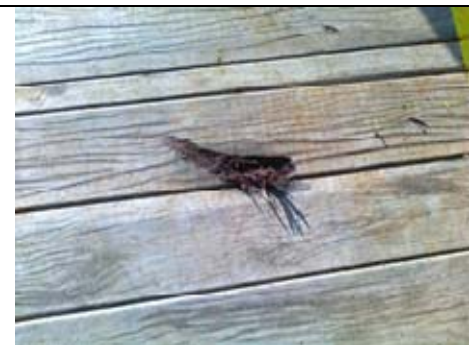
Deck boards and partial wheel
