Safety Alert

From the International Association of Drilling Contractors

ALERT 12 – 16

TAG LINE RELEASES LIFEBOAT DURING LIFTING OPERATION

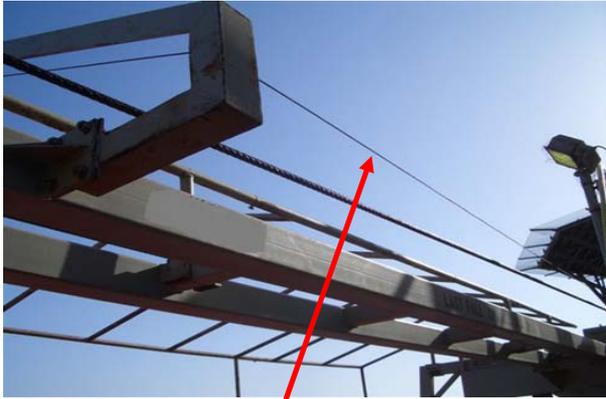
During a lifting operation to move a steel plate during high winds, one of the tag lines being used caught on the port lifeboat release wire, releasing the gravity brake and allowing the boat to be lowered to the sea. The lifeboat did not disconnect from the falls and was winched back up to the davits without damage.

Cable release wire that was fouled by the tag line, pressure applied and deactivated the gravity brake.

- All crews were instructed to ensure all tag lines are fit for purpose and sufficient replacement stock is held onboard.
- The crews were reminded to review lifeboat maintenance procedures to ensure that the gravity brake is tested by use of the wire release and not by lifting the counter weight.

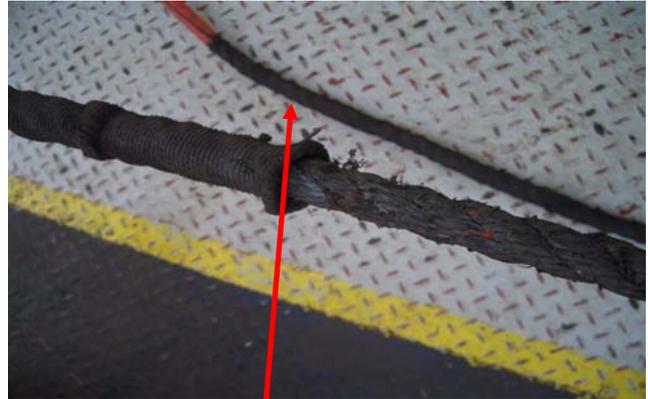
- The hazard created by the high wind was not fully recognized, and the opportunity to call a time out was not taken. The potential to snag the lifeboat release wire had not been recognized during the risk assessment.
- Although the tag lines in use were of the tangle free type, the textile covering on the upper body of the line had become loose and retracted causing a snagging point to occur. This caught the release line and activated the lifeboat brake.
- When the brake drum was opened for inspection, a large amount of oil residue was found on the brake lining. The oil sump had been overfilled above the manufacturer's recommendations allowing oil to seep through the seals into the brake area. The oil on the brake linings reduced the ability and efficiency of the brake to reset when the counterweight was reapplied.

The outer sleeve of this tag line created a snagging hazard.
