Safety Alert

ALERT 10 – 14

RIG MOVE – ROTARY TABLE FELL OFF TRUCK

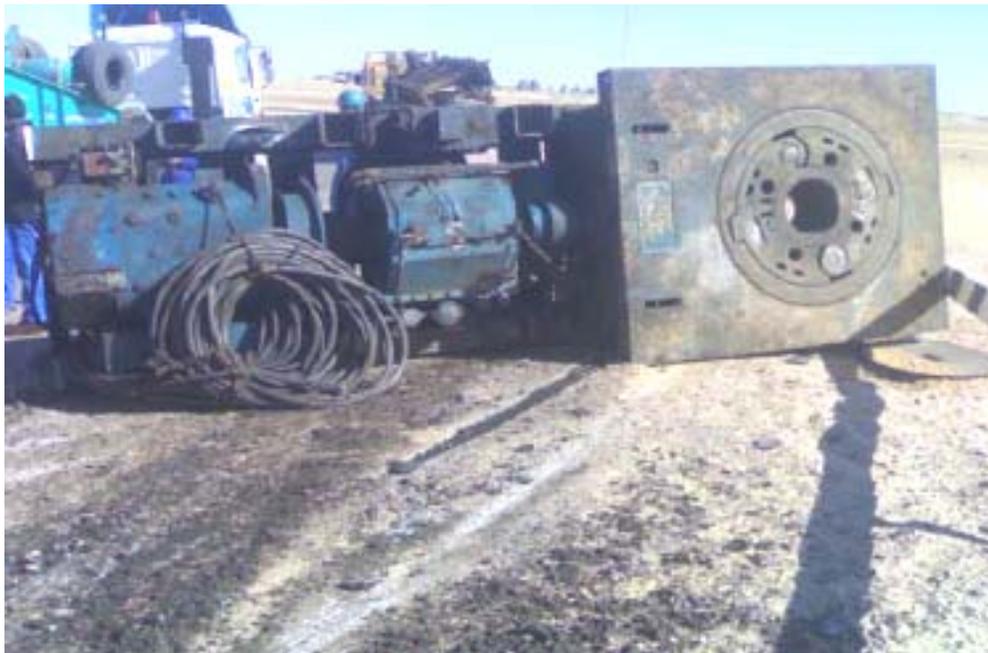
During rig move a subcontractor truck was loaded with the rig's rotary table which weighs approximately eight tons. It was secured to the truck with four boomer type chain binders. At 70 km (43 miles) from the old location and 500 meters (1640 feet) before entering the gate to the new location, one of the chain binders broke which allowed the other three chain binders to loosen. The rotary table fell off the right side of the truck and hit the black top causing damage to the road surface. The rotary table skid took all the impact and will be inspected before being back into service.

- Failure to check the securing devices prior to the vehicle leaving the old location.
- Incorrect chain binder “boomer type” was used to secure the load.
- Excessive speed caused the load to shift.

- Instructed rig movers to use “ratchet type” binders.
- Instructed rig supervisors and truck pushers that no truck is to leave the location without the load being secured properly and then checked by the truck pushers.
- Ensure that trucks travel at a safe speed for the road conditions. Discussion of road conditions and safe driving speed based on those conditions should be included in the pre-move safety meetings held every morning with the truck drivers. This discussion is to be documented.
