ALERT 14 – 08

MAINTENANCE ON ACCOMMODATION'S ELEVATOR RESULTS IN A FATALITY

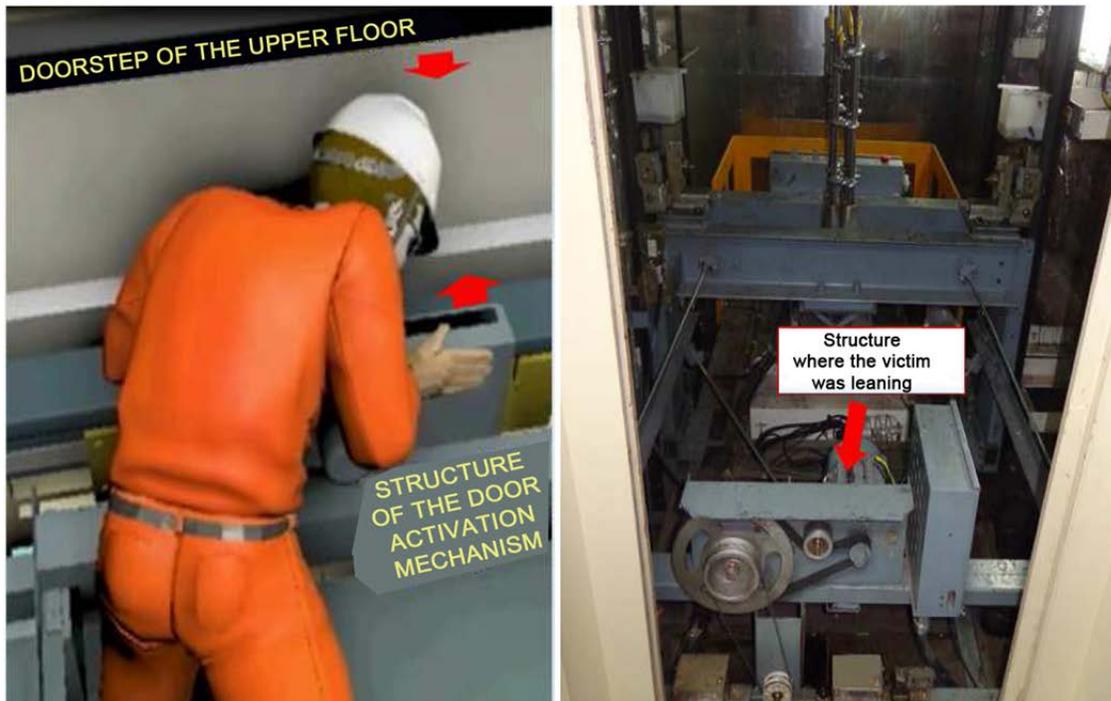
During the maintenance of the activation system of the load lift door, a team comprising of an electrician (injured person) and an electronic technician decided to visually check the accommodation's elevator, in order to compare both mechanisms to facilitate the repair of the load lift. When checking the accommodations elevator, the electrician entered the elevator, climbed on the top of the cabin, changed the operation mode from "Auto" to "Inspection" (maintenance mode), and performed the required inspections. The electrician was unable to determine what was affecting the activation mechanism of the load lift. Concluding the inspection, he took the lift down to just above the lower floor. He then changed the operation mode to "Auto" and leaned over the structure of the door activation mechanism, which placed his head between the lift structure and the door sill of the higher level. Since the lift was positioned above the so called "door zone," it started its lifting process to level the elevator, which compressed the electrician's head resulting in the fatality.

- Activity performed without a Permit to Work, including proper energy isolation. Thus the risks were not assessed.
- Lack of procedure for elevator maintenance.
- Lack of training for the elevator maintenance team.
- Activity performed without supervision.
- Poor safety culture.

- The company reminded all installation personnel to include the supervision or immediate leadership in maintenance activity planning;
- Rig Managers were instructed to keep strict control of the correct utilization of Risk Analysis and the Permit to Work system;

- All Rig Managers and maintenance employees were reminded that, during services planning and PTW issuance, they are required to know the equipment that they will be using in order to identify the appropriate training to perform the task;

- All employees were reminded to apply and follow all company operating policies/procedures and to enforce the concept of "If in doubt, Stop!"
- The company reinforced the leadership role of all Rig Managers and focus on safety;

- The company set out to clearly define the maintenance activities to be carried out by the onboard crew and the ones to be performed by specialized companies/manufacturers, based on manufacturers manuals and instructions;

- The company established training requirements (operation, rescue, maintenance) which were provided to elevator manufacturers upon delivery of equipment to offshore units.
