ALERT 14 – 11

LACK OF COMMUNICATION RESULTS IN FATALITY

Safety Alert

From the International Association of Drilling Contractors

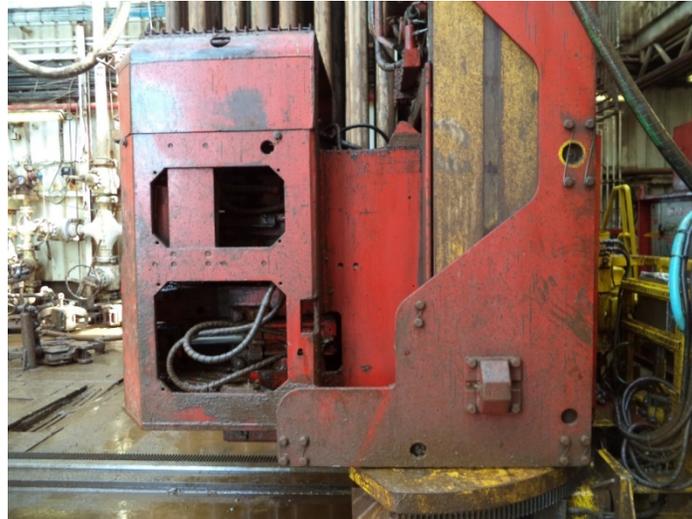
The iron roughneck was in “single” mode and in this position the iron roughneck inner carriage is extended out of the carriage’s frame resulting in a 16 inch (41cm) gap between the iron roughneck and the rear access cover. The Mechanic climbed over the rear bumper bars on the PHM and entered into the 16 inch (41cm) gap between the iron roughneck inner carriage and the rear access cover.

Iron Roughneck, Inner Carriage Extended

- Enhanced Control-of-Work Process
- Reinforced restricted access, all personnel must pass through the Drillers Cabin before accessing Rig Floor
- Reviewed all Rig Specific Procedures for operation of remotely operated equipment
- Placed signage stating “This Equipment May Be Remotely Operated”
 - Installed expanded metal screen on iron roughneck rear and side access points
 - Installed a retractable barrier to restrict access between iron roughneck and existing handrails
- Clearly communicated that compliance with requirements exceeds all “operational pressures”
- Liaised with Equipment Manufacturer regarding installation of guards
