ALERT 14 – 17**LINE-OF-FIRE INCIDENT RESULTS IN FACIAL INJURIES****WHAT HAPPENED:**

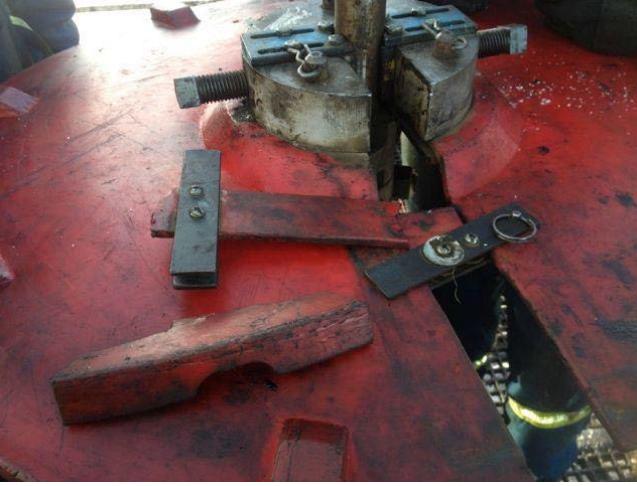
The gate piece of the rod wheel broke away, striking a worker.	A new rod wheel

- Defective tools: The rod wheel is made of plastic.
- If the rod wheel backspins from torque, the gate in the wheel is subject to failure.
- Improper procedures: There was no safe method of placing torque into a rod string using a rod wheel. If control of the wheel is lost, the resulting backspin places workers at risk from disintegration of the gate.
- There are no manufacturer operating specifications for the rod wheel that helps to identify the torque limitations or maximum number of turns on a rod string before it becomes a hazard.
- Use of a rod wheel relies on the workers manually holding a device with torque applied and, if they lose control of the wheel and it fails, there is no way to protect the workers.

- Recommended engineering control: The use of jaw-type rod tong dies coupled with a backup arm to rotate the rod string removes the hazard to workers.
