ALERT 14 – 26

## LINE-OF-FIRE INCIDENT RESULTS IN MEDICAL TREATMENT CASE

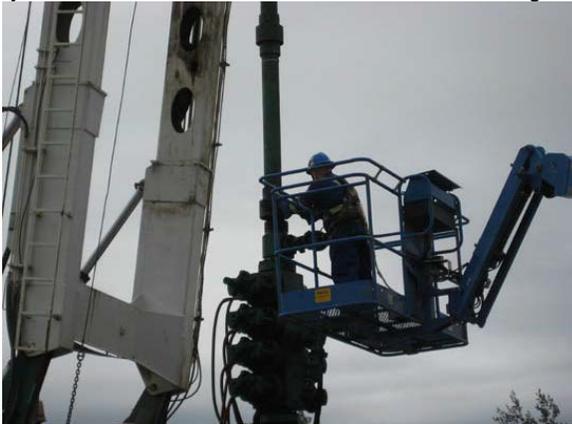
Image 1 is the position of the employee before being struck.

- The lubricator assembly sprung free off the top of the BOP stack and sprung backwards, striking the operator in the Aerial lift in the face and knocking him down.
- The crew had not identified a potential stuck connection nor the stored energy that could be released during the disconnection process.

- The company will endeavor to find an engineering solution to prevent the lube from kicking out of the BOP.
- The JSA procedure has been changed, to identify the hazard and ensure that all personnel are clear before the lubricator assembly is lifted off the top of the BOP stack.
- The company will also reinforce the importance of pausing and identifying any new hazards when the scope of a job changes.
- There will be an internal hazard alert sent out

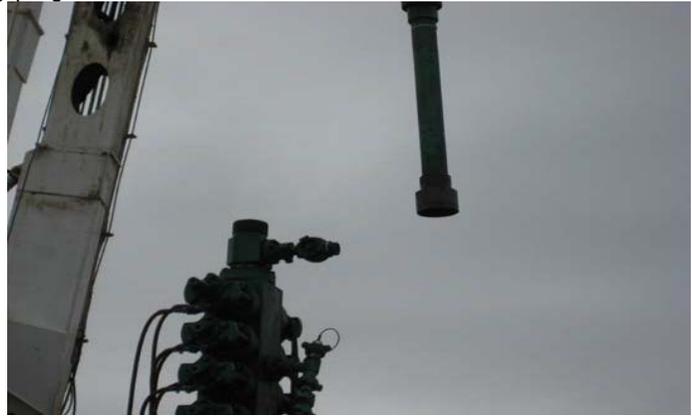
Image 2 is the approximate kick of the lubricator stack.

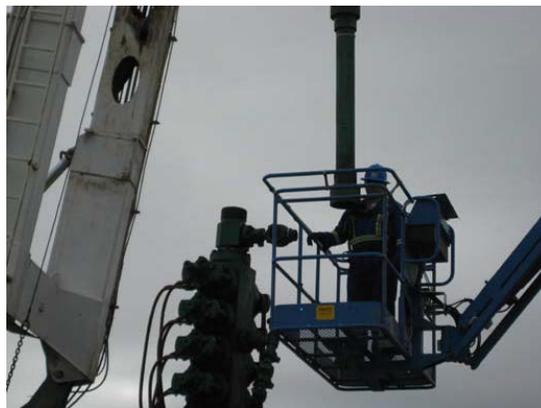
Image 3 is the employee being struck by the lubricator.
