ALERT 14 – 28

FALL FROM EQUIPMENT ONTO A TRAILER RESULTS IN A LACERATION

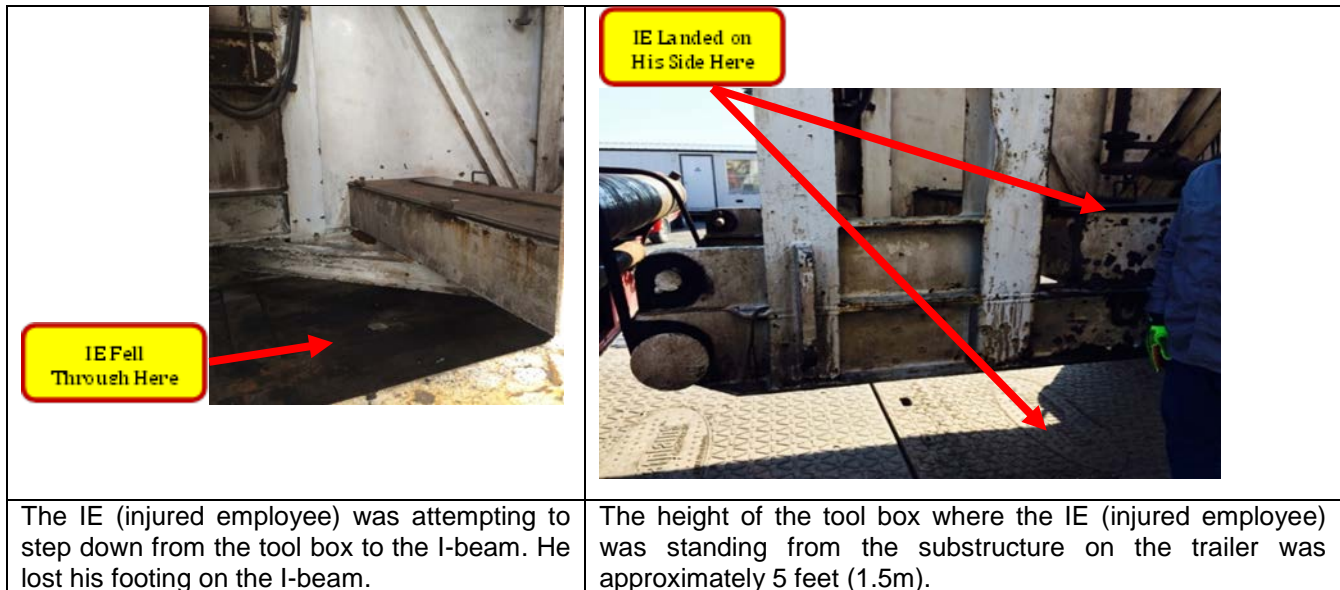
Once loaded onto a trailer for transport to a new location, the “toe” extension on the Driller side substructure base was removed due to it extending too far off the trailer because the driver was concerned about maneuvering the load to the new location. With the extension secured, two employees climbed up inside of the substructure to remove the pins. After the extension was removed, the employees then climbed down. While descending, one employee slipped off of a tool box, which was fabricated into the substructure. He fell approximately 5 feet (1.5m) to the ground and landed on his right side. Shortly thereafter, he noticed a laceration in his arm pit that required sutures to close. It appears that the employee may have struck a keeper pin as he fell from the substructure.

- The employee did not remain tied off as he descended the substructure and trailer.
- The “toe” extension had not been removed prior to it being loaded onto the trailer, and it was removed only after the driver expressed concern.
- JSA was not performed once a decision was made to remove the “toe” extension.
- A work basket was available, but it was not used to remove the pins.
- The Rig Manager (who was at the trailer and provided instruction) did not take a leadership role (he did not make sure that the above safety actions were implemented).

- Employees were reminded of the tie-off requirements when working at heights, which includes the determination of means for maintaining the tie offs when ascending and descending equipment.
- The Rig Manager was reminded to coordinate with the Truck Pusher and Truck Driver to determine if an extension should be removed prior to a load out (i.e., utilize a measuring tape to determine overall length).
- All crew members were reminded that a documented JSA must be performed for any critical, abnormal, or major change in an operation.
- Utilize the right tool for the job; the work basket should have been utilized to remove the pins.
- The Rig Manager was reminded that he must ensure that company expectations (JSA, SWA, tool / equipment selection, working at height) are discussed and implemented, especially for any critical, abnormal, or major change in an operation.
