ALERT 14-29

PERSONNEL BASKET FAILURE – SERIOUS NEAR HIT

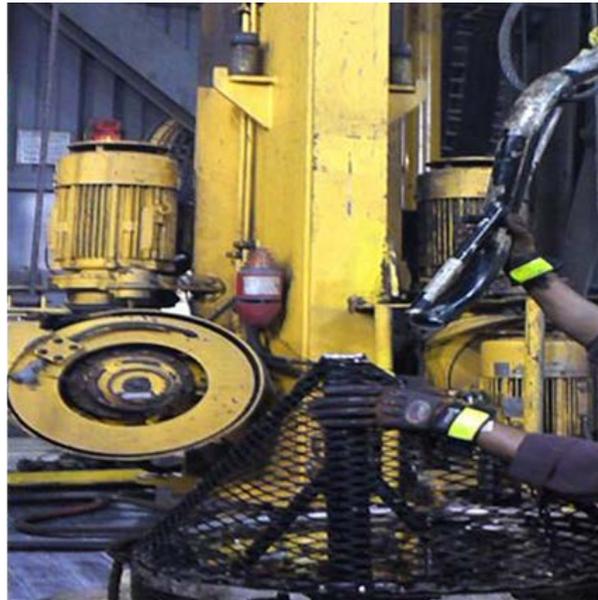
While lifting a Floorhand in a personnel basket to perform scheduled maintenance on the Pipe Racking System inside the derrick, the curved lifting pipe used to suspend the basket partially separated when the basket hung up on an obstruction. The basket and rider were approximately 110 feet above the rig floor when the incident occurred. The rider felt the basket tilt and called “all stop” over a hand held radio he was using to communicate with the banksman. The basket continued to tilt and the rider repeated the command “all stop”. The basket stopped just as the lifting pipe partially failed.

Personnel Basket with Separated Lifting Pipe

The personnel basket was designed as a lightweight aluminum basket to be used inside the derrick to lift a single rider. It had a Safe Working Load of 400 pounds with a tensile strength of 4,000 pounds. The hydraulic utility winch used to lift the basket was certified for personnel lifting but had a hoisting capacity of 14,000 pounds, which exceeded the tensile strength of the basket lifting pipe. When the basket hung up on an obstruction, the winch exerted more force than the basket could withstand and the basket partially separated from the lifting pipe.

- Extreme caution should be exercised when using personnel baskets which have a tensile strength below the hoisting capacity of the winch being used to lift them.

- The travel path of the basket should be surveyed for any obstructions that could contact the basket and a banksman should be positioned to have a clear view of the basket and rider at all times.

- Continuous hand signals should be used as the primary means of communication. Should hand signals cease, the lifting equipment operator must immediately stop movement and must not resume movement until clearly directed to do so. If radio communications are used the commands should be also be continuous with the operator immediately stopping movement if a command is not heard.

- Secondary fall protection attached to an anchor point independent of the personnel basket should be considered in the risk assessment conducted for all personnel lifting operations.
