MACONDO WELL INCIDENT
Transocean Investigation Report
Volume I

June 2011

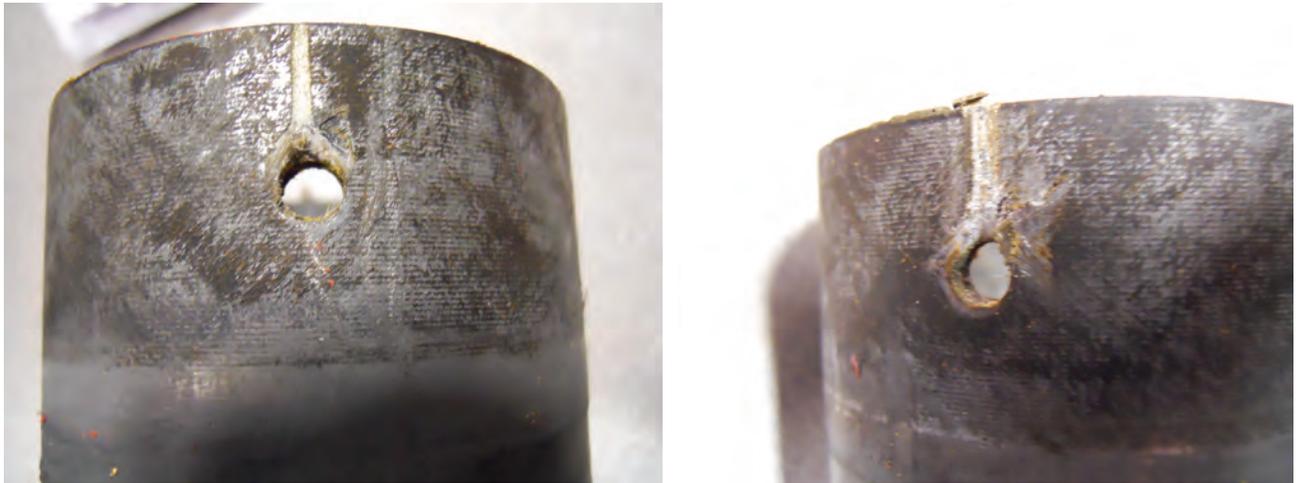
Figures 14 and 15 Flow Tube Damage During “Normal” Float Conversion Test

The first test checked the pressure at which the float collar normally would convert. A load was applied to the conversion ball at the seat position in an attempt to force the failure of the retaining screws and thus activate the floats. The screws did not fail; instead, the collar holding the screws in place failed under the applied load. The collar failure occurred at almost the same pressure on both floats tested: 410 psi and 406 psi, respectively. See *Figures 14 and 15*.

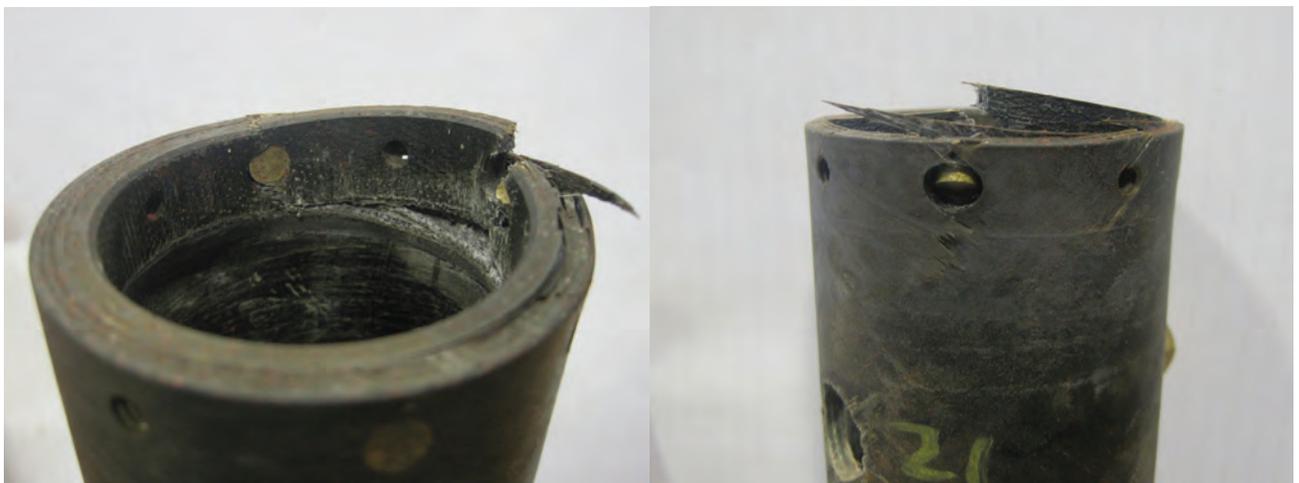
Figures 16 and 17 Actuation Ball Ejected Through Seat of Flow Tube

The second test checked the pressure at which the ball would be ejected from the tube (i.e., the pressure at which the ball seat in the tube would fail), and thus prevent the float collar from converting. The tube was installed in a plate and glued in place, and a load was applied to the 2-in. ball until it broke through the smaller 1.93-in. seat. The ball broke through at 1,477 psi on the first float and 1,840 psi on the second. This generally confirms the Weatherford representative’s assertion that the setting ball would pass through the tube without converting the floats if the pressure reached or exceeded 1,300 psi.³³ See *Figures 16 and 17*.

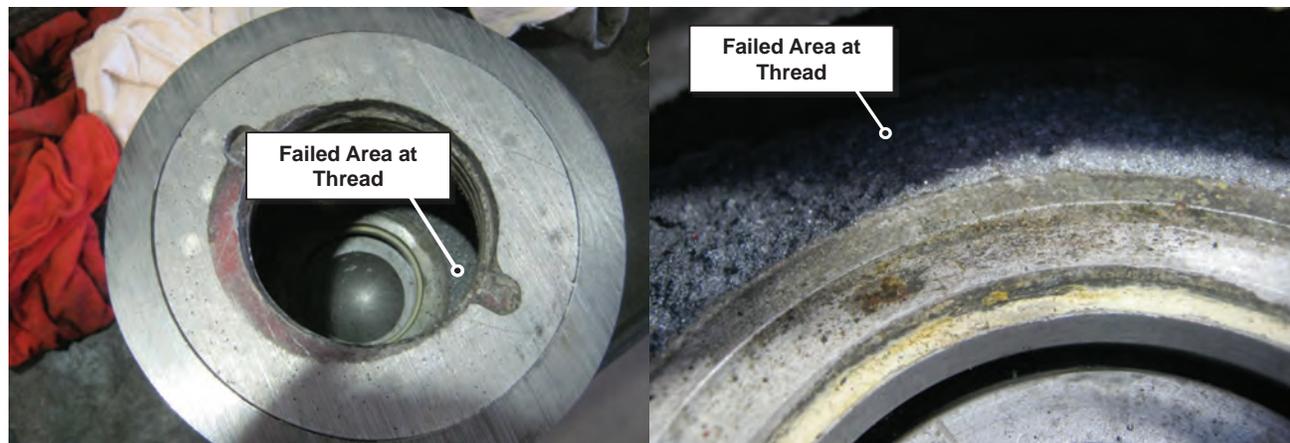
Figures 18 and 19 Damaged Internal Float Assembly

In the fourth test, the internal flapper assembly was exposed to a load from above to check the pressure required to cause the failure of the internal assembly, which was threaded into the collar. In this scenario, only one float was tested. It took a total of 10,155 psi (or 81,800 lb.) to cause the assembly to fail at the threaded connection. See Figures 18 and 19.

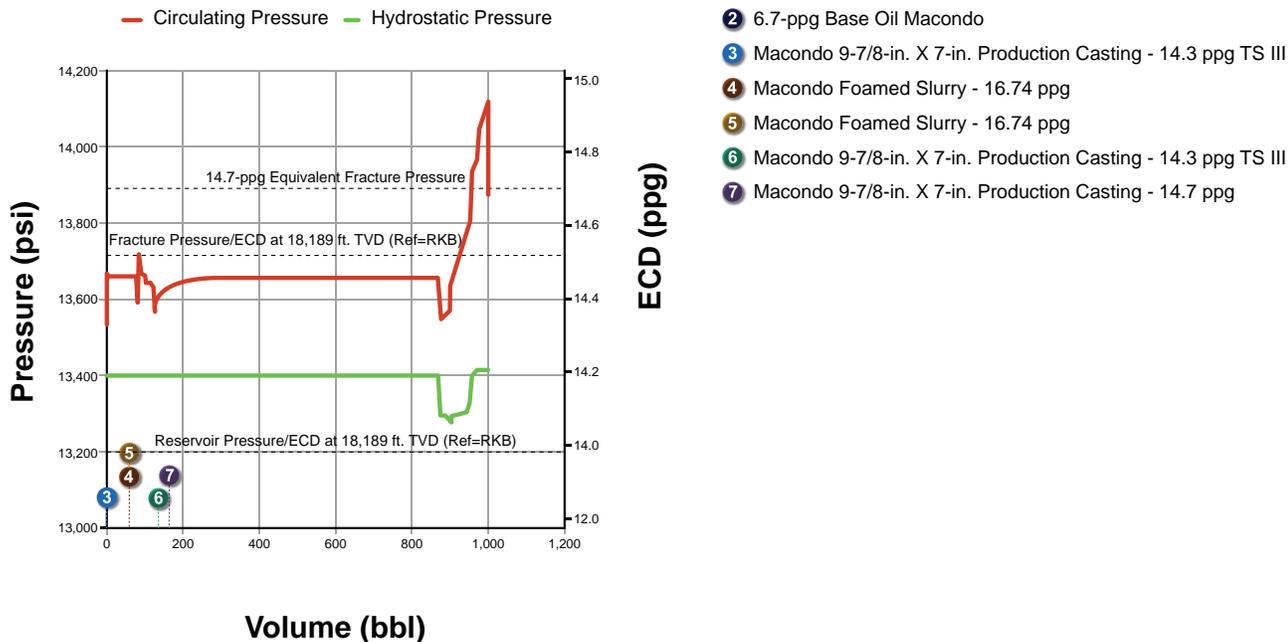
Figure 22 Circulating Pressure and Density Plot Showing Fracture Pressure would be Exceeded During Displacement (*Circulating Pressure and Density at Reservoir Zone: Downhole Annular Pressure and ECD vs. Liquid Volume*)

During the drilling of the final section of the well, BP correspondence noted that when picking up off bottom (lifting the drill string from the bottom of the well) with a 14.7-ppg equivalent circulating density (ECD) at 18,260 ft., the formations fractured and fluid was lost from the well to the formations.⁹¹ Halliburton’s April 18, 2010, report also showed that, according to its modeling, the ECD during cement displacement would exceed the fracture pressure at 18,189 ft. by more than 400 psi.⁹² See Figure 22.

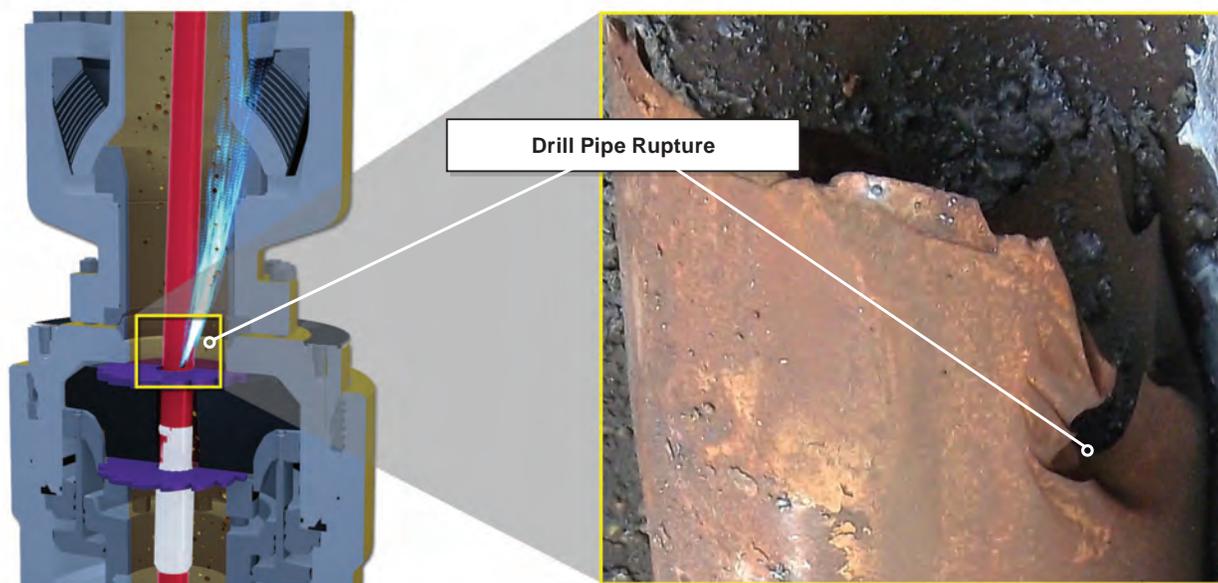
Figure 14 Rupture of Drill Pipe at Upper Annular BOP

Post-incident examination indicates that the eroded drill pipe located in the upper annular BOP burst under the increasing drill pipe pressure, which allowed hydrocarbons to flow through the ruptured drill pipe into the riser. As the rig began to drift away from the wellhead, the drill pipe was stretched between the rig and the BOP stack, where it was being held by the upper annular BOP and VBRs. The rig traveling block fell at approximately 10:20 p.m.; by then the weakened drill pipe had parted under strain in the area of the upper annular BOP, increasing the flow of hydrocarbons through the drill pipe and up the riser.
