Safety ALERT

Foot Fractured Caught Between Shifting Risers

Alert 2-19

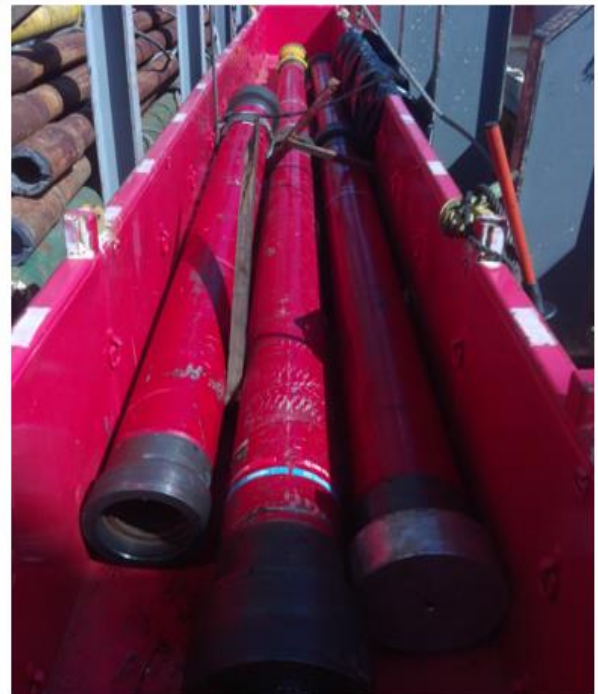
Final position of risers.
