# Safety ALERT

## *Finger Injury results from BOP Handling*

*Alert 4-19*

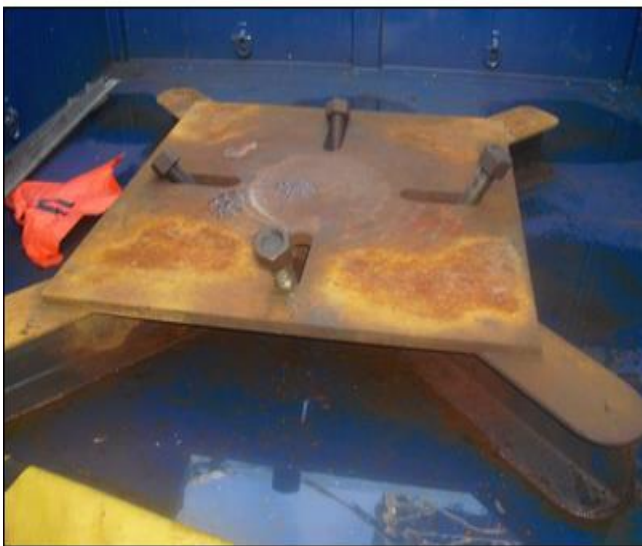
Securing plate BOP was landed on
