# Safety Alert

ALERT 13 – 09

## HIGH PRESSURE RELEASE RESULTS IN INJURY

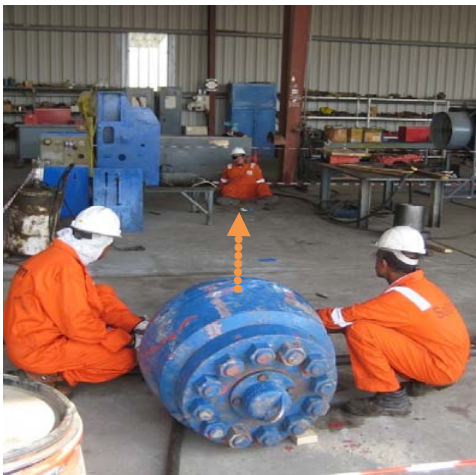
The maintenance team, consisting of three crew members, had been involved in stripping a pulsation damper's bottom plate, which had a damaged seal groove. Prior to starting the task, the crew checked the pulsation damper gauge for pressure and verified a zero pressure reading. After unscrewing all flange mounting studs and Allen-screws from the bottom plate, the crew started to remove the bottom plate with the extractor studs, which enabled them to move the bottom plate slightly. As per the advice of the crew supervisor and in order to remove the stuck bottom plate, it was decided to utilize the two inserts in the gap between the bottom plate and dampener body in combination with the extractor studs. While two of the crew members forced the bottom plate open with wedges from opposing sides, another crew member (injured person), who was positioned in front of the bottom plate, was using the pneumatic spanner to screw-in the extractor studs. Without warning, the diaphragm burst out due to the pressure inside, resulting in the bottom flange being discharged from the pulsation dampener. The bottom plate struck the injured person on the thigh of his right leg, throwing him approximately 6 meters (20 feet) due to the differential pressure wave, and causing serious injury to his right leg.

Position of IP after accident

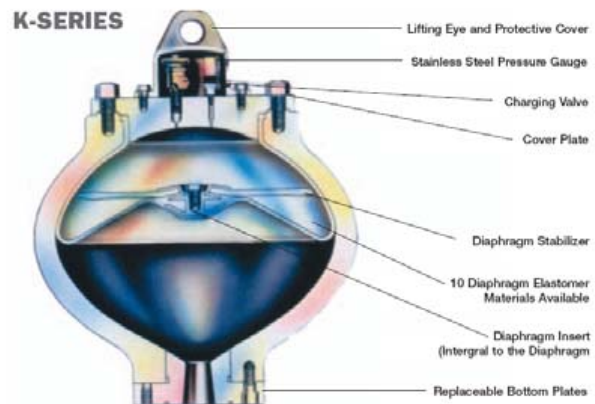
Pulsation Damper K-Series Diagram

The gauge read zero psi as witnessed by three separate people before dismantling of the dampener began; however, the gauge was faulty and showed an inaccurate reading. Consequently, the crew members involved in the operation did not anticipate the contained pressure and failed to bleed off the pressure by opening the charging valve. The pulsation damper had approximately 750 psi of pressure within, while the bottom plate was being removed. In addition, the contributing causes were:

- Pulsation damper gauge had an expired calibration.
- Pulsation dampener diaphragm was not secured to the diaphragm stabilizer with the diaphragm locking screw, which resulted in the diaphragm expanding like a balloon due to the system pressure, and piercing through the bottom flange hole, as the crew tried to remove the flange.
- The crew had no experience in removal of the pulsation damper's bottom plate.
- There was no Permit-To-Work (PTW) issued, Job Safety Analysis (JSA) completed and Toolbox Talk (TBT) conducted prior to starting the task.

- The company communicated the relevant Safety Alert to all rigs and logistic base teams.
- All maintenance crews were reminded that the system pressure must be bled off completely by opening the charging valve. Following this, the charging valve and gauge must be unscrewed from the pulsation damper. Further, it is recommended to remove the top cover plate during disassembly of the pulsation damper. This information should be reflected in the relevant JSA and discussed during the TBT Meeting.

- Pulsation damper plate stabilizers should always be secured to the diaphragm with the stabilizer screw (ensure during replacement of diaphragm elastomer).
