Safety Alert

From the International Association of Drilling Contractors

ALERT 13 – 10

HOT WORK OPERATIONS RESULTS IN DROPPED OBJECT

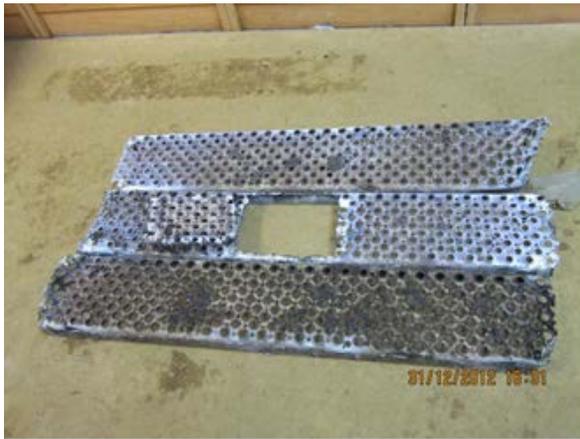
The 3 sections of grating measured 70 cm x 37cm (2ft x 1ft) and weighed in total 5.7Kg (13lbs).

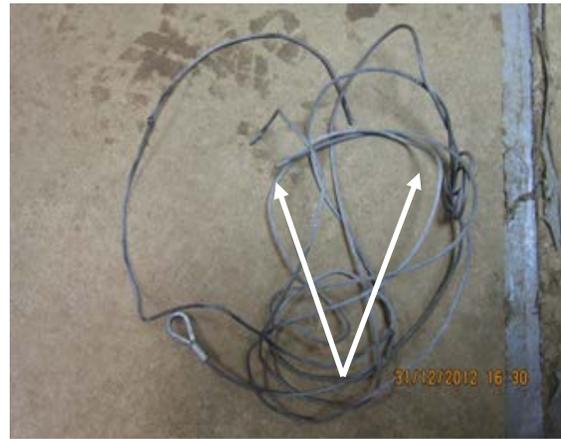
Retaining wire used to secure the grating. Arrow shows points of failure.

- During oxy/acetylene cutting of the grating, burning slag had made contact with the retention wire causing damage which had gone unnoticed.
- When the grating was cut free from the derrick structure the weight of the grating bearing on the damaged wire caused the retention wire to fail at the damaged point.
- The drop zone was insufficient.
- Personnel were present in the landing zone.
- There was only single point retention fitted to the grating.

- The company reviewed their method of securing the grating to include a primary and secondary attachment. The secondary attachment should be a minimum of a certified 1 ton wire rope sling.
- The company's risk assessment procedure was reviewed to include controls to prevent damage to any lifting equipment which was to be used.
- All employees are required to inspect all lifting equipment and accessories prior to and after every operation.
- All employees were reminded, during JSA review, to take measures to ensure no personnel enter into the drop zone.
- The company initiated a stand down and held a Toolbox Talk to inform all personnel of the ongoing work. Additionally, measures were implemented to restrict personnel from all outside areas during critical operations.
