Safety Alert

From the International Association of Drilling Contractors

ALERT 13 – 19

CONFLICTING PROCEDURES RESULTS IN RESTRICTED WORK CASE

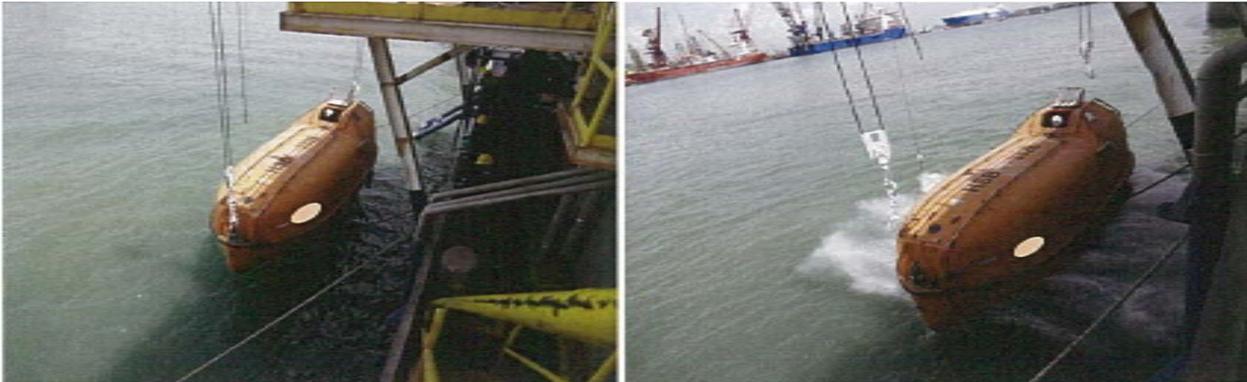
A third party surveyor, who was not assigned to the rig, attended the rig during a five (5) year survey. The surveyor wanted to test the lifeboat with an "on-load" release to the water. The Assistant Barge-Master (ABM) was assisting the surveyor to conduct the test and was sitting on a crew seat near the coxswain's seat with his hand flat on the seat to brace for impact. When the life boat was released "on-load," it fell and impacted the water. Upon impact, a small 1kg (2.2lbs) fire extinguisher, which manufacturer fitted near the coxswain's seat, released from its bracket and fell hitting the ABM's right hand and injuring his finger. The ABM was treated at a local hospital, placed on work restriction, and returned to work.

- The fire extinguisher fitted by life boat manufacturer was located in a position adjacent to the lifeboat coxswain's seat from where it released under dynamic loading and fell hitting an employee.

- The retaining clip on the fire extinguisher securing strap either failed during the test or prior to the test (unknown) allowing fire extinguisher to release.

- The lifeboat was not partially immersed in the water to reduce the dynamic effects as per the IMO operational work instruction. The classification society instruction stated "just clear of the water."

- The lifeboat was released from 1/2m to 1m (1.6 feet to 3.3 feet) out of the water; thus, increasing the effects of the impact.

- The company notified the manufacturer of the event in relation to the location of fire extinguisher.
- The company is taking steps to ensure that any items that may be effected to dynamic loading are properly secured prior to testing.

- The company initiated improved scrutiny of periodic checks on lifesaving and emergency appliances.
- All rigs are to ensure that any and all third party vendors provide a work instruction, risk assessment and JSA for any proposed activity; and must utilize permit to work and risk assessment to review and control the proposed activity.

- All rig managers are to ensure that proposed activity is conducted as per the work instruction and are required to stop the operation if the work scope deviates from the designated work instruction.

- All rig managers were reminded not to allow third-party personnel, even class surveyors, to perform operations without strict adherence to the company's safety management system or IMO instruction, and that they must maintain a firm system of control over all activities onboard.
