# Safety Alert

ALERT 13 – 23

## FAILURE TO TORQUE DRILL PIPE RESULTS IN SERIOUS NEAR MISS EVENT

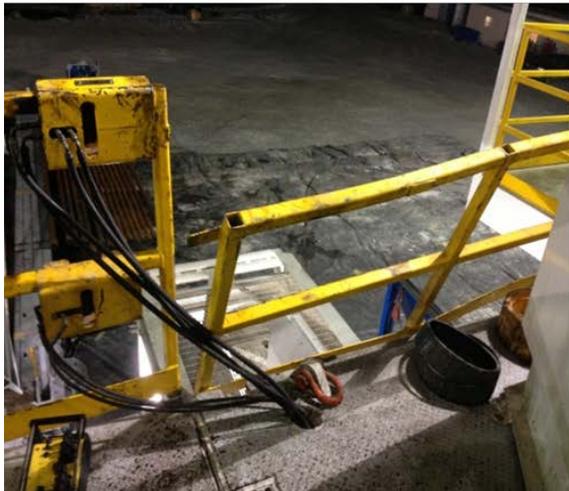
The crew had made up a stand of drill pipe in the mousehole. After hoisting the stand out of the mousehole, and while it was still hanging in the elevators, the crew began to make up a float sub to the bottom of the stand using the iron roughneck. Unknown to them, when the stand was originally made up in the mousehole, the connection (tool joint) between the top and middle joints did not get fully torqued thereby creating a “loose” connection. When the iron roughneck was engaged to spin the bottom joint of the stand to make it up into the float sub, it also backed out the “loose” connection between the middle joint and top joint of drill pipe, separating the bottom two joints of the stand from the top joint. The bottom two joints fell damaging the hand rails on the rig floor before continuing off the floor and coming to rest against the substructure. No injuries occurred.

Damage to Handrail

- Incorrect Torque Procedure – The iron roughneck operator applied the correct torque to the tool joint, but he did not notice that the jaws had bottomed out; i.e., the torque was not applied to the tool joint, just the jaws. He did not verify that the tool joint was tight before removing the machine from the pipe.
- Low Quality JSA / Work Plan - The JSA / Work Plan and review did not address the correct procedure for the specific operation (in this case, installing a float sub), nor the specific hazards associated with the task.

- The company reminded and instructed all employees on the iron roughneck torque procedure. The machine operator must be aware of the operating procedure of the iron roughneck, especially in verifying that correct torque is applied to the tool joint and in paying attention to the position of the jaws when reaching the designated torque. When in doubt, reposition the jaws and reapply the torque to make sure that the tool joint is tight.

- The company also reminded all employees that the iron roughnecks should not be engaged to spin a stand to the right with weight hanging in the elevators. I.e., the Driller needs to slack weight off the stand when the pipe is being spun onto any tool or tool joint.
