# Safety Alert

ALERT 13 – 26

## FAILURE OF LIFTING EYEBOLT RESULTS IN DROPPED OBJECT

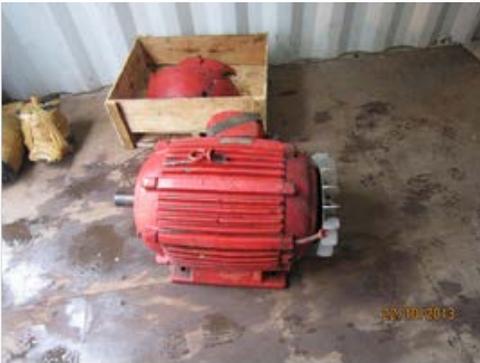
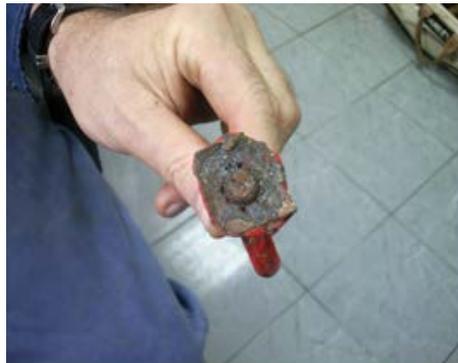
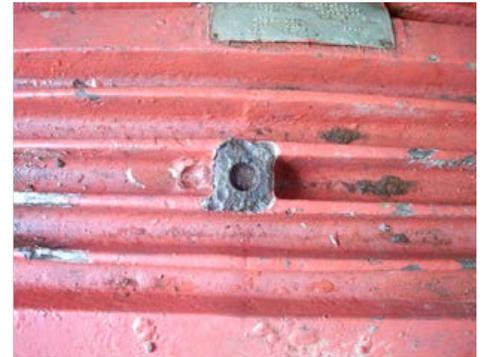
The deck crew was attempting to move an electric motor weighing approximately 200kg (440 pounds) from the shelter deck into a sea container. The motor was lifted using a crane. The banks-man signaled the crane operator to pick up the motor and lift it to the container, which was 5 meters (16 feet) away. The motor was lifted and moved to a height of approximately 2.5 meters (8 feet). When the motor approached the container at a height of about 60cm (2 feet), two roustabouts entered the container to position the motor from inside using taglines. As the motor was being pulled into the sea container it tapped the wall of the container. The motor casing parted at the eyebolt anchor mount allowing the motor to fall to the floor. The crane operator stopped the job and informed the Supervisor. No personnel were injured.

- Failure of the lifting eye.
- The motor had been in storage for a period of approximately 5 years. It was identified during the investigation the lifting eye had previously parted and had been welded to the frame of the motor at an earlier time by persons unknown. The implications of this were not realized by the crew and they thought that they could safely complete the task. The eyebolt had not been included in the lifting gear inspection routine.
- The motor had been painted and the lifting eye looked to be in good condition.
- Lack of knowledge by the deck crew to identify the hazards associated with previous failures of lifting eyes, and the fact they should never be welded.

- Rig crews were instructed to remove all lifting eyes from motors in storage and on location and replace the eyelet with a suitable bolt that conforms to the thread pattern of the motor.
- If eye bolts are to be utilized, rig crews were instructed to include the lifting eye bolts on the lifting inspection registers and routine maintenance inspections.
- All crews were advised of the previous alerts on lifting eye failures and inspection requirements.
- All personnel were reminded that lifting eyes are to be utilized for final positioning only. Electric motors are to be placed inside a designated basket for movement around the rig or they are to be slung by deck crew.
- Rig crews were reminded that lifting eyebolts are designed for final positioning on mounting brackets/foundation only and should not be utilized for overhead lifting and transport.
