# Safety Alert

ALERT 13 – 28

## SUDDEN ICE PLUG RELEASE RESULTS IN STRUCK-BY INJURY

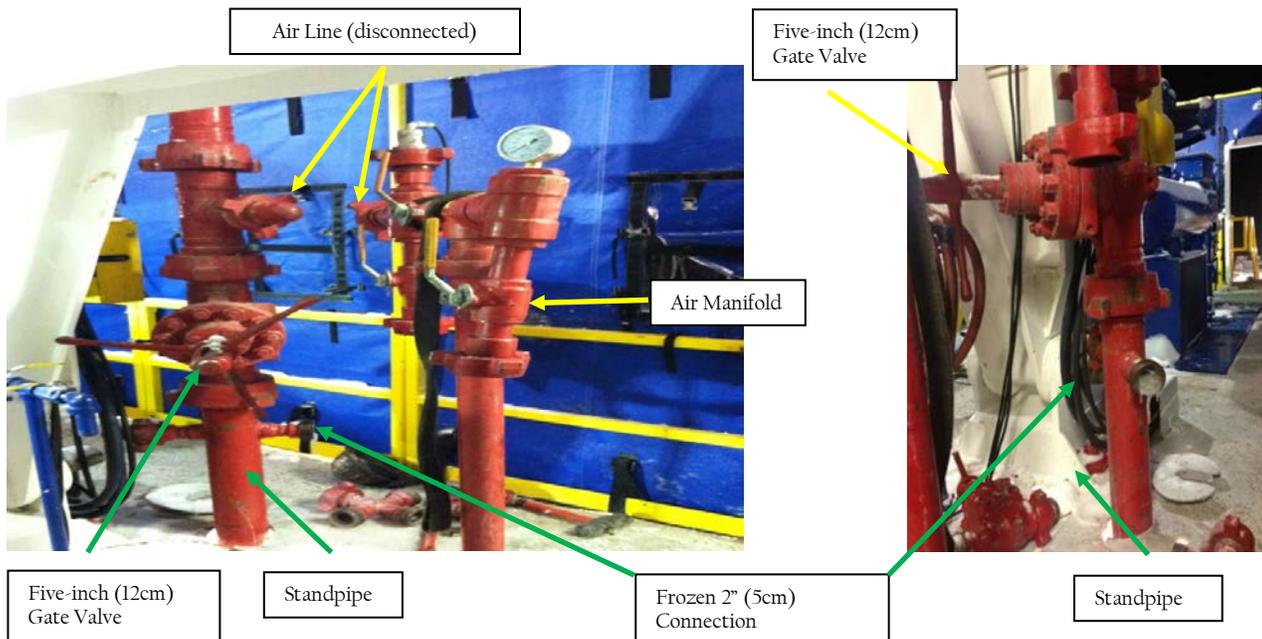
While converting from air to mud, the employee was attempting to reinstall the pressure gauge on the standpipe manifold. When he removed the bull plug from the manifold, he noticed ice had accumulated inside the two-inch (5cm) line. He notified the Driller and then attempted to remove the ice using a hand tool. Trapped pressure existed inside the lower section of the standpipe. As the ice dislodged from the line, it struck the employee in the ribs on the right side, causing internal injuries. He sustained further injuries when he fell back into the handrail striking his shoulder.

- Trapped pressure contained in the section of the standpipe below the five-inch (12cm) gate valve was not recognized and released prior to removing the two-inch (5cm) bull plug from the lower section of the standpipe.

- The crew assumed that the standpipe below the five-inch (12cm) gate valve did not have pressure since they were drilling with air, which was supplied and tied in above the five-inch (12cm) gate valve.

- Air pressure was contained in the standpipe below the five-inch (12cm) valve either from a leaking valve or from releasing pressure into the standpipe through the valve to make a connection while air drilling.

- Pressure reading devices (gauge or transducer) had been removed from the lower section of the standpipe for the air drilling.
- The crew did not understand the manifold configuration and did not realize that up-line approval was required in order for changes to be made to the manifold.

- The crew did not expect icing on the inside of the standpipe.

- Crewmembers were reminded to discuss the potential for “trapped pressure” and the importance of NEVER ASSUMING that pressure does not exist in a line.
- Employees were reminded to be aware of and to stay out of the potential “line of fire”.
- All crew members were made aware that extra effort must be taken to prevent pressurizing the lower section of the standpipe during air drilling operations.
- Crews were instructed that pressure reading devices are not to be removed from any isolated line unless other measures are taken to verify the presence of trapped pressure.
- Effort shall be made to assist crews, new to a rig/rig type, in order to develop a rig specific JSA (with appropriate detail) to familiarize them with any new aspects of a rig or rig type.

Crewmembers must be reminded of the potential for icing inside of any line and are to discuss (during JSA and periodically during cold weather operations) the hazards and steps to prevent an incident from occurring during any operation requiring separation/disconnection of lines/connections.
