Safety Alert

From the International Association of Drilling Contractors

ALERT 13 – 29

COMPLACENCY WITH A COMMON JOB TASK RESULTS IN INJURY TO THE DERRICKMAN

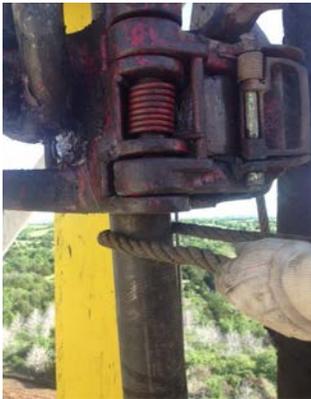
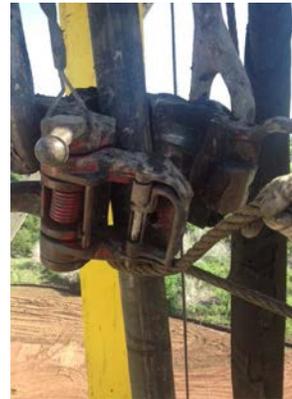
The Driller was watching the Derrickman via a CCTV monitor. After verifying that the rope around the stand was secure and that the elevators were unlatched, he floated the top drive link tilt cylinders back towards well center and began slacking off the top drive to get another stand of pipe. The Driller then looked up towards the fingerboard to verify that the stand had cleared the top drive and, after noticing it had not cleared, he quickly released the brake control joystick to apply full air pressure to the draw works brake to stop the load. The box (top) end of the stand had hung up somewhere on the top drive between the pipe handler stabbing guide and the link tilt actuator. The downward travel of the load had stacked weight on top of the stand and had put a “bow” in the pipe.

It was discovered that the Derrickman’s rope had become lodged between the spring-loaded latch handle and the body of the elevators, which was the reason why the stand had not cleared the top drive. Rather than letting go of the rope and moving to a safe position, the Derrickman attempted to free the rope by “jerking” on it. Instantaneously, the stand came free from its lodged position underneath the top drive and the stored energy in the “bow” of the pipe immediately shot the stand out towards the fingerboard and directly into the off-driller’s side (ODS) alleyway, where it forcefully struck the Derrickman in the mid-section and drove him into the back handrails of the fingerboard. Due to the extent of his injury, the injured employee was transported to a medical facility.

- The Driller failed to completely stop the traveling equipment after disengaging the clutch, which is common practice during tripping operations. He also failed to visually verify that the stand was clear from the elevators and top drive and secured by the Derrickman before slacking off to come down and latch the next stand.
- The Derrickman had positioned his pullback rope too high (too close to the elevators), which allowed the rope to get caught in the elevator latch mechanism which prevented the Derrickman from being able to clear the stand from the elevators.
- The Derrickman attempted to free the pullback rope hung up in the elevators rather than letting it go. Additionally, he was positioned in the direct path of the stand of drill pipe as it freed itself from the logged position and was thus struck by it.

- The Driller was reminded that he should come to a complete stop once the pulled stand is properly positioned at the fingerboard level. He should also visually verify and ensure that the stand is secured and the path of travel is clear of any other obstructions prior to lowering the traveling equipment.

- “Stop” stickers will be made, distributed and posted at the Driller location on all company rigs to provide a visual reminder.
- The company suggested a recommended practice for Derrickmen is to keep their pullback rope below the waist. This practice will be emphasized via distribution and review of this report and follow-up, on-site instruction will be provided by rig leadership and Drilling Superintendents.

- If a stand cannot be secured and cleared by the Derrickman for any reason, he should immediately release the pullback rope and move out of harm’s way by positioning both feet on the monkeyboard. This recommended practice will be emphasized via distribution and review of this report and follow-up, on-site instruction will be provided by our rig leadership and Drilling Superintendents.
