Safety Alert

ALERT 13 – 30

FAILURE TO TORQUE LIFT SUB RESULTS IN DROPPED MONEL DRILL COLLAR

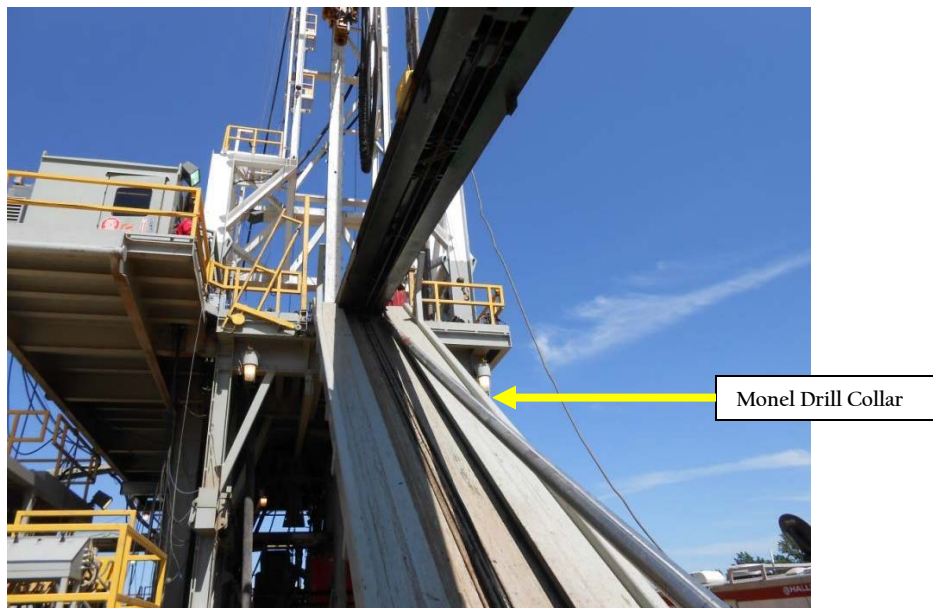
At some point while the crew was making up the float sub to the stabilizer, the lift sub unscrewed from the pipe-cat. When the iron roughneck was removed, the BHA, which was sitting on the rig floor, fell out of the V-door and land on the pipe-cat.

- The lifting sub that was placed into the monel drill collar was made up with chain tongs without being torqued before being lifted with the top drive. No one stopped the job to insure the connections were properly torqued.
- No one was watching the lifting sub to insure it was not coming unscrewed while the connection was being made between the float sub and the stabilizer. The iron roughneck was spinning the connection together at the bottom which allowed the lifting sub to twist out in the opposite direction at the top/overhead.
- There was no direct supervision watching over the operation to insure the task was completed “per standard procedure”, torquing the connections.

- All equipment being lifted overhead with a lifting sub, lifting eye, etc., should be properly torqued to the manufacturer’s recommendation before being raised to the vertical position. All personnel must utilize the stop work authority, never take short cuts, and complete the task as required.
- The idea of drawing a chalk line on the lifting sub to the collar was discussed and to designate someone to visually watch the lifting sub to insure it does not back out of the connection.
- Moving forward and for future operations it will now be required that the operator’s well site supervisor, directional driller or MWD employee must be present on the rig floor in addition to the tool pusher while working the BHA.
- Utilize the stop work authority to stop the job until all required personnel are present.
