# Safety Alert

ALERT 08 – 42

## DROPPED OBJECT: KELLY DISCONNECTS FROM HOOK

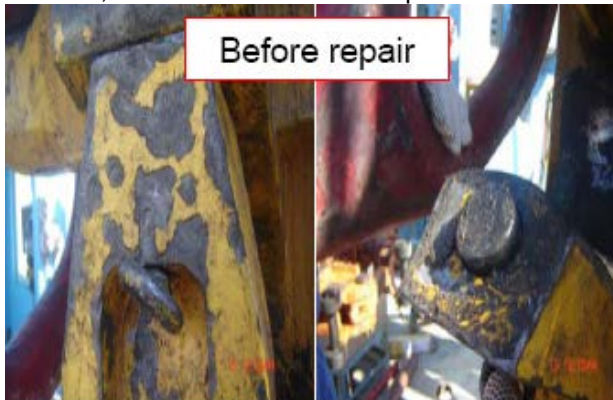
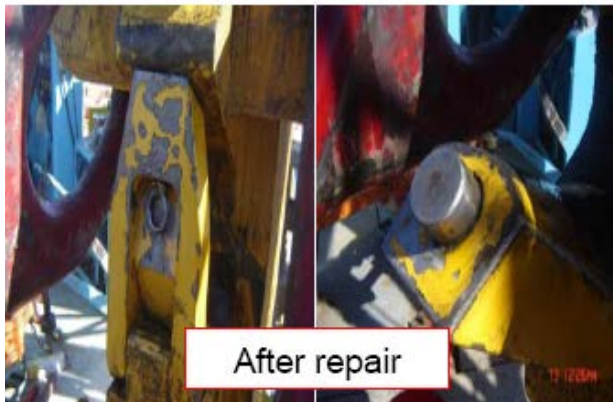
During drilling of the surface hole (12 ¼"), the driller made a connection and started to wash / ream down to bottom. Due to tight hole conditions, the drill string stopped two feet before the bushings were able to be set into the rotary table. The driller received direct instructions from the company representative to operate the kelly spinner to overcome the tight hole and the drill string did move down for ½ foot. The driller was re-instructed by the company representative to move the string up and down. During the process of moving the string down, the drill string reached a bridge, but the driller didn't notice it. This resulted in the string bouncing and the swivel hitting the hook, causing the latch to open and the kelly to drop to the rig floor resulting in damages to Kelly, rig floor handrail, mast ladder and driller's panel.

- The rig was provided with a 220 ton swivel instead of 150 ton swivel. Due to this, the bail diameter of this swivel is bigger than the hook space could accommodate. The larger bail made it difficult to close the hook without using force. This mismatch was not assessed by the engineering team or the rig crew. Failure to follow Management of Change (MOC) procedures.
- The air hoist was attached to a whip check that was used to close the lock of the hook latch. This resulted in bending the locking pin, preventing the pin from fully engaging. (Deviation from standard procedure).
- The driller was not paying attention to the hook load (weight indicator), so hitting the bridge caused the kelly to bounce.

- Swivel was replaced with one that fit the hook opening. In addition the kelly was replaced.
- The latch lock was repaired and the hook pin was inspected.
- Rig supervisors were instructed that any change in equipment shall be accompanied with a risk assessment in order to identify hazards and consequences. *Refer to the company's "Design Control and Development", Procedures and instructions Manual.*
