## IADC Safety by Design group scores victory with tongs, takes on mismatched hammer unions

### REDESIGNING TONGS

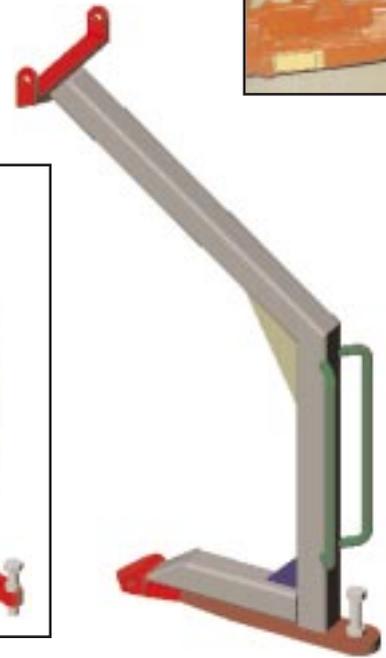
Safety foremost in tong redesigns: Industry-driven revamps of drilling tongs have had one goal—improving safety. The reengineering process was initiated by the IADC Safety by Design Subcommittee, which works under the auspices of the IADC HSE Committee. Several manufacturers enthusiastically shifted into high gear to develop more worker-friendly tongs. These photos show the changes. At top left is Foley Corp's new tong (inset shows old device); The 2 photos at top right (photo and inset) show Varco BJ's redesigned tong. The drawing at lower right shows National-Oilwell Harrisburg Woolley's changes (inset shows the old tong).

Other manufacturers lost little time implementing their own design changes. For example, **National-Oilwell Harrisburg Woolley** has modified its tong hanger and block and introduced several new tong handles. The company plans to showcase a display of the new tong features at the Offshore Technology Conference. Woolley's improved tong handles, the company says, will prevent damage to operators' hands. Some offer a soft plastic cushion for any body part caught between the make out and break out tongs.

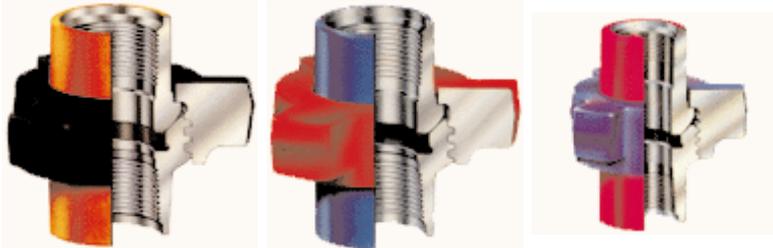
The worker understandably believes that 2 compatible components have been joined that will withstand pressures to the rated 6,000 psi. Unfortunately, though, a 5/16-in. gap exists between the diameters of the thread and wingnut halves.

A persistent hazard: The Safety by Design Subcommittee is targeting mismatched hammer unions, which poses a persistent threat on the rig floor. The problem occurs because male halves of 2-in. 602 and 1002 hammer unions (left and center, respectively) will make up onto the female, or wingnut, half of 2-in. 1502 unions (right). Despite the compatible threading, though, the mismatched components will not hold pressure, because a 5/16-in. gap exists between the diameters of the male and female halves. When pressurized, therefore, the components can blow apart, with deadly and environmentally harmful effects.

H&P IDC decided to eliminate all 602s and 1002s and to standardize on 1502 hammer unions.

Shorter-term answers include discriminating by color, either maintaining that of the manufacturer or by standardizing on another. Another idea was to attach safety cable or chains across the union halves. Pre-job coordination among all parties was also suggested, along with inspections of stand pipes and choke manifolds for potentials to mismatch.
