Safety Alert

ALERT 10 – 26

CRANE LIFTING OPERATION RESULTS IN A FATALITY

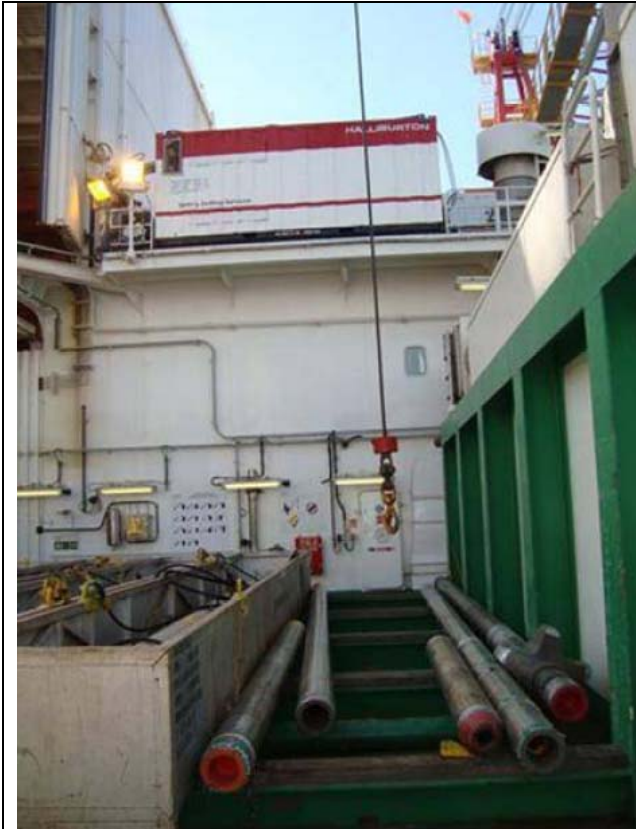
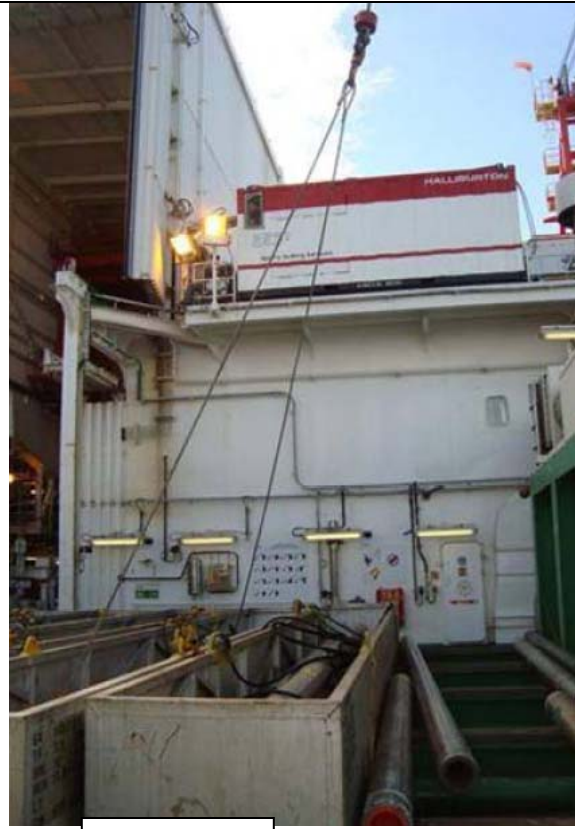
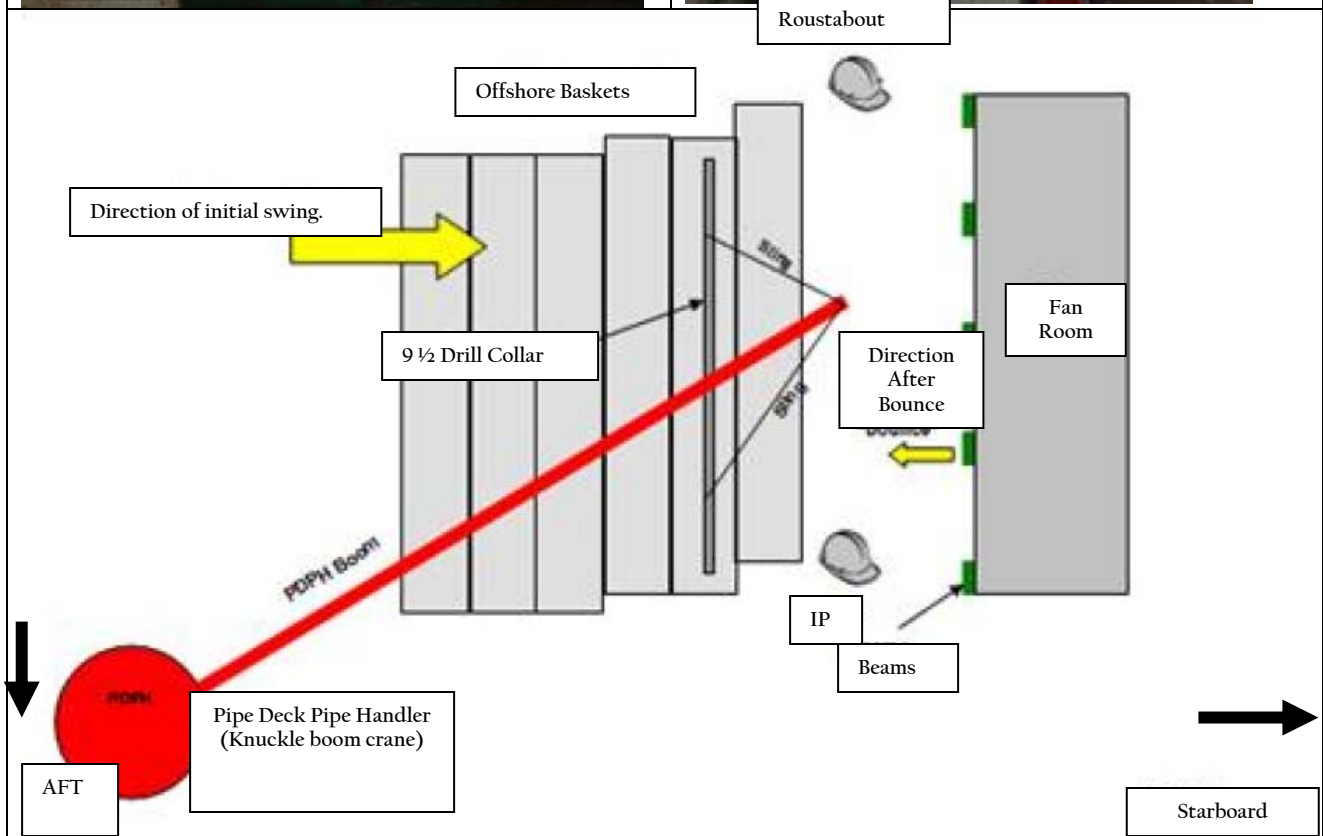
The incident occurred on the starboard aft pipe deck and involved the removal of a non-magnetic drill collar from its transport basket and laying it out in the adjacent open bay. The injured party (IP) and another roustabout carried out the slinging of the collar in preparation for lifting. The injured party, who was the designated banksman (signalman), signaled the crane operator to lift the collar out of the basket. As the lift progressed, the other roustabout involved in the lifting operation realized that the boom was not properly positioned over the load and called for a stop. By this time the collar was clear of the basket and swung towards the injured party who was clear of it as it passed. The collar struck the protective beams, and on its return swing, the collar impacted the IP in the lower left abdomen area. The IP was transported onshore and received medical attention, but expired two days later.

- Conducted a Safety Stand-down to discuss incident and lessons learned and instructed personnel that the Task Based Risk Assessment (TBRA) process is to be used consistently. (*JSA equivalent*).

- Reinforced with personnel to always use an escape route and protect themselves first.
- Task-Based Risk Assessment (TBRA) for general lifting was upgraded (*JSA equivalent*).

- Reinforced 4-point check process for crane lifting operations. (*StepBack 5x5 equivalent*).
- Translated all TBRA's to the native language(s) of workers.

- Required a TBRA to be completed each tour (12 hours) for crane lifting operations.
- Instructed supervisors to conduct verification of task-based risk assessments via the observation safety program.

- Added a 2nd translator to each rig so that there would be 24 hour translator coverage.
- Instructed crane operators to take tension on all loads, then stop lifting before load leaves the deck and ensure it is safe to lift.
