# Safety Alert

From the International Association of Drilling Contractors

ALERT 00-24

## PROPER SAFETY CLAMP LOCATION REDUCES DAMAGE FROM HIGH PRESSURE HOSE FAILURES

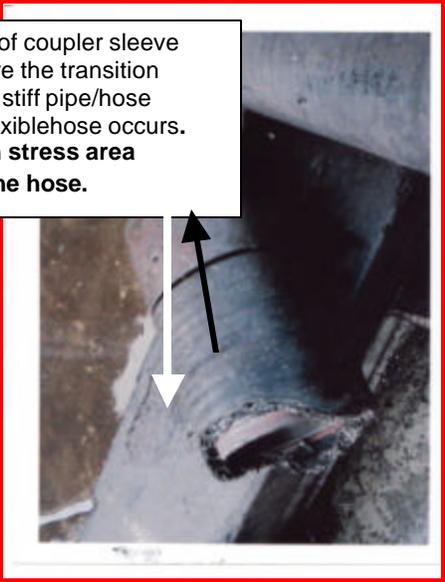
Both of these hoses failed shortly after the high-pressure mud system including the hoses was pressure-tested to rated working capacity. Failure to high-pressure hoses most often occurs at the transition point from the rigid steel coupling to the flexible hose.

End of coupler sleeve where the transition from stiff pipe/hose to flexible hose occurs. **High stress area on the hose.**

- Do not attach the safety line to the lifting eye that some manufacturers place on the steel coupler.
- Share the attached pictures of failed hoses with all personnel to show the importance of attaching the safety line six to ten inches inboard of the end of the coupler sleeve.

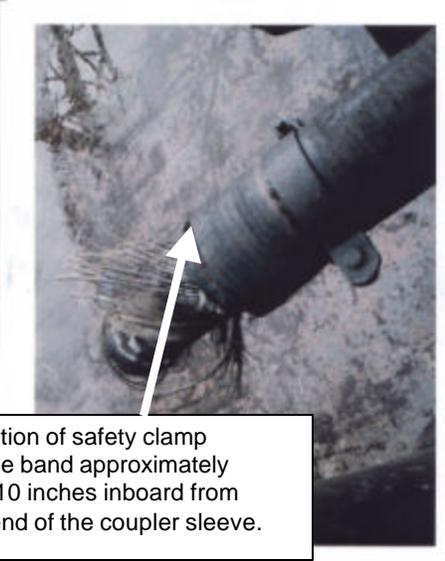
Location of safety clamp on the band approximately 6 to 10 inches inboard from the end of the coupler sleeve.

- The date the hose was manufactured and when it was put into service should be documented so its service life can be tracked.
- The *IADC Drilling Manual* states that the placement of safety clamps should be as follows: Rotary hose 6"-18" inboard of the coupling; vibrator hose 6"-10" inboard of the coupling. Refer to the manual for additional information.

- Many manufacturers place bands on the hoses indicating the proper location of the safety clamps. Check with your hose manufacturer to ensure proper placement.
