# Safety Alert

ALERT 07 – 27

## INCORRECT SLING APPLICATION RESULTS IN HIGH POTENTIAL NEAR MISS

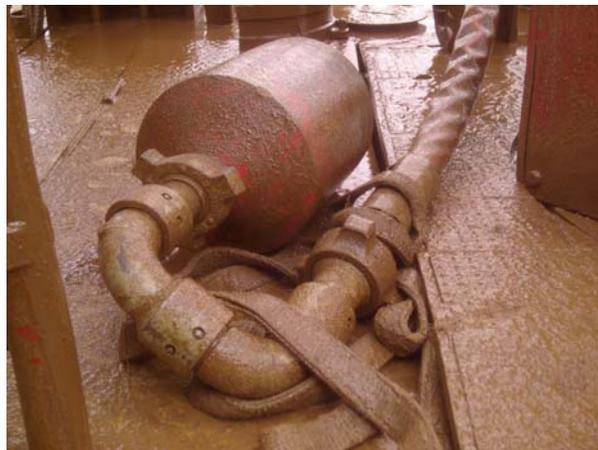
A 13 3/8" casing string had been run to the setting depth. The last few joints were washed down using a third party circulating head. The final joint to be run was a 15 foot pup joint, however, the Company Man instructed the crew to lay down the pup joint and pick up a full joint. The circulating head was re-installed onto the full joint by the crew on the catwalk. The joint was then made up and the hose connected. As soon as the pumps were brought on line to 30 SPM, the circulating head blew off. The web sling that was being used to secure the circulating head came unfastened and allowed the head to fall approximately 15m to the rig floor. No one was injured.

The selection and application of the safety sling was incorrect. A JSA was conducted, but the specific type of safety sling to be used had not been identified. The third party supervisor did not properly install or operate the equipment. The incident occurred directly after crew change. The oncoming crew did not take the required time to verify the equipment was properly installed and secured. The circulating head had previously been used and was known to be in good working order. It is therefore possible that because third party did not supervise the installation of the circulating head, the crew may have cross threaded it and as a result it blew off at a low pressure. The weight of the circulating hose was not taken by an air winch which allowed the casing head to be unreasonably side loaded.

- JSA revised to include proper use of securing sling and proper application.
- Training schedule made for on site rigging and slinging practice to include the proper use of wire rope slings, shackles and winch lines to secure equipment used at height (Dropped Objects Management System).
- Rig Managers to ensure third party equipment is properly installed, secured and operated. Third party companies to comply with the above by having qualified personnel.
- Discussion with all Rig & Line Managers at the Monthly Rig Manager's meeting shortly following incident.
- Line management to ensure distribution of incident to area rigs; understanding and compliance of the company's RMS policies and procedures.
