Safety Alert

From the International Association of Drilling Contractors

ALERT 09 – 21

SLIP & TRIP RESULTS IN MTO

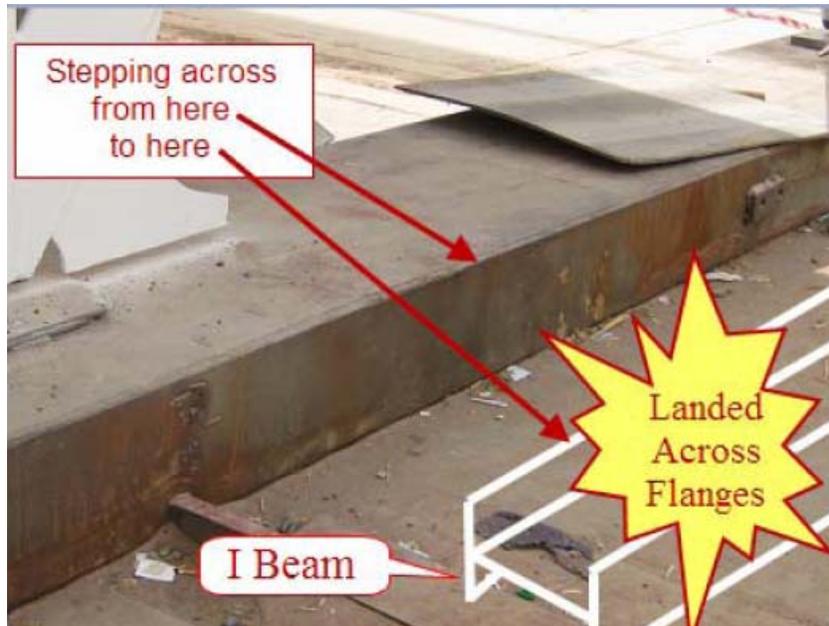
A company Team Leader was visiting the project site. After viewing the Texas Deck in the fabrication area, the injured person (IP) was stepping off of the raised support that the structure was sitting on and was attempting to step on the flange of a large beam laying on its side about two feet (0.61 meters) away. His footing slipped and he fell onto the beam, face down, landing on both flanges. His left arm/wrist/hand struck one flange while his left thigh struck the other flange. In addition, it knocked the wind out of him. Other than some obvious soreness, there was no indication of injury. A couple of hours later there was some swelling and redness near the knuckle of the left index finger and a trip to the clinic was made, whereby an ice-pack and tensor bandage was applied. Upon arriving home his wrist was still tender, so he made a visit to the doctor and it was discovered that he had received a minor fracture to a bone in his wrist.

- Lack of attention while walking through a construction area.
- Insufficient range of sizes available for PPE (boots) available for visitors at main office.
- Failure to communicate with main stores if additional stock was available.

- Do not step over a gap onto an irregular walking surface, especially if there is nothing available to steady yourself, such as a handrail. Step down off of one level before stepping up onto another.
- Constantly assess your personal positioning when walking through, or between, project assemblies and materials. Make sure of your footing before you commit yourself.
- If properly sized PPE is not available, in this case safety boots, then do not proceed out to the worksite until adequate protection can be obtained.
