ALERT 14 – 21

## LACK OF COMMUNICATION / FAILURE TO STOP JOB RESULTS IN FATALITY

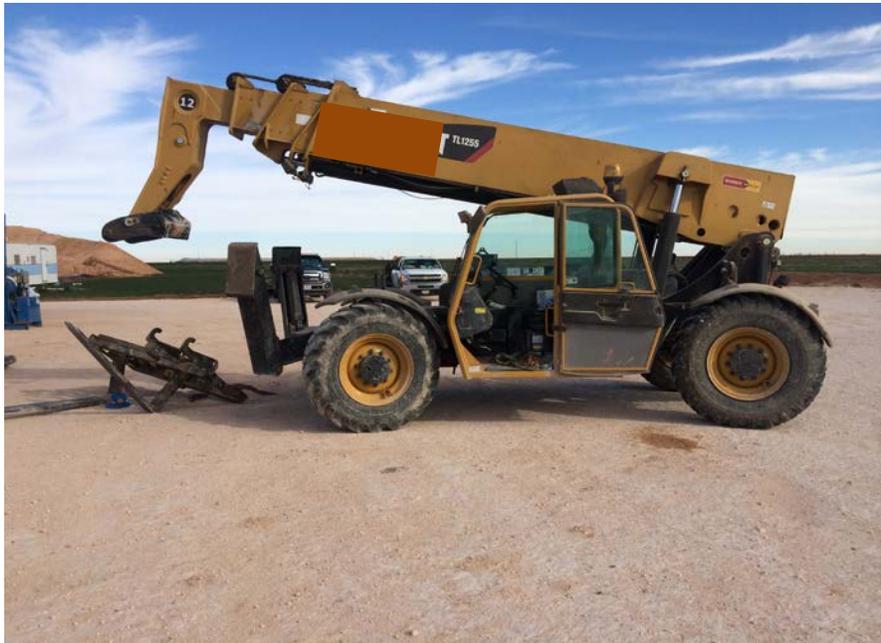
The rig crew was in the process of running casing. They had reached a point where a marker joint needed to be picked up and placed into the pipe handling system so that it could be made up in the casing string. The crew retrieved the forklift that had been rented for use on this location. They tilted the fork carriage forward so that the forks could be spread out. As the forklift operator tilted the 600 pound (272 kilogram) fork carriage forward, and because the hydraulic pins on the bottom were not attached to the carriage, the entire carriage swung free and was suspended only by the hooks. The crew attempted to hammer the pins out, not realizing they were hydraulic. Their intent was to pin the carriage correctly. The night company man was observing the operation and, after a discussion with the employees, it was agreed that the lift would be used in its “as is” condition to place the marker joint into the pipe handling system; and that the forklift would be corrected later. One employee was positioned in front of the forks in order to slide it over while two other employees pushed on the bottom section of the fork and away from the carriage. One employee stated to the employee, who was ultimately fatally injured, “Hey, you are in a bad spot” as he was standing directly underneath the carriage. The employee replied, “This is only going to take a second.” As they pushed on the bottom section of the fork, the fork carriage was pushed free of its hanging points and the entire fork carriage fell off of the lift. As the fork carriage fell, it struck the employee who was standing directly underneath the carriage on the head, thereby knocking and pinning him to the ground. He sustained fatal injuries.

- The day company man had ordered a bucket to be used on the lift later to level the location. When the bucket was delivered, the forks were removed and the bucket was picked up and set aside off location. When the forks were picked back up, they appeared to be pinned correctly; however, the pins on the bottom of the carriage were not engaged through the carriage (they were only through the carriage holder).
- Untrained personnel were used to remove and reinstall the forks on the forklift unit.

- The company re-emphasized STOP JOB authority to all personnel. Regardless of who is giving the direction, if the job is not safe, it will not be done until it is made safe.

- The company reminded all employees who are trained on forklifts that they are not permitted to remove the forks for any reason. If the forklift is rented, the employee will politely tell the company man that this task requires permission from the Tool Pusher.

- The company notified the other rigs in their fleet of the event. All personnel were instructed to never remove forks from the system. If the operator requires the forks removed and the forklift used for a different task, then they must call someone out who is trained to do so.

- The company will continue to train their personnel as forklift operators only.
- The company re-emphasized with all personnel that inspections at shift change or before the use of the forklift after shift change is mandatory. If the forklift is not in proper working condition, it shall be locked-out and tagged-out until it is fixed.
