ALERT 14 – 06

TANK CABLE STRIKE RESULTS IN INJURY TO EMPLOYEE

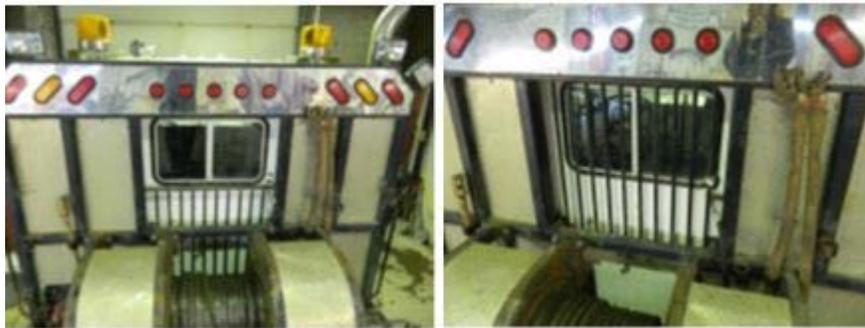
NOTE: In the pictures above, The window protection is down in the left picture as opposed to the correct position in the right picture.

- The rear window guard (cage) on the rear of the cab was not secured during the task allowing the winch line tail chain to punch through the rear window of the truck striking the driver.

- The company reminded all drivers and swampers that when winching tanks onto truck, the bottom front edge of the tank should be positioned so the tank is prevented from kicking out. This can be done by lining up the bottom edge of the tank with a slight overhang over the edge of the mat. The edge of the mat will prevent the tank from kicking out in the event that the truck fails to roll forward or the tank slips on the mat.
- All drivers were reminded to ensure that the cage of the rear window is always in the closed and locked position.
- All employees were reminded that the bridles, on tanks used to attach to the winch line, should be inspected and replaced as necessary.
