ALERT 14 – 09

HIGH POTENTIAL INCIDENT– STRUCK BY DROPPED OBJECT

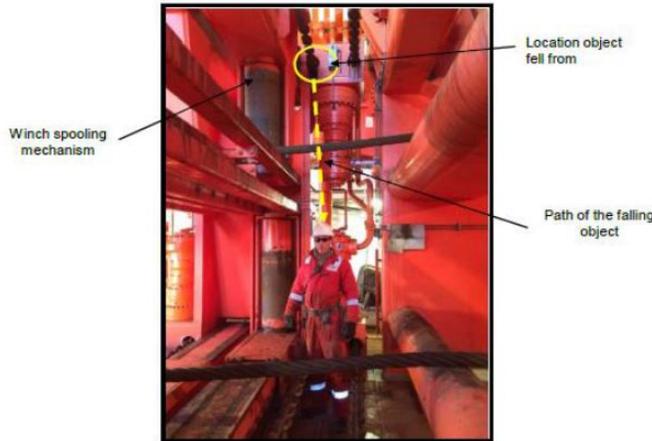
As part of the plough recovery sequence and whilst spooling a 200 meter (656 feet) pennant onto the storage pocket of an anchor handling winch, a chain guide, weighing 21 kilograms (46 pounds), and two sheared securing bolts dropped a distance of approximately 2 meters (6.5 feet) from the starboard chain motor area. The chain guide struck a member of the deck crew on the brim of his hard hat knocking it off. The chain guard then fell onto his chest causing superficial injuries and ultimately landed, with the sheared bolts, on the vessel deck. Using the Drops Calculator as a benchmark in the classification of the potential consequences of a dropped object, the outcome of this incident could have resulted in a fatality.

Position of IP

Chain Guide Chain

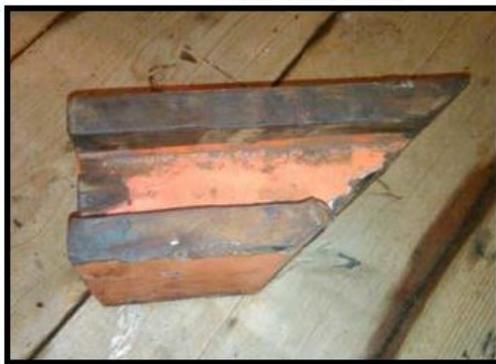
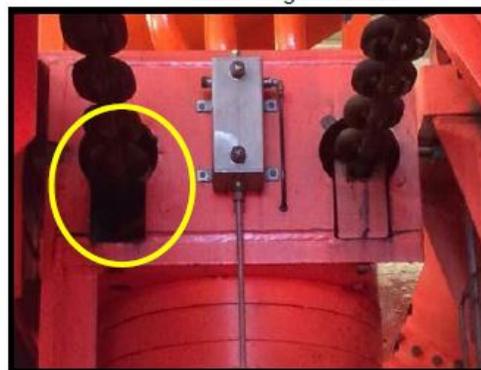
Guide Original location

- The initial investigation found that one bolt appeared to have fractured; this had the potential to cause misalignment of the chain guide during normal operations. This misalignment appears to have resulted in the chain guide to catch on the chain, resulting in the shearing of the second bolt and fall to the deck.
- The injured party should not have been in the area during this operation.

- The company required their maintenance staff to ensure that all securing bolts are checked within the winch house area across the fleet.
- The company required all managers to hold a “Time Out For Safety” session to discuss this safety notice.
