# Safety Alert

ALERT 04 – 49

## DROPPED 18 5/8" CASING NEAR MISS INCIDENT

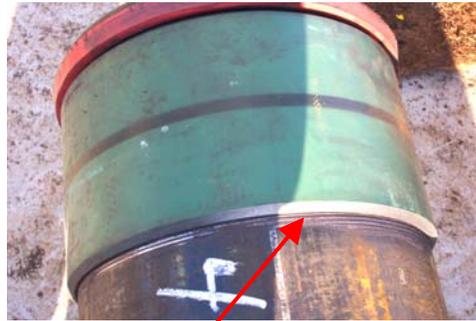
1. The Service Representative preferred to use a pickup line over single joint elevators. He felt that it was just as safe, and would be easier for the rig floorhands and stabber hands. All parties failed to see the hazard of using a single wrap around casing with a beveled collar.
2. The pickup line was 35 feet long and the elevator bales were 18 feet. This meant that the pickup line was only long enough to wrap around the casing once.
3. The Driller picked up the joint of casing from the V-door onto the rig floor. At the top of the V-door the floor has an offset. The casing struck the offset, causing it to vibrate. This may have contributed to the pickup line slipping off the casing.
4. The beveled shoulder made it easier for the pickup line to slip over the collar as it was being moved.

Note the beveled collar shoulder.

1. Using casing pickup elevators is the preferred method of picking up casing. The operation should always attempt to secure the appropriate elevators prior to running casing.
2. If pickup elevators cannot be obtained, then a pickup line of the appropriate length may be used. The line should be long enough to reach the casing in the V-door and allow for two wraps on it, and for the casing stabber to remove them easily.
3. The pickup line must be inspected prior to use to ensure that it is certified for the weight of the pipe to be lifted and in good condition.

4. Although there were no injuries in this incident, it is a good reminder that no one should ever turn their back on moving casing, and they should have a clear escape route available at all times. This should be covered in the JSA.
5. The OIM should conduct the JSA with all parties involved to ensure that everyone involved is aware of the dangers and correct procedures associated with the job. "Never take anything for granted."
6. Although the Service Representatives handle most of the job, responsibility for safety remains with the rig supervisors.
