ALERT 14 – 16

IMPROPER HAND PLACEMENT RESULTS IN AMPUTATION

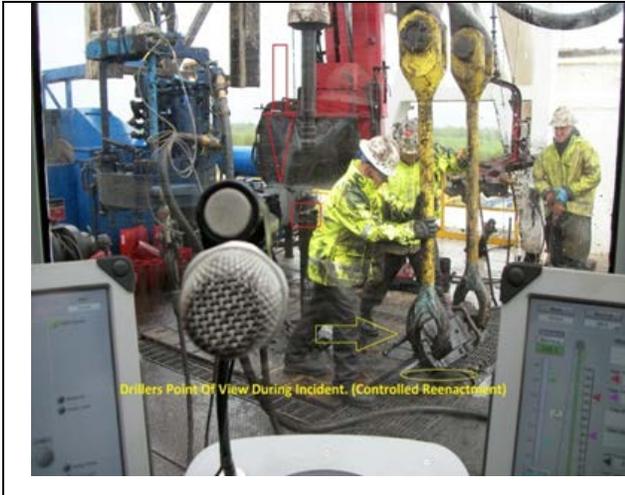
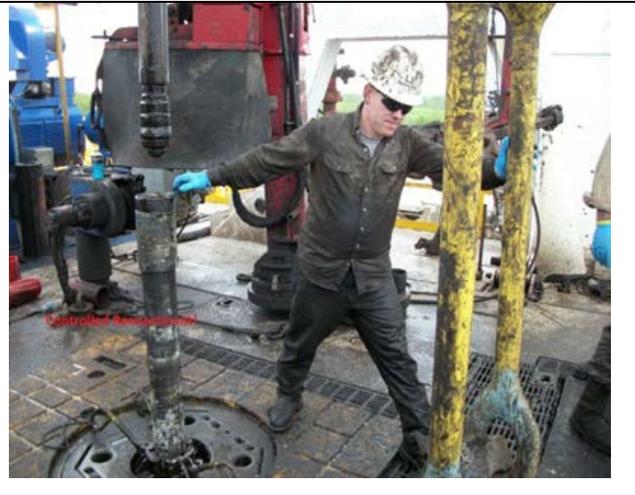
The rig crew and a 3rd party company were running casing with a Casing Running Tool (CRT). After running the casing to the curve (kick-off point), the slips were set, the elevators were removed, and the CRT was lowered to fill up the casing. As the CRT was nearing the top of the casing in the rotary, a 3rd party casing employee (IP or injured person) grabbed the top of the casing for leverage. In an attempt to gain leverage, he placed part of his fingers inside the casing while pushing the elevator links out of the way with his other hand. As the CRT was lowered, his fingers were trapped between the CRT and the casing resulting in the amputation of his fingertips.

- The 3rd party casing employee placed his hand into a pinch point for leverage.
- The 3rd party employee was a Short Service Employee (SSE) and was not recognized in the pre-task JSA as such prior to beginning the casing operation.
- The slips were set with the top of the casing low to the floor which allowed for a “convenient” leverage point for employees working on the floor.
- With the slips set where the top of the casing was low to the floor, there was not enough room to allow the insertion of the CRT without removing the elevators.
- Crew positioning, while pushing the elevators and links back, minimized the Driller’s view.
- Wet weather conditions minimized the Driller’s view of the work area.

The company instructed all rigs in the fleet to review and revise the rig specific JSAs to:

- Remind all crew members, including rig and 3rd party contractors, to never place their hands and fingers into any pinch points, especially on top of pipe or casing that is being run in / out of the hole.

- During the pre-job safety meeting, the supervisor should question 3rd party personnel to determine their experience level / SSE status, and to remind all personnel to be more watchful over inexperienced personnel.

- For fill-up operations, set the slips high enough to keep personnel from being able to reach into the top of the casing for leverage.
- Setting the slips high should allow the CRT to be inserted into the casing without removing the elevators. If this is not feasible, then other steps should be determined and communicated to identify the potential pinch points and to remind personnel to keep their hands and fingers clear.

- Keep the floor area around the casing clear of personnel when lowering the CRT.
- Whenever conditions (weather, obstruction by personnel, etc.) minimize the view of the work area, a Stop Work should be called to discuss the concerns and determine the steps to proceed more safely.
