Safety Alert

ALERT 13 – 01

FALL FROM V-DOOR RESULTS IN NEAR MISS

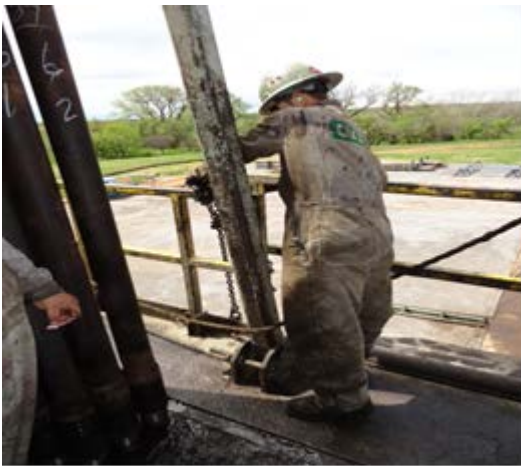
Position of the Injured Employee prior to his fall and the position of the snatch block chain.

- The V-door gate was opened pre-maturely which allowed the injured person to work from a height without the use of a guard rail in place.
- The injured person and the crew member running the hoist were not communicating properly during this procedure.
- The snatch block was hung from a handrail too close to the open V-door area.
- The crew became complacent and did not recognize the potential hazard in performing multiple tasks at the same time.

- Reviewed and/or updated all JSAs for this particular task and the information was shared amongst all rigs in the fleet.
- Reminded crew members that the V-door gate should never be open until you are ready to either lay something down or lift something to the rig floor. The crew members were also reminded to take one step at a time.
- Reminded all crew members to remain in constant communication during such a task.
- Informed all rigs that the snatch block should be hung below the V-door gate. This would allow the V-door gate to remain closed until they are ready to open it.
- The crew was reminded about the need to recognize the potential of all hazards while performing their job tasks.

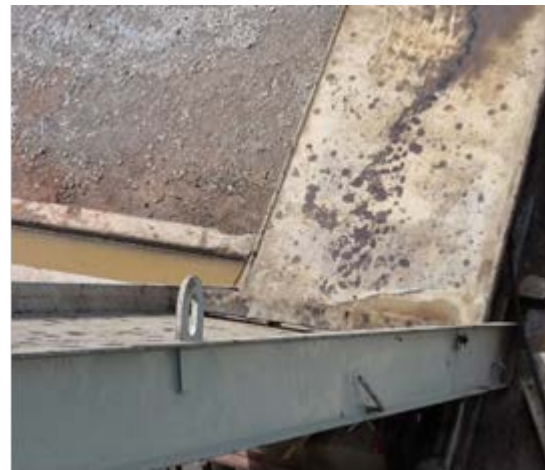
Position of the employee after his fall.
