## RIG FLOOR PLATE FALLS TO PRODUCTION DECK

Alert 6-19

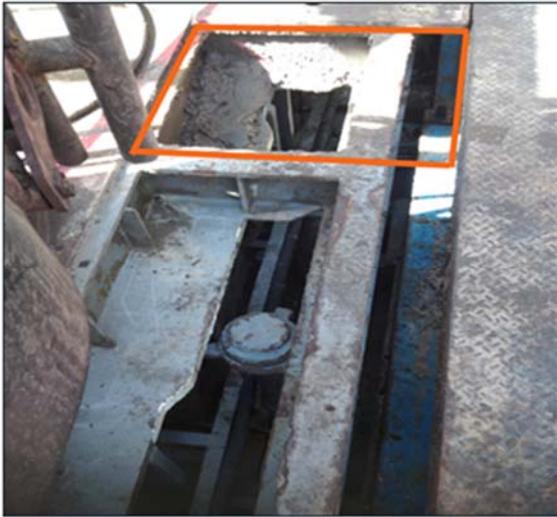
Figure 2 – Original position of the plate

- During construction of the rig, the plate that fell was not installed as per the construction drawing. It was designed to be a single piece but was found to have been cut from its parent plate and installed into its designated slot without being welded back together, resulting in the plate not being secured to the base.
- The procedure utilized for the rig floor cleaning activity did not provide detailed instructions for the safe execution of the task, including effective mitigation against dropped object risks.
- The rotary table housing sub-structure had an existing gap which allowed for the plate (or other potential dropped objects) to fall through. This was not identified by anyone since rig delivery.
- Design rating of the platform's top deck removable slot cover was not adequate to withstand an impact from a dropped object of this weight and height.

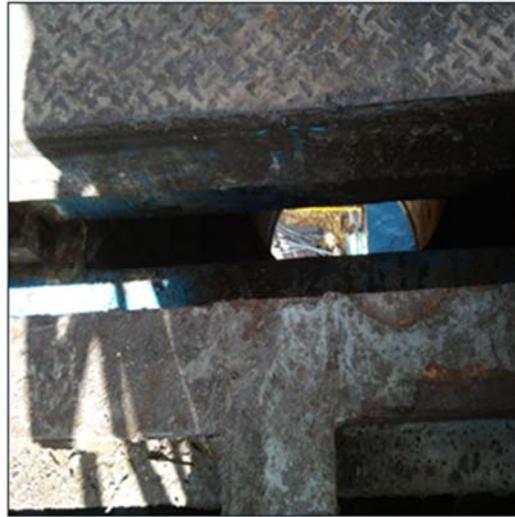
Figure 3 - Gap in rotary where plate fell through
