ALERT 14 – 11

LACK OF COMMUNICATION RESULTS IN FATALITY

Safety Alert

From the International Association of Drilling Contractors

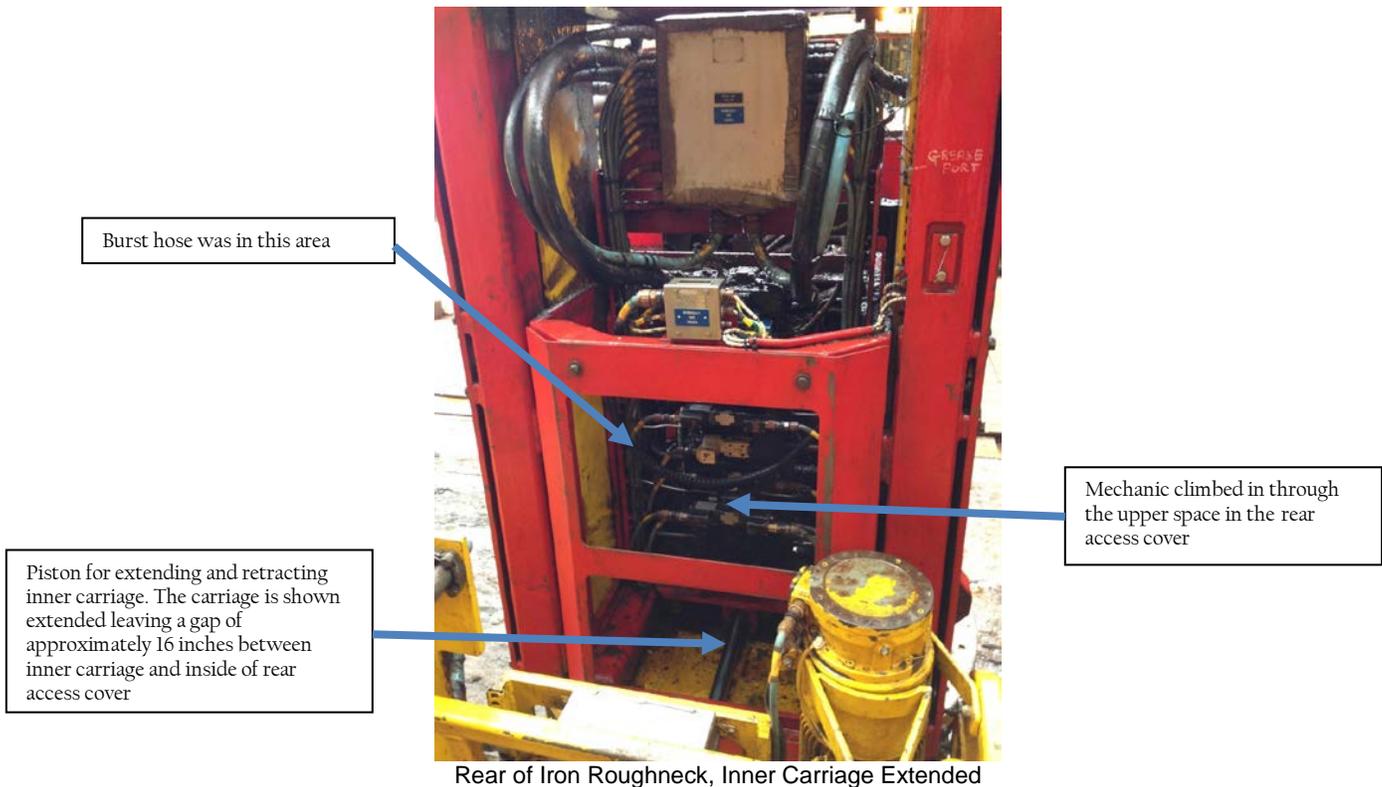
The iron roughneck was in “single” mode and in this position the iron roughneck inner carriage is extended out of the carriage’s frame resulting in a 16 inch (41cm) gap between the iron roughneck and the rear access cover. The Mechanic climbed over the rear bumper bars on the PHM and entered into the 16 inch (41cm) gap between the iron roughneck inner carriage and the rear access cover.

The Assistant Driller functioned the PHM to “normal” mode (which causes the iron roughneck inner carriage to retract back into the assembly frame) and then functioned the PHM to rotate to the aft set-back area to pick up a stand of pipe.

- Inadequate Communication - Mechanic returned to the worksite via a restricted access and commenced intrusive work on the iron roughneck without notifying the Driller or the drill crew, even though he had been informed that the PHM was required for operations.
- Routine non-compliance with Energy Isolation Requirements – rig floor hydraulic equipment was worked on routinely without effective isolation
