MACONDO WELL INCIDENT
Transocean Investigation Report
Volume I

June 2011

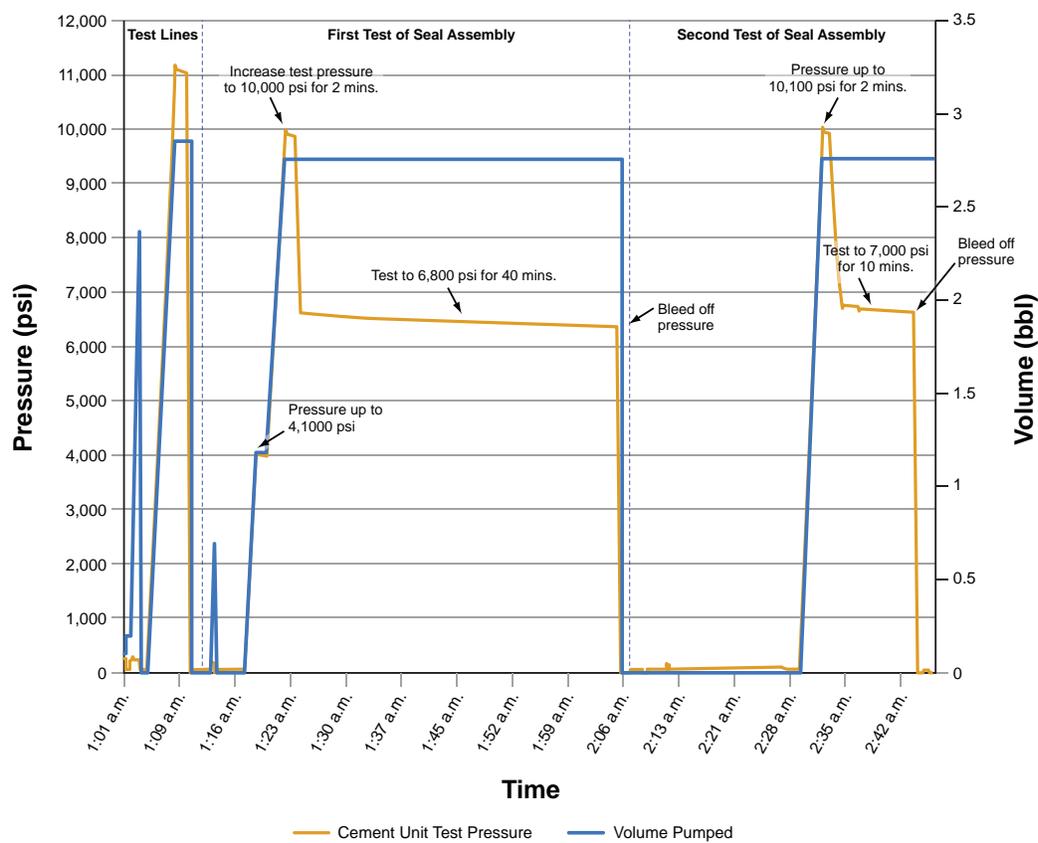
Figure 3 9-7/8-in. Casing Hanger Seal Assembly Tests (1:01–2:47 a.m.)

The installation of the wellhead housing, casing hangers, and seal assemblies occurred without incident.³ On April 20, 2010, at 1:17 a.m., after cementing operations were complete, the last seal assembly installed for the 9-7/8-in. x 7-in. production casing was tested. The seal was tested to 10,000 pounds per square inch (psi) for 30 seconds and then to 6,800 psi for 40 minutes.⁴ After the running assembly was fully released from the casing hanger, a second test was conducted to 10,100 psi for 30 seconds and then to 7,000 psi for 7 minutes to ensure the seals were still effective.⁵ Figure 3 shows the tests conducted on the seal assembly.⁶

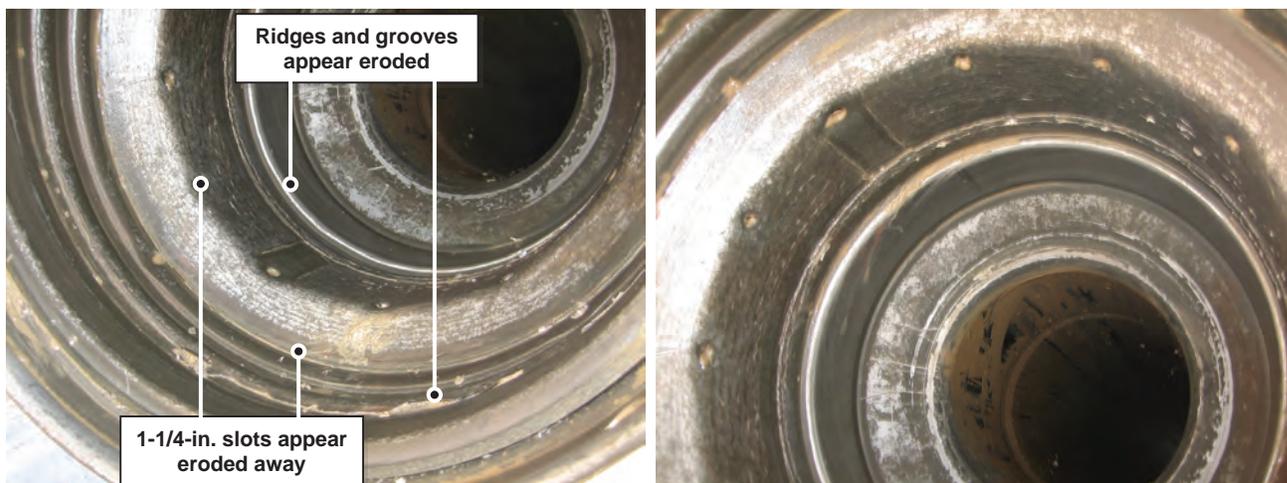
Figure 4 Macondo 9-7/8-in. Casing Hanger (Interior)

At the time this report was completed, the official Dril-Quip analysis of the wellhead, casing hanger, and seal assembly condition was still underway. However, the photographic evidence available to the investigation team does not appear to show flow around the outside of the production casing, hanger, and seal assembly; evidence of flow related to the blowout appears from the interior of the casing. *Figures 4 and 5* are photographs obtained after retrieval of the hanger assembly, showing the condition of the production casing hanger after it was retrieved from the well.⁸

Based on available information, the investigation team concluded that there were no failure points associated with the subsea wellhead system or its components, including the low- and high-pressure wellhead housings, the casing hanger, or the seal assembly that contributed to the Macondo incident.

E Previously, a lead impression block was run on Sept. 9, 2010. The result of this operation confirmed the 9-7/8-in. casing hanger was properly seated.

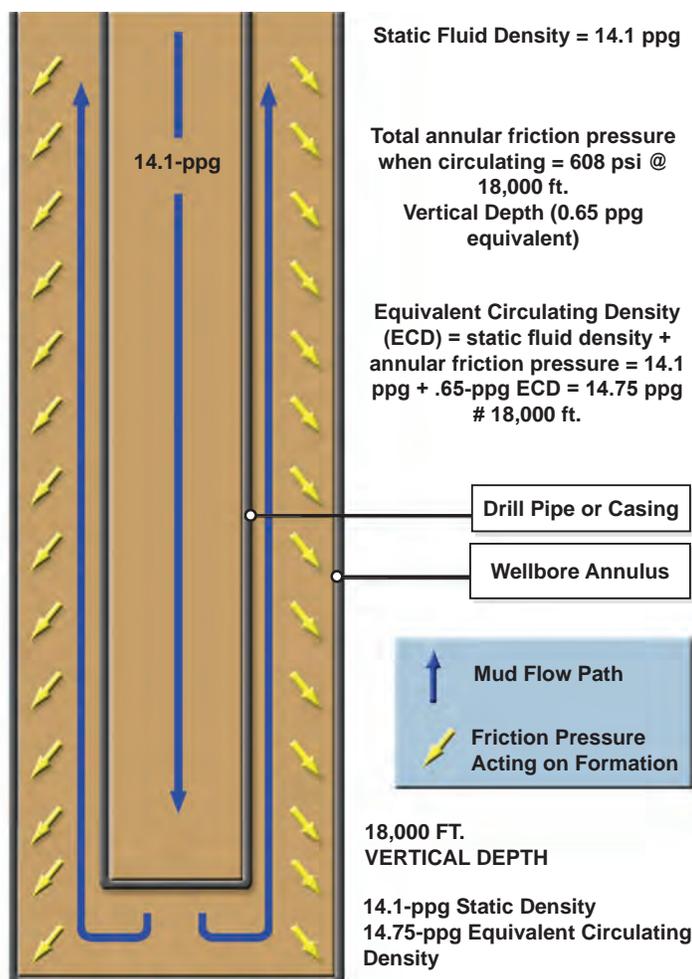
Figure 6 Equivalent Circulating Density

The long-string casing design used by BP at Macondo imposed stringent limits on allowable ECD. This narrow window drove the design of a cement program that was overly complex and that ultimately failed. The program called for pumping a minimal volume of cement that left room for normal field margin for error; it required exact calculation of annular volume and precise execution in order to produce an effective barrier to the reservoir.

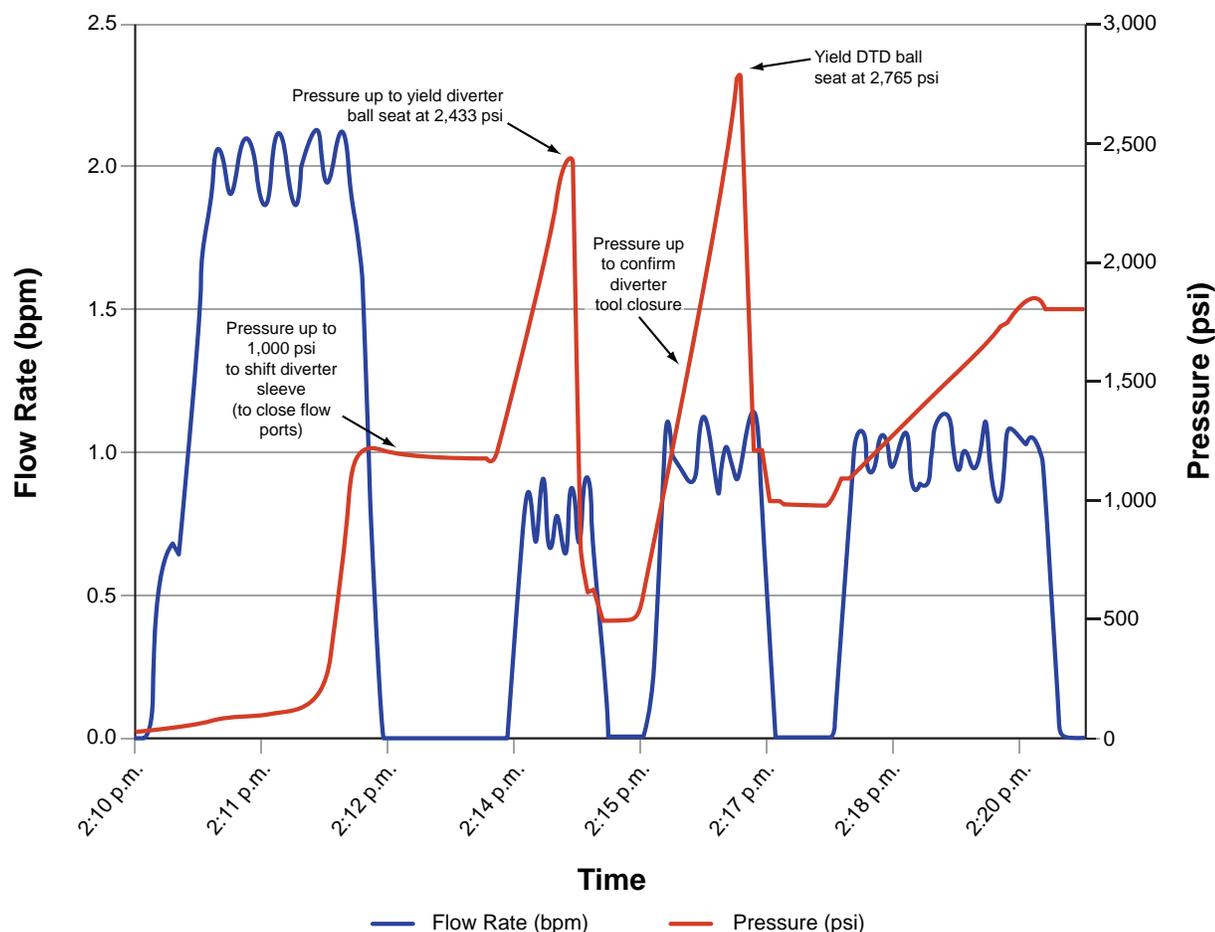
Figure 10 Conversion of Diverter Tool (to Closed Position) and Test with DTD (April 19, 2010)

The diverter tool is located above the casing hanger running tool. After the production casing was run to a depth of 18,304 ft. on April 19, 2010, the diverter tool was closed by inserting a 1-5/8 in. diameter brass ball into and down the drill string to a seat in the diverter tool. A pressure of 1,000 psi was then applied to the drill pipe.²⁰ This pressure activated the shear pins holding the diverter tool sleeve, which shifted the sleeve down, isolating the circulation ports and closing the diverter tool.²¹ Pressure was then increased to 2,433 psi to push the ball through the diverter sub-ball seat, allowing it to free-fall to the diverter test device (DTD), located approximately 300 ft. below the diverter tool. Pressure was then further increased to 2,765 psi, to confirm that (1) the diverter tool ports had closed, and (2) the DTD seat had sheared and the ball had free-fallen to the float collar located 189 ft. above the casing shoe.²² The investigation team concluded that no problems were encountered during the conversion and test of the diverter tool. *Figure 10* shows the pressures for conversion of the diverter tool and verification with the DTD.

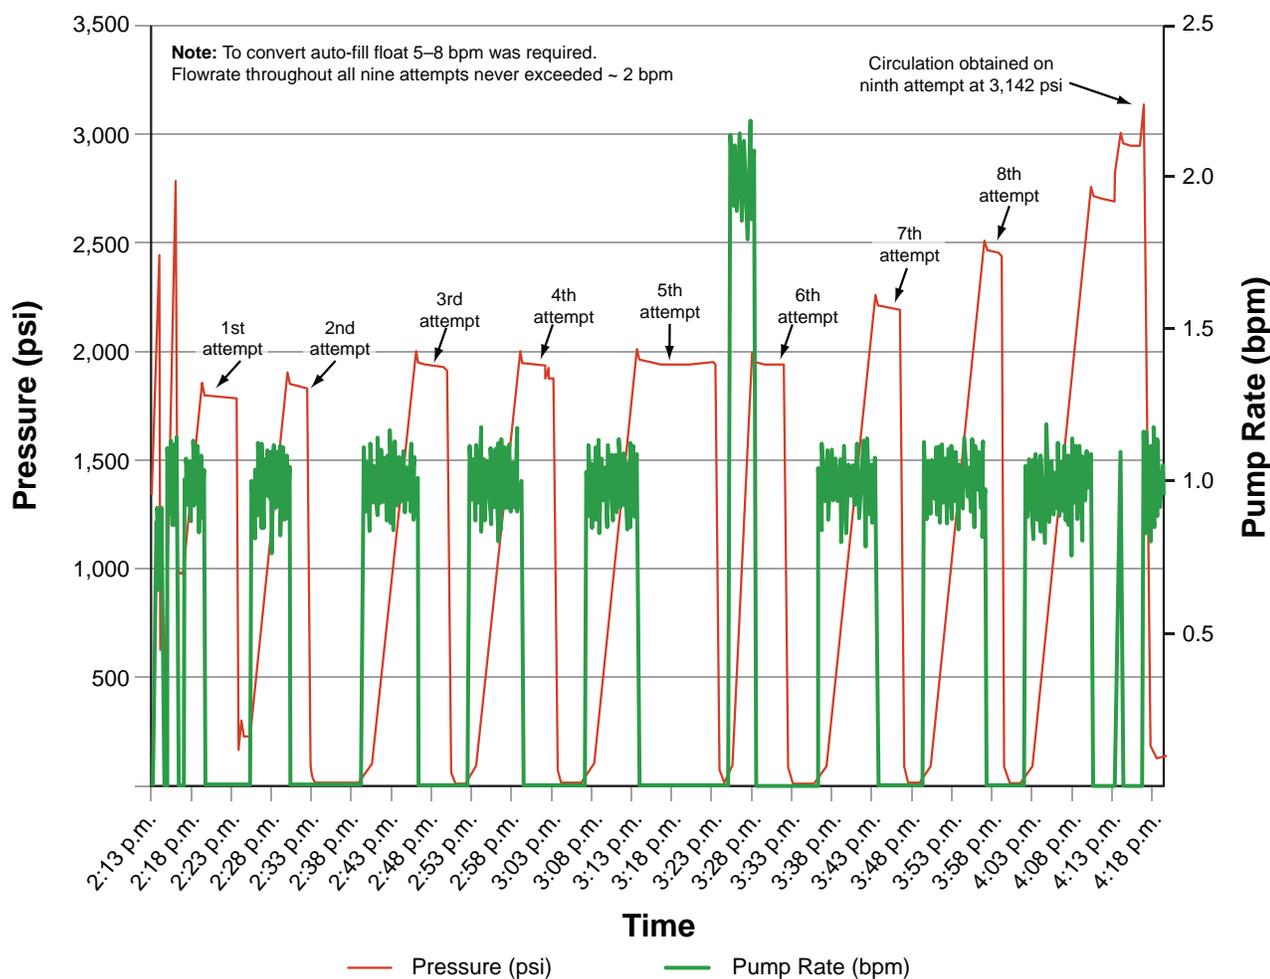
Figure 13 Nine Attempts Prior to Assumed Conversion of Auto-Fill Float Collar (April 19,2010)

There were a total of nine attempts to convert the auto-fill float collar, as can be seen in *Figure 13*:²⁵

- 1st attempt: Pressured up to 1,845 psi at 1 bpm and bled pressure off fast
- 2nd attempt: Pressured up 1,900 psi at 1 bpm and bled pressure off fast
- 3rd attempt: Pressured up to 1,997 at 1 bpm, held at 1,950 psi, and bled pressure off
- 4th attempt: Pressured up to 1,998 at 1 bpm, took 6.7 barrels (bbl), held 1,940 psi, and bled pressure off
- 5th attempt: Pressured up to 2,006 psi at 1 bpm, took 6.6 bbl, held 10 minutes, and bled pressure off
- 6th attempt: Pressured up to 2,004 psi at 2 bpm and bled pressure off
- 7th attempt: Pressured up to 2,255 psi at 1 bpm, took 7.3 bbl, and bled pressure off fast
- 8th attempt: Pressured up to 2,507 psi at 1 bpm, took 7.8 bbl, held at 2,450 psi, and bled pressure off fast
- 9th Attempt: Pressured up to 2,750 psi at 1 bpm, held for 2 minutes, increased pressure to 3,000 psi, held for 2 minutes, and sheared/apparently converted at 3,142 psi

BP never instructed the drill crew to pump at more than 2 bpm, despite its own procedure calling for 8 bpm.

The first attempt to convert the float collar at the lower flow rate of 1 bpm failed to establish circulation. Instead, the pressure rose to 1,900 psi, indicating that debris or formation cuttings likely were blocking the drilling fluid from flowing through the float collar. During subsequent attempts, the BP well site leader and engineer called shore for approval from the BP onshore supervisor to increase pressure to 2,200 psi, then 3,000 psi, and finally 3,500 psi.²⁶ While pressure was increased with each successive attempt to convert the float collar, the BP onsite engineer contacted the onshore Weatherford representative, who informed him that the actuating ball would go through the tube but would not actually convert the floats if the pressure reached and exceeded 1,300 psi. There was no Weatherford representative on the rig dedicated to supervising the conversion process. However, an Allamon diverter tool representative familiar with the equipment was onboard and recommended procedures to convert the equipment.²⁷

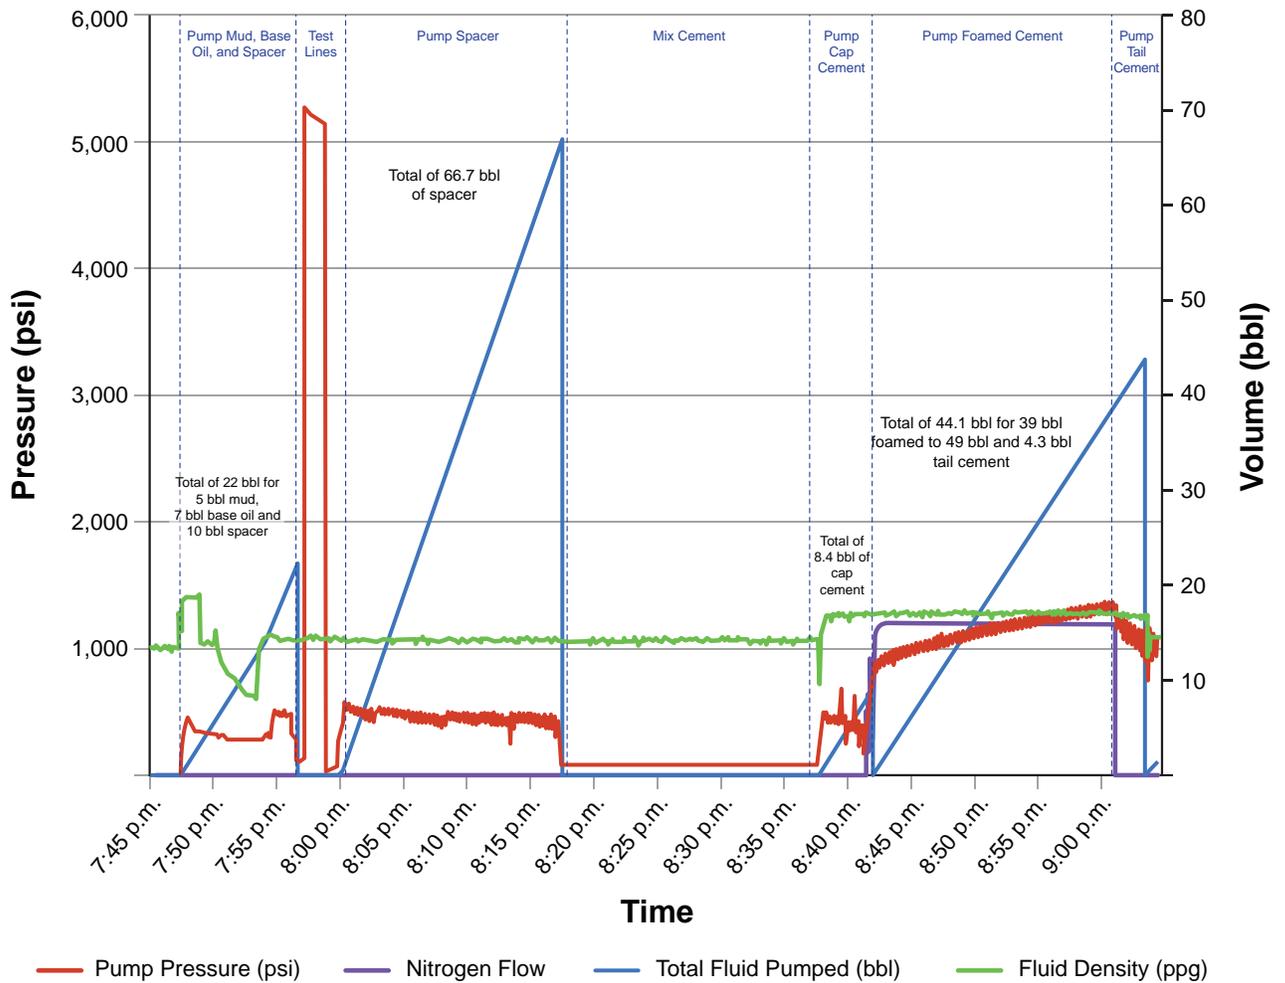
Figure 23 Actual Cement Volumes Pumped for 9-7/8-in. x 7 in. Production Casing (April 19, 2010)

Data recorded during the displacement of the cement shows a distinct change in the flow-out volume subsequent to bumping the bottom plug. The return flow rate decreased by approximately 0.4 bpm then remained constant until the end of displacement.⁹⁴ Normally, a small increase in flow rate may be expected as the foamed cement rises in the annulus and expands proportionally to the increase in its foam quality.

The decrease indicates that losses may have occurred when the fracture pressure was exceeded. This flow-rate reduction would equal a 4.9-bbl loss over 12.5 minutes. The investigation team was unable to identify the specific loss zone and loss fluid. A 4.9-bbl loss of cement, approximately 10% of the planned total volume, would reduce the estimated top of cement by 96 ft. to only 412 ft. above the shallowest hydrocarbon-bearing sand, possibly compromising the effectiveness of the barrier. See *Figures 23 and 24*.

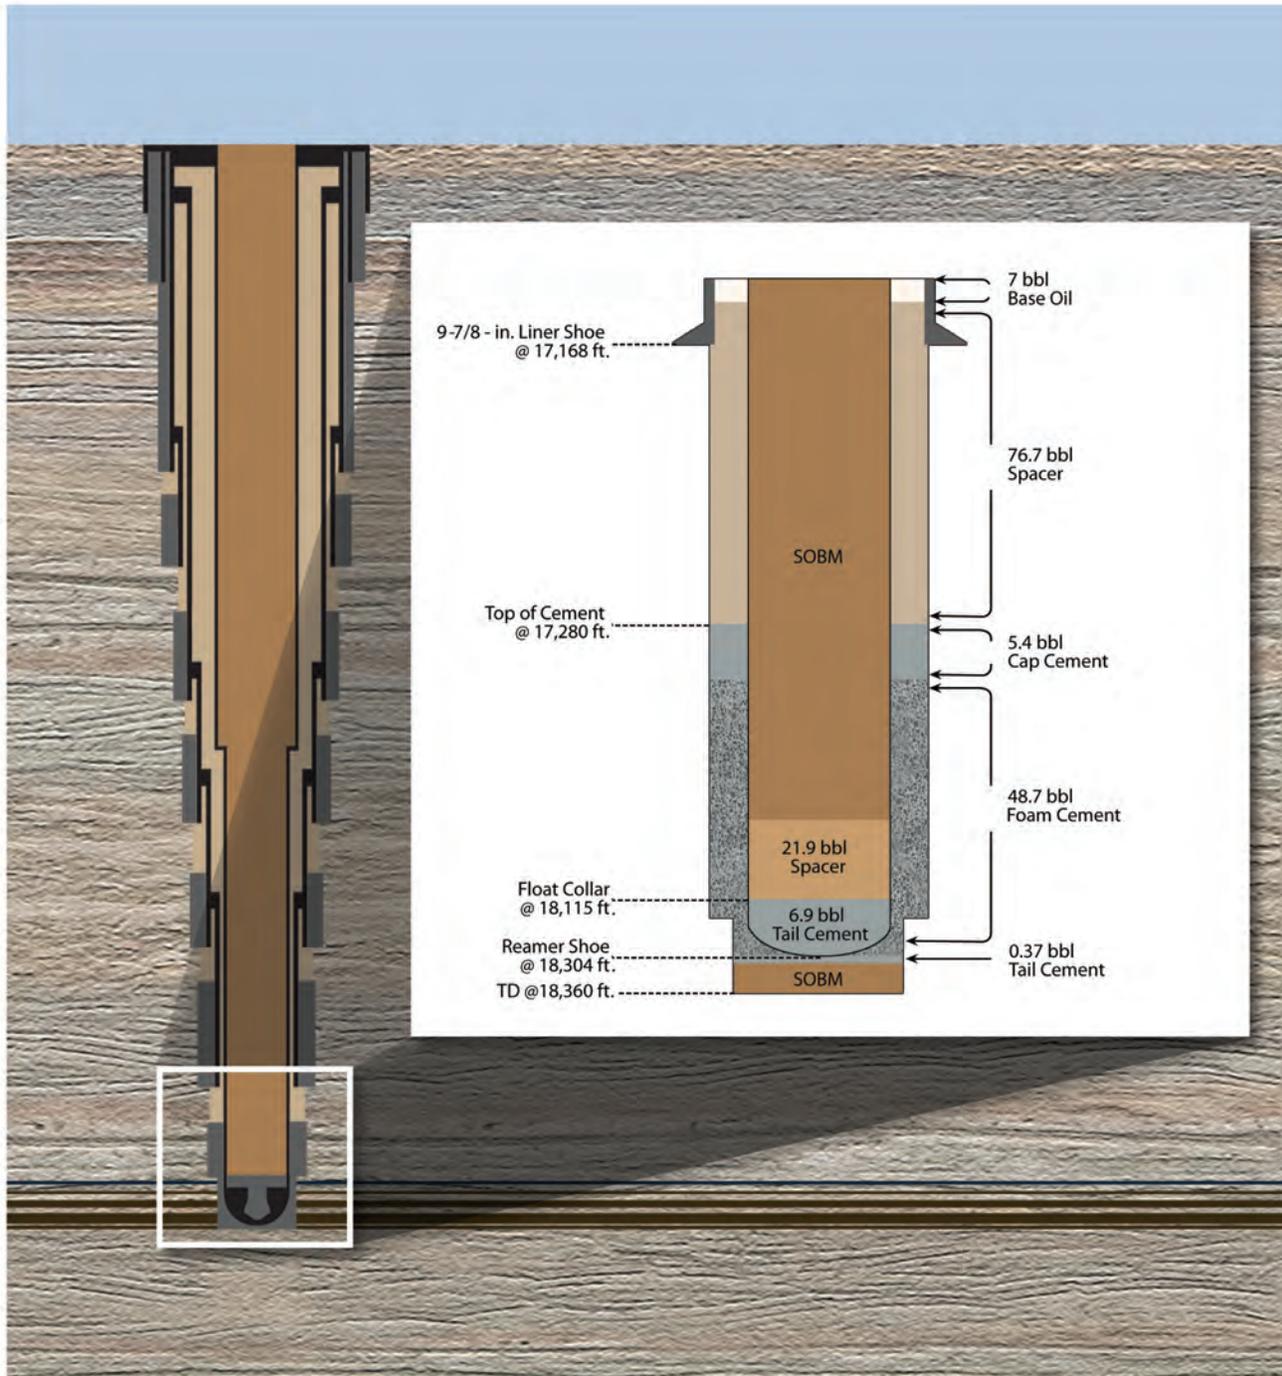
Figure 24 Actual Cement Volumes Pumped for 9-7/8-in. x 7-in. Production Casing (April 19, 2010)

Because Halliburton ran only limited tests on spacer/mud/cement compatibility, the investigation team believes that the cement in the annulus and shoe track could have been contaminated with mud and/or spacer, potentially delaying or preventing the cement from setting and developing the required compressive strength.^{AA}

Contributing to the likelihood of contamination was the length of casing through which the cement had to be pumped. At 13,055 ft., the wiper plugs had to remove contaminant along a considerable length of casing, compared to the small volume of cement the operator had planned to pump.^{95, AB} The BP well team was aware of the risks associated with pumping such a small volume over the long interval and was concerned about contamination.⁹⁶ Running and cementing a liner instead of the long string may have decreased this risk by reducing the amount of contaminants wiped from the casing wall during displacement.^{AC}

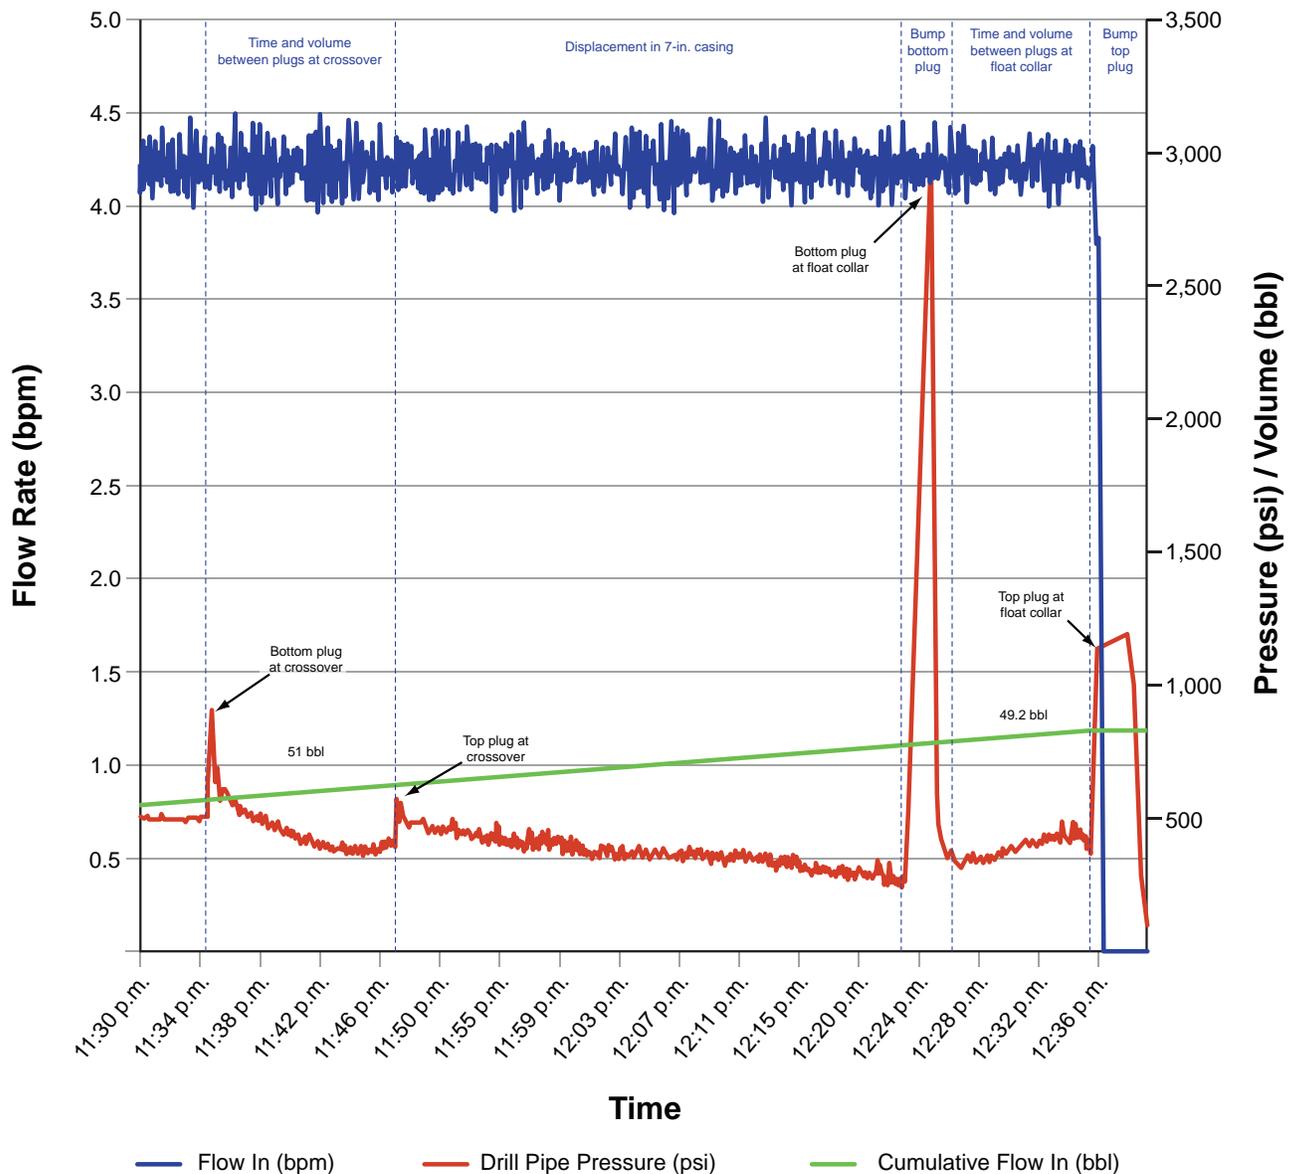
Figure 25 Reduction in Foamed Slurry Volume from 12,487 ft. crossover to 18,115 ft. (Float Collar)

The investigation team analyzed the cement volume to determine whether there was any evidence that contamination occurred during displacement. Volumes were calculated at two locations (See Figure 25):

- Where the plugs went through the 9-7/8-in. x 7-in. crossover at 12,487 ft.
- Where the plugs reached the float collar at 18,115 ft.

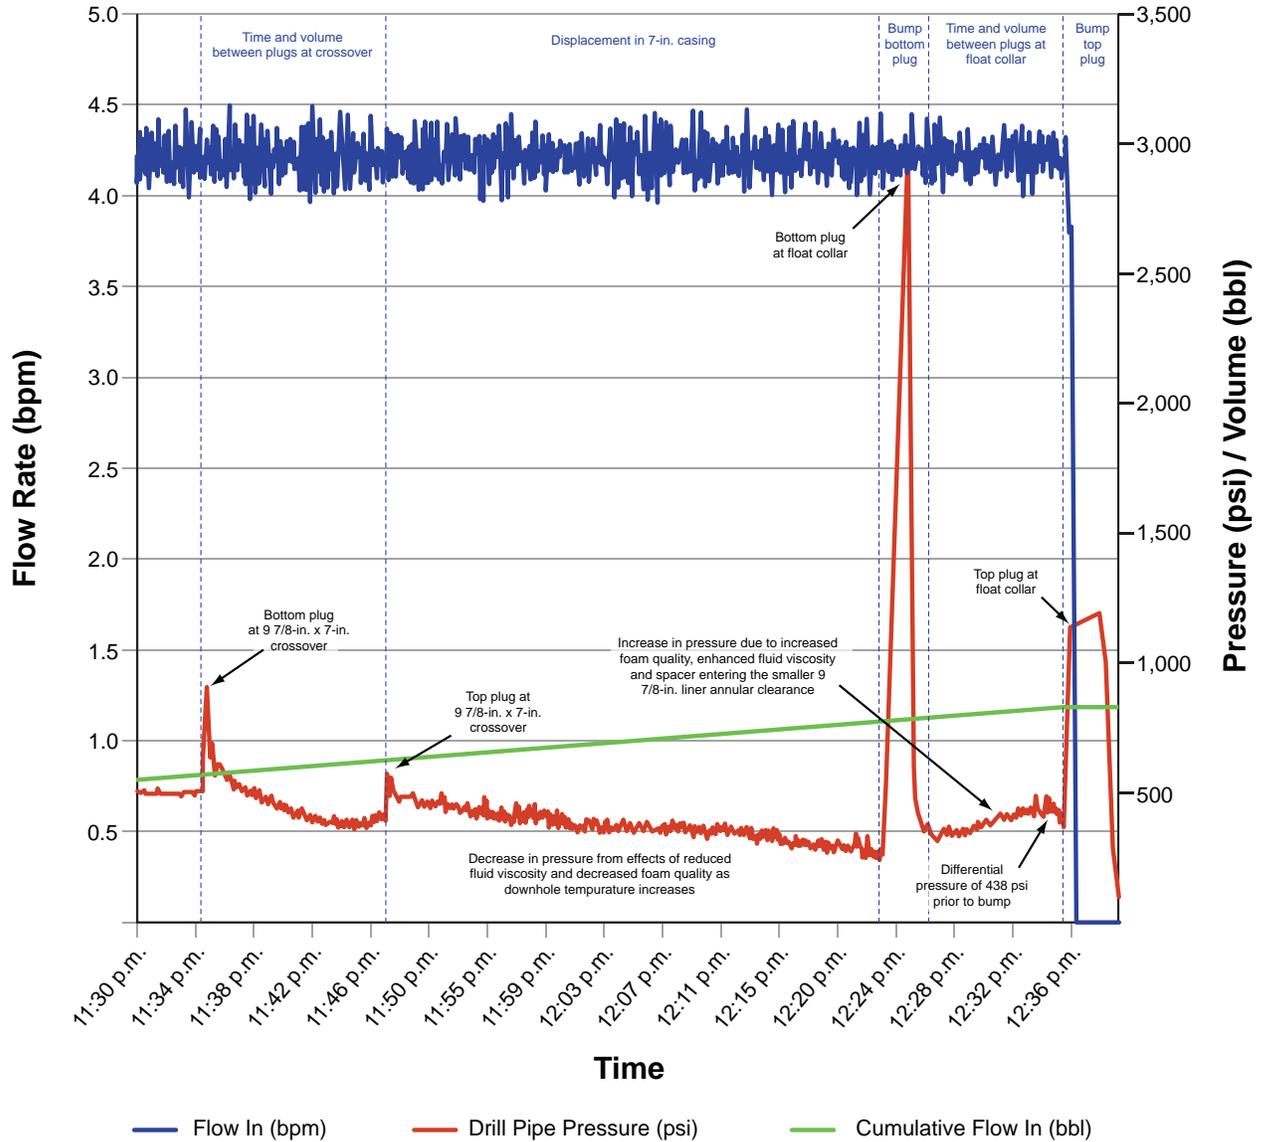
Figure 26 Differential Pressure at the End of 9-7/8-in. x 7-in. Production Casing Cement Program Displacement (April 19, 2010)

Once cement has been fully displaced, it should occupy the internal space within the casing shoe track and extend up to a pre-determined height in the annulus, as specified in the operator's well plan. Normally, a U-tube effect occurs because the longer cement column in the annulus exerts more pressure than the shorter cement column inside the casing. That difference in pressure, or lift pressure, must be determined accurately to confirm that the float collar is functioning properly. As noted previously, the float collar valves should block the back-pressure from the cement in the annulus, stopping the cement from flowing back into the casing. Lift pressure is the only way to test the effectiveness of the float collar once cementing operations are completed. See Figure 26.

A1 The difference in pressure seen prior to bumping the top wiper plug on the float collar at approximately 4 bpm was 438 psi. The initial circulating pressure at about 4.2 bpm with drilling mud was 330 psi. Lift pressure = 438 psi – 330 psi = 108 psi.

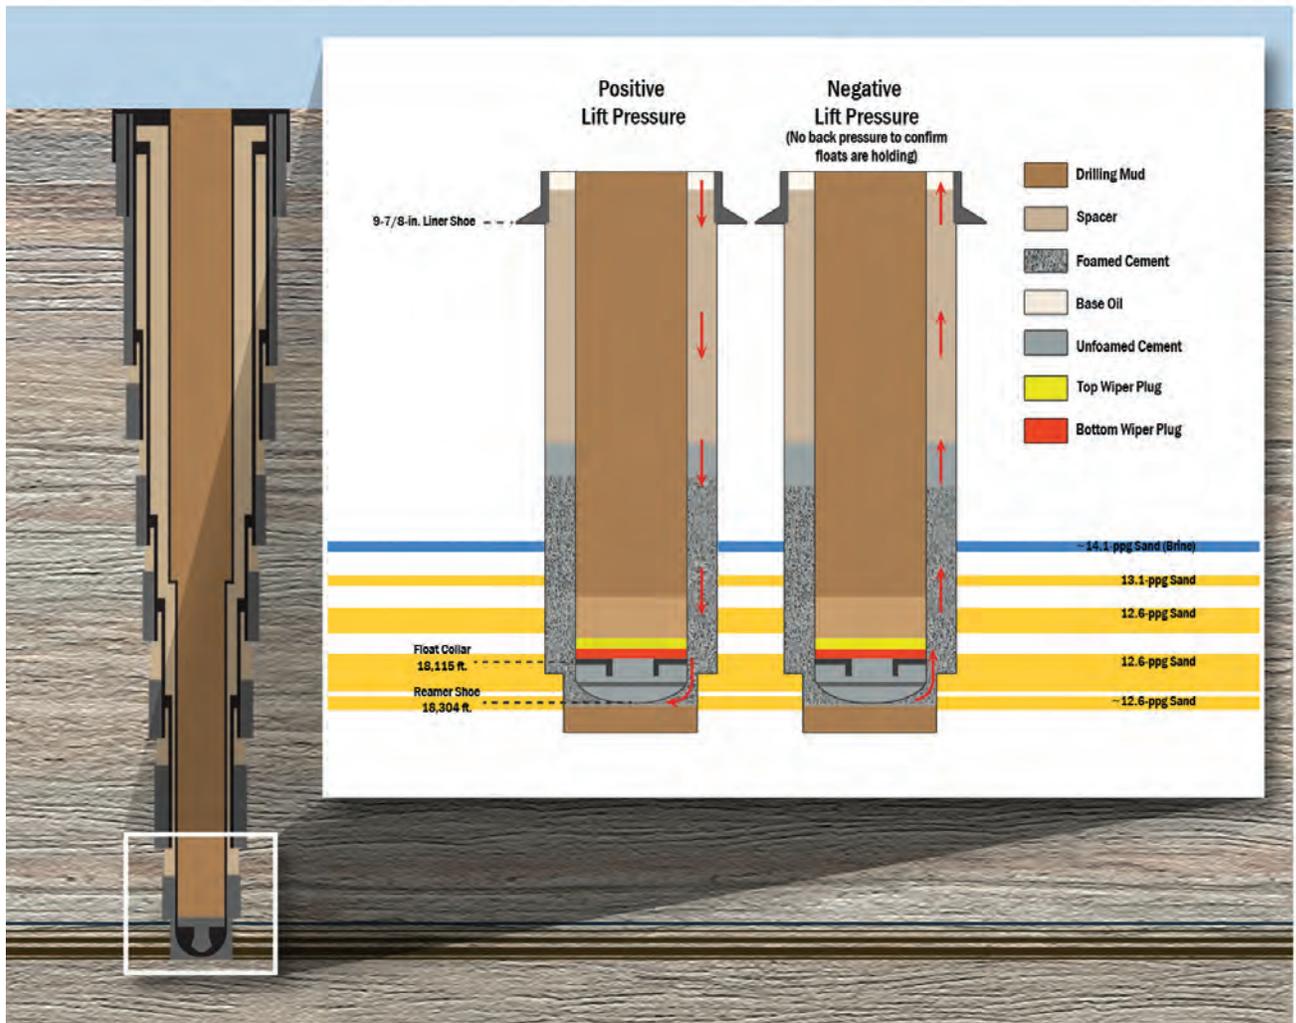
Figure 27 Expected (Positive) and Actual (Negative) Lift Pressure Post Cementing of the Production Casing

The discussion above on the lift pressure also can be correlated back to the cement program. At BP's direction, Halliburton incorporated base oil into the fluid schedule to minimize pressure on the formation.¹⁰⁷ Pumping base oil, which is much lighter than drilling mud, ahead of the spacer reduced the lift pressure by approximately 42 psi at the end of the job. This further ensured that there was no back-pressure to confirm whether the float collar was, in fact, holding.

Figure 27 illustrates the expected direction of flow due to the U-tube effect (positive lift pressure) and the actual direction of fluid flow once displacement was completed (negative lift pressure) on the Macondo well.

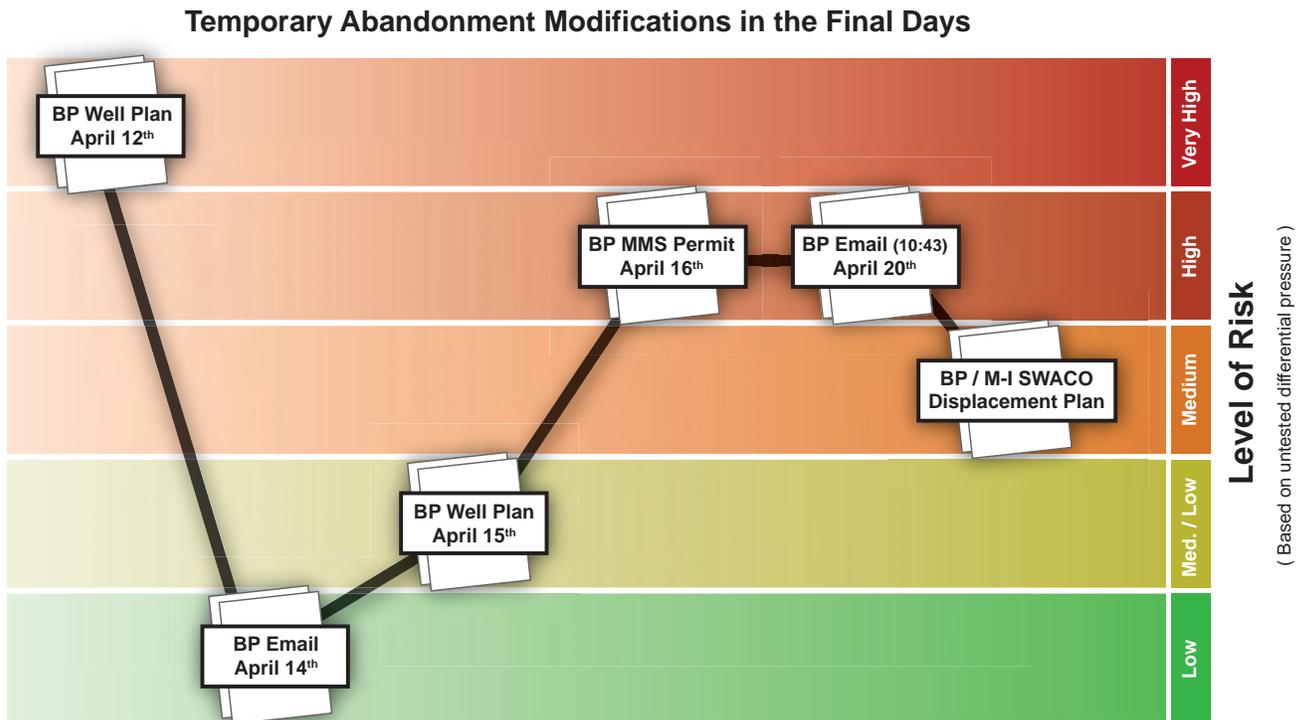
Figure 1 Temporary Abandonment Modifications, April 12–20, 2010

- The underbalance was magnified significantly by the decision to place the plug 3,300 ft. below the mud line.
- The final procedure was never approved by MMS.
- The final “procedure” was merely a bullet-point outline with minimal detail, as denoted by its title: “Quick Ops Note.” See Figure 7.
- The team found no evidence that formal risk assessments were conducted on the viability, safety, and alternative approaches to the various plans.

What follows is an outline of each of the plans generated by the operator and the evolution of procedural changes that ultimately resulted in a final temporary abandonment plan that contained unnecessary risk and contributed to the cause of the incident.

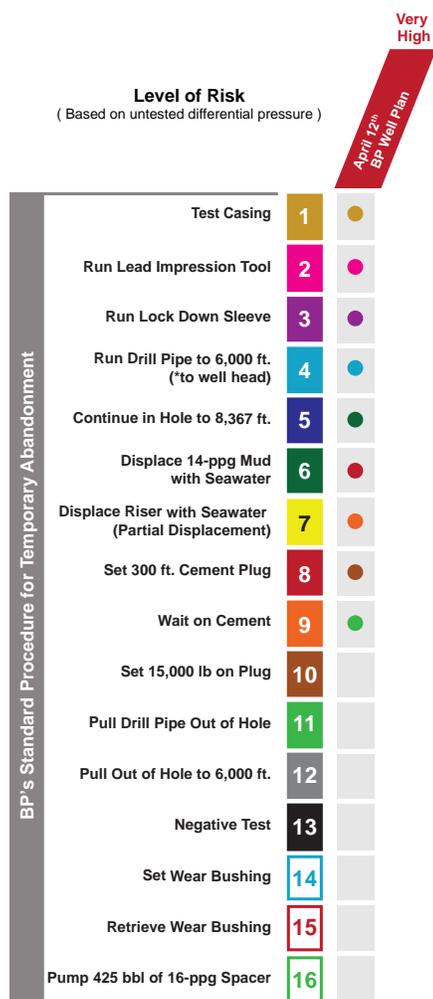
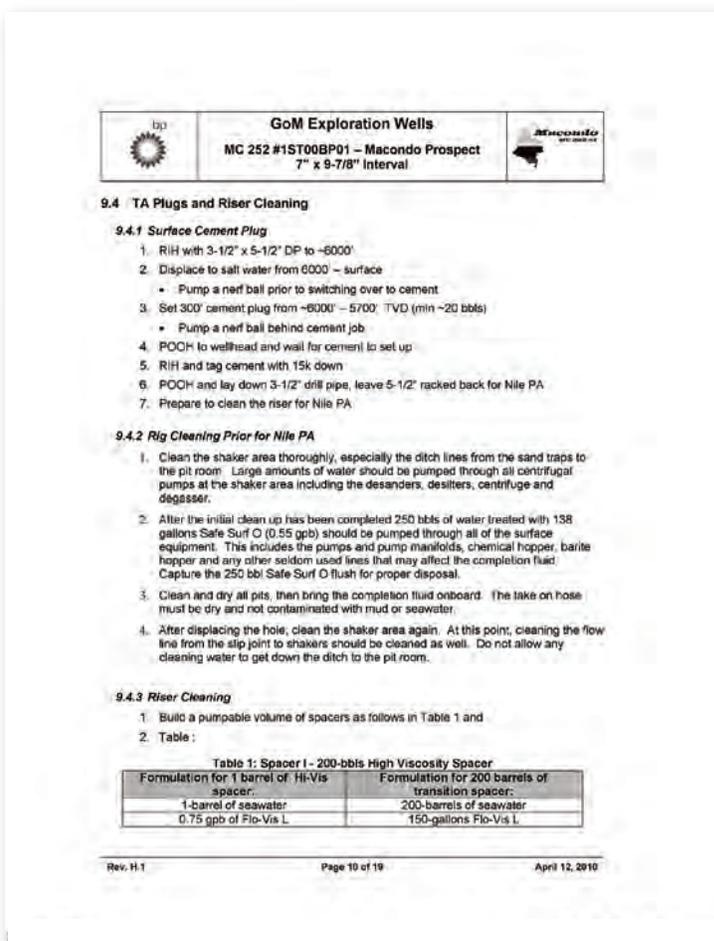
Figure 2 April 12 Temporary Abandonment Plan

The operator’s original temporary abandonment procedure was dated April 12, 2010.⁵ It directed the setting of the lock-down sleeve first to secure the production casing to the wellhead. Next, the well would be displaced with seawater to 933 ft. below the mud line, where a surface cement plug would be set. The April 12 plan did not include a negative pressure test to confirm the integrity of the cement barrier at the bottom of the well, which would have been the only (untested) barrier in place to prevent hydrocarbons from entering the wellbore when heavy drilling mud was to be removed and replaced, or displaced, with lighter seawater. See Figure 3a. The displacement phase of a temporary abandonment operation is particularly delicate as the well becomes underbalanced.

There is no indication that BP used a formal risk assessment to evaluate the April 12 plan.

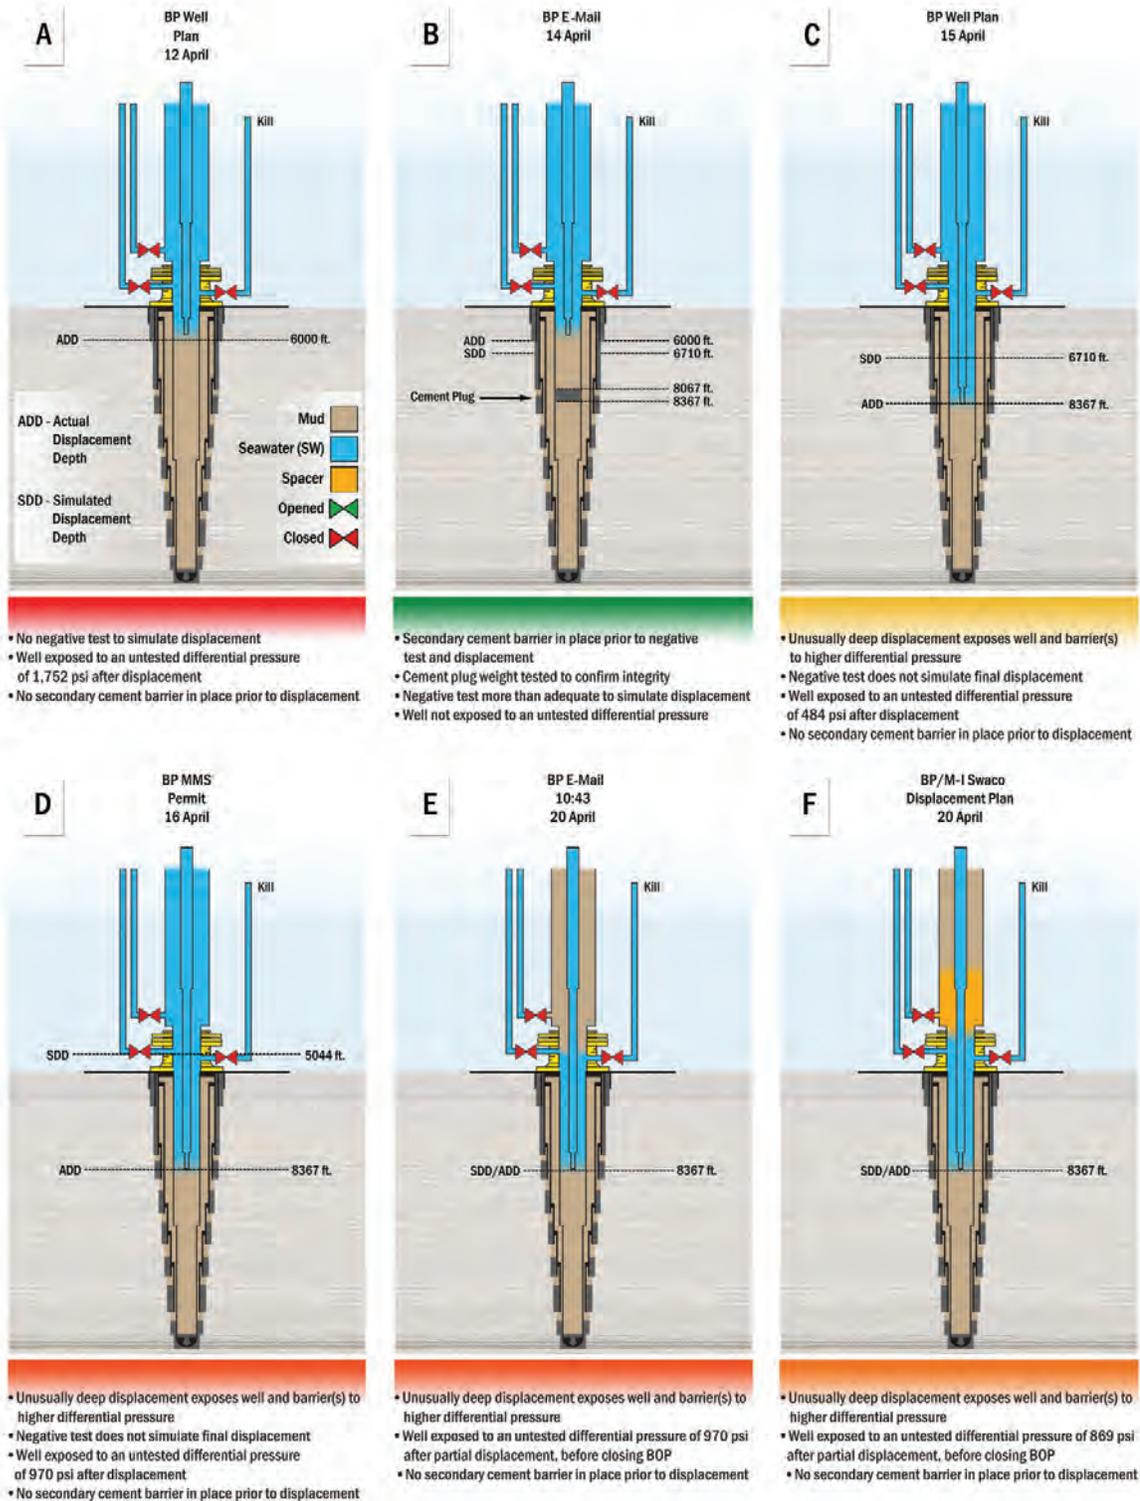
Figure 3 Risk Associated with Procedural Changes

Risk Associated with Procedural Changes

Increasing Risk

(Based on untested differential pressure)

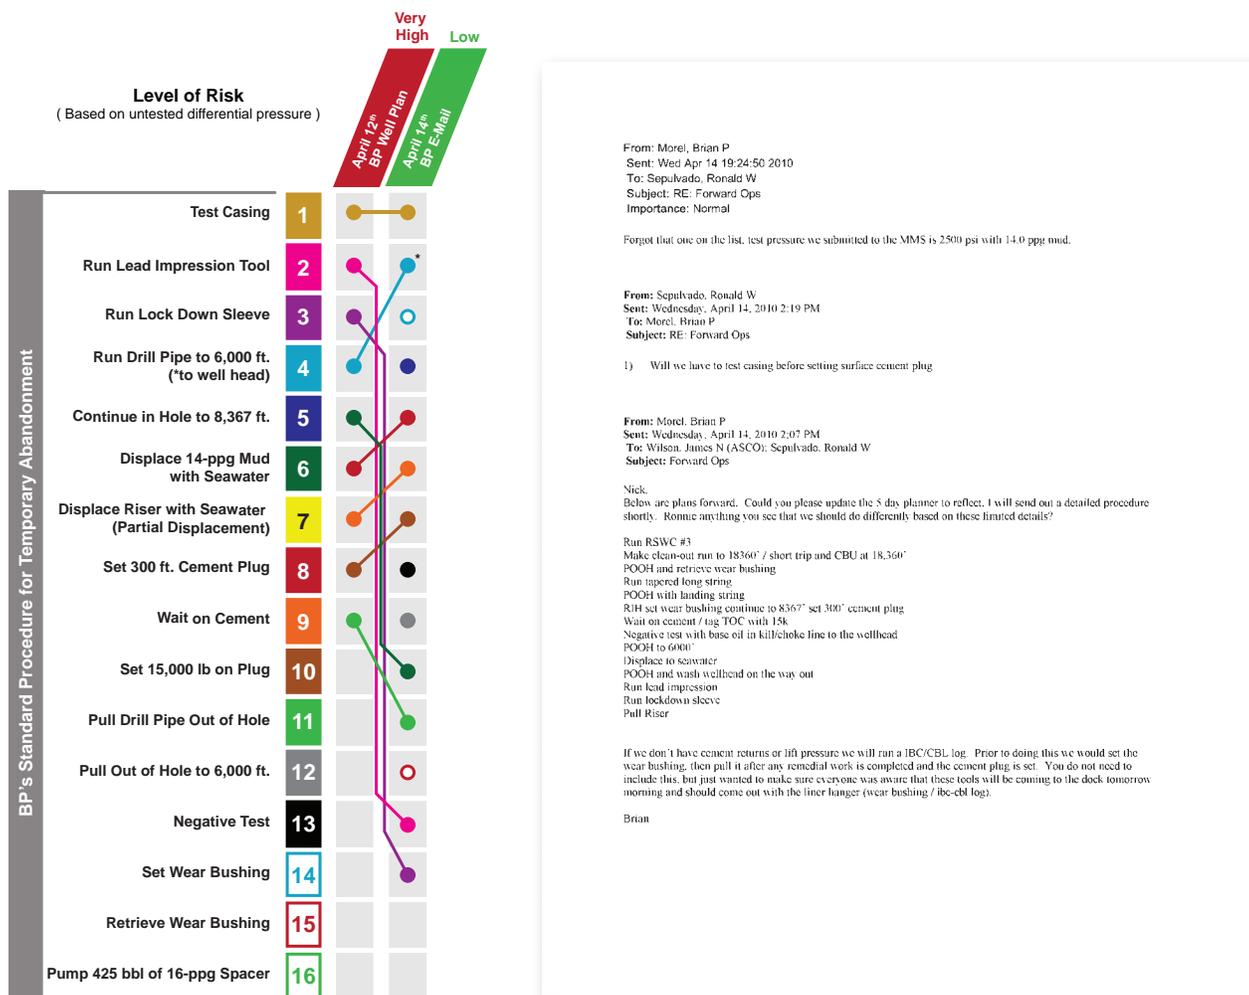
Figure 4 (a) Temporary Abandonment Plan Modifications - April 14 (b) April 14 Temporary Abandonment Plan

The April 14 version of the operator’s temporary abandonment plan was e-mailed to the BP well site leader, or “company man,” on the *Deepwater Horizon* by a shore-based engineer.⁶ The safest of all five versions, the April 14 plan dictated that a surface cement plug be set in mud and that a negative pressure test be conducted before the heavy drilling mud was displaced with seawater. It also called for installing the lock-down sleeve last, which would have eliminated the risk of damaging the device when the drill pipe was run into the well to set the surface cement plug. See appendix F for a detailed discussion of the lock-down sleeve decision.

This plan also increased the depth from the top of the cement plug to 3,000 ft. below the mud line, significantly deeper than the MMS limit of 1,000 ft. below the mud line. That alteration (which required and eventually would receive MMS approval, though not in relation to this plan) was made to accommodate the lock-down sleeve installation. The sleeve is set in position with a running tool by applying weight, and the device manufacturer, Dril-Quip, recommends using 100,000 lb. That force is generated by hanging drill string from below the running tool. While the additional space created above the cement plug maximized the operator’s options to use varying drill strings with differing weights to reach the 100,000-lb. threshold, it remains unclear why they chose 3,000 ft. in this and subsequent plans, including on April 20, when a shallower depth could also have been used to accommodate Dril-Quip’s requirements.

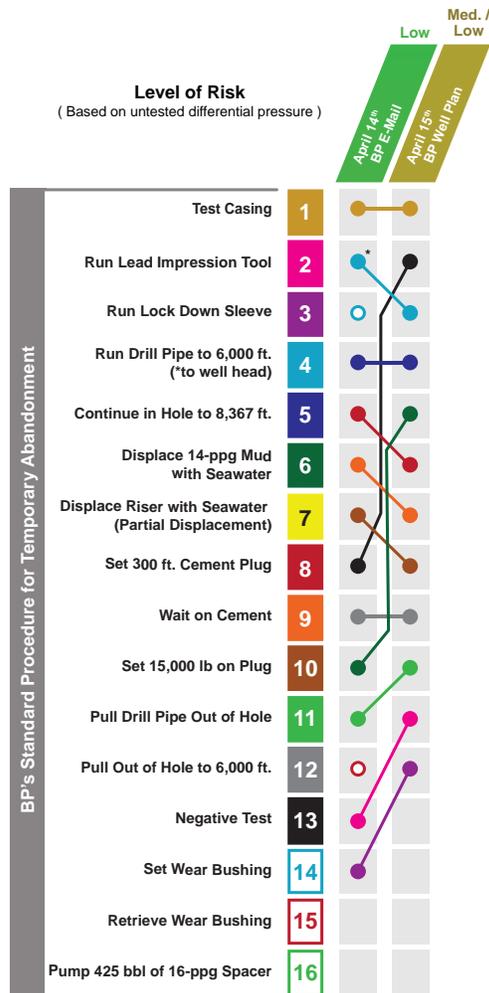
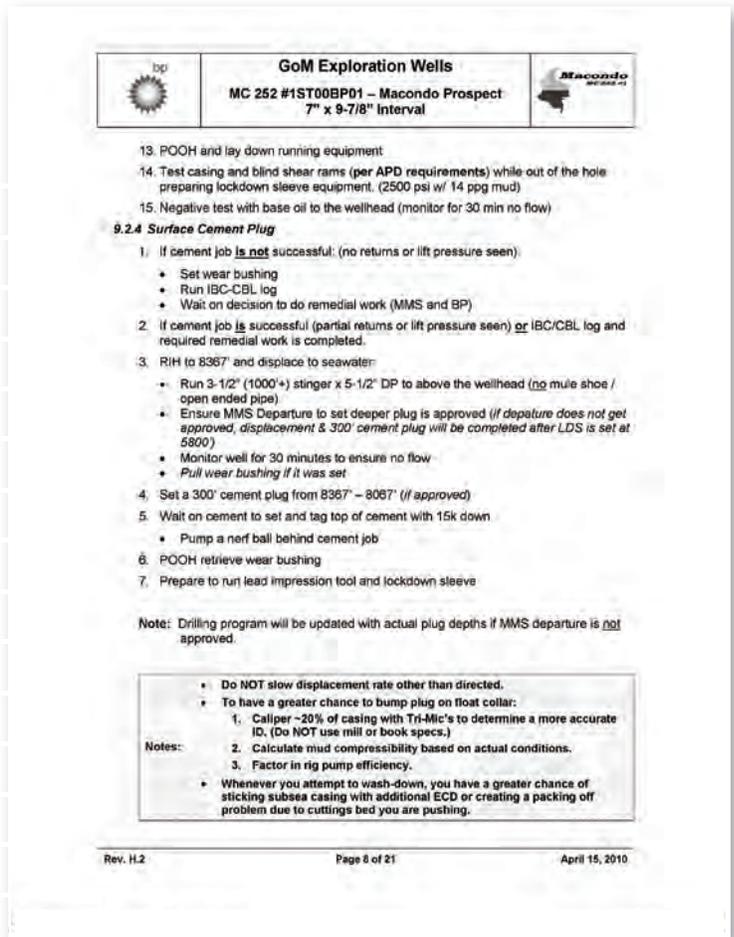
Figure 5 (a) Temporary Abandonment Plan Modifications - April 15 (b) April 15 Temporary Abandonment Plan

On April 15, BP altered the temporary abandonment plan again.⁸ Although plugs are commonly set in mud, a well site leader recommended using seawater to reduce the risk of cement contamination.⁹ This meant that the well would be displaced with seawater without a secondary barrier in place, which significantly increased the risk of the temporary abandonment operation. The well would be underbalanced with only the insufficiently tested cement at the bottom of the well, serving as a barrier to pressure in the formation.

The unusually deep seawater displacement to the planned cement plug depth — 3,300 ft. below the mud line instead of 933 ft. — also meant that the negative pressure test would no longer be adequate to test the well to the full under balanced condition in the procedure. The April 15 procedure kept the same negative pressure test as the April 14 plan, displacing the choke or kill lines with base oil to the wellhead.¹⁰ However, because of the unusually deep seawater displacement to the planned cement plug depth, the negative pressure test would not simulate the conditions that would exist when the BOP stack and riser were removed.¹¹ Displacing the lines with base oil simulates seawater to a depth of only approximately 1,643 ft. below the mud line, significantly less than the 3,300 ft. below the mud line planned for setting the cement plug.

Because this temporary abandonment plan would have resulted in an inadequate negative pressure test prior to displacing the well, and because the well would be underbalanced with an insufficiently tested barrier, the April 15 procedure posed significant safety risks. See figure 3c.
