MACONDO WELL INCIDENT
Transocean Investigation Report
Volume I

June 2011

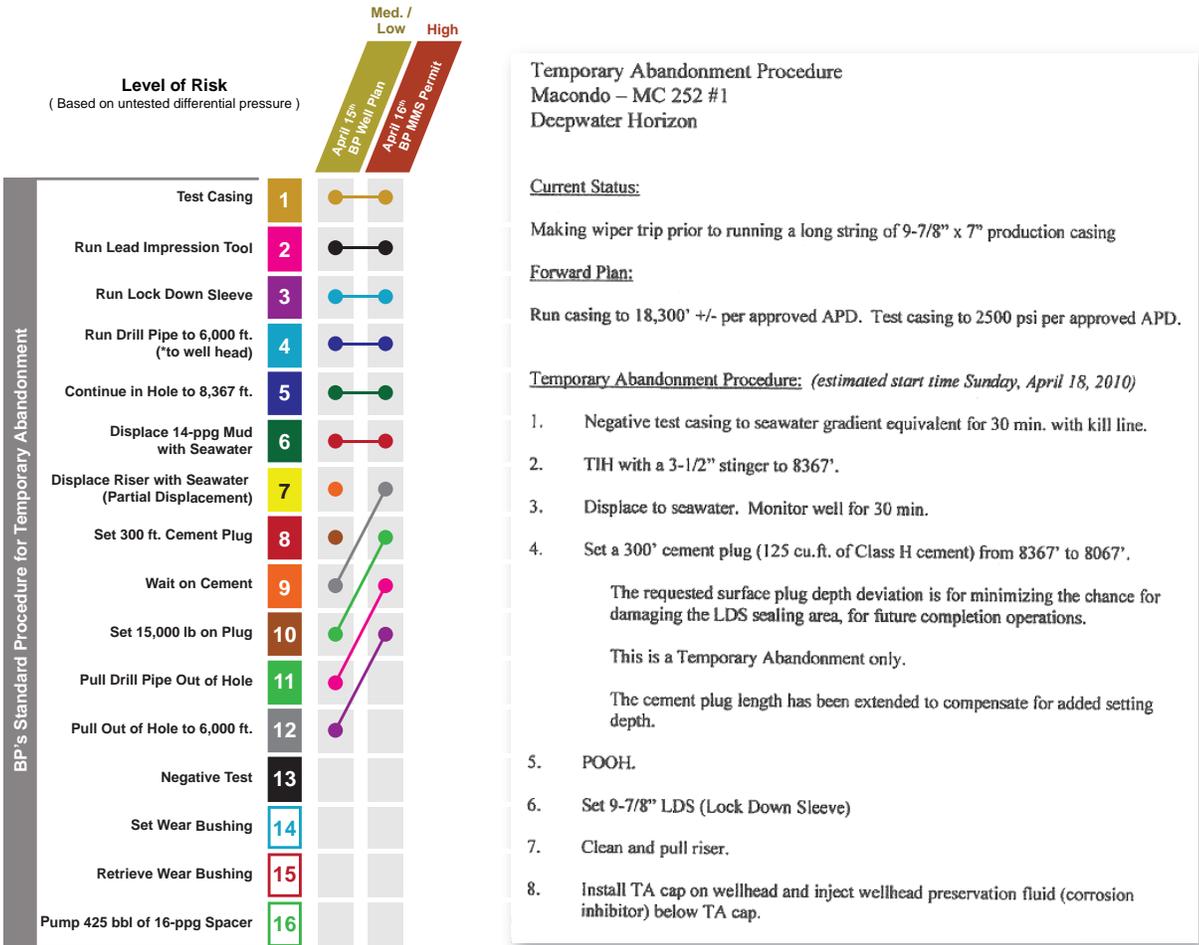
Figure 6 (a) Temporary Abandonment Plan Modifications - April 16 (b) April 16 Temporary Abandonment Plan

BP adopted another plan on April 16, one that would ultimately be the MMS-approved plan.¹² In this version, the negative pressure test would be conducted with seawater rather than base oil in the kill line. The seawater would compromise the negative pressure test even further, as it would simulate a displacement with seawater to just 5,044 ft., despite the planned displacement to 8,367 ft. In addition, this plan again specified setting the surface cement plug *after* conducting the negative pressure test and displacing the well. Thus, no secondary cement barrier would be in place while conducting the negative pressure test and before the well was exposed to additional underbalance from a displacement at 8,367 ft.

As with the April 14 temporary abandonment plan, this MMS-approved plan also called for setting a 300-ft. surface cement plug at a depth between 3,000 ft. and 3,300 ft. below the mud line (8,067–8,367 ft. total). This time, BP received approval from MMS to exceed the 1,000-ft. depth guidelines.¹³ Usually at that depth, plugs are weight tested.¹⁴ But because the plan defined the barrier as a “surface plug,” federal regulations did not require it to be weight tested.¹⁵ This procedure afforded time-saving benefits: As no weight testing was required, it was not necessary to wait for the cement to set before proceeding with the temporary abandonment operation. See Figure 3d.

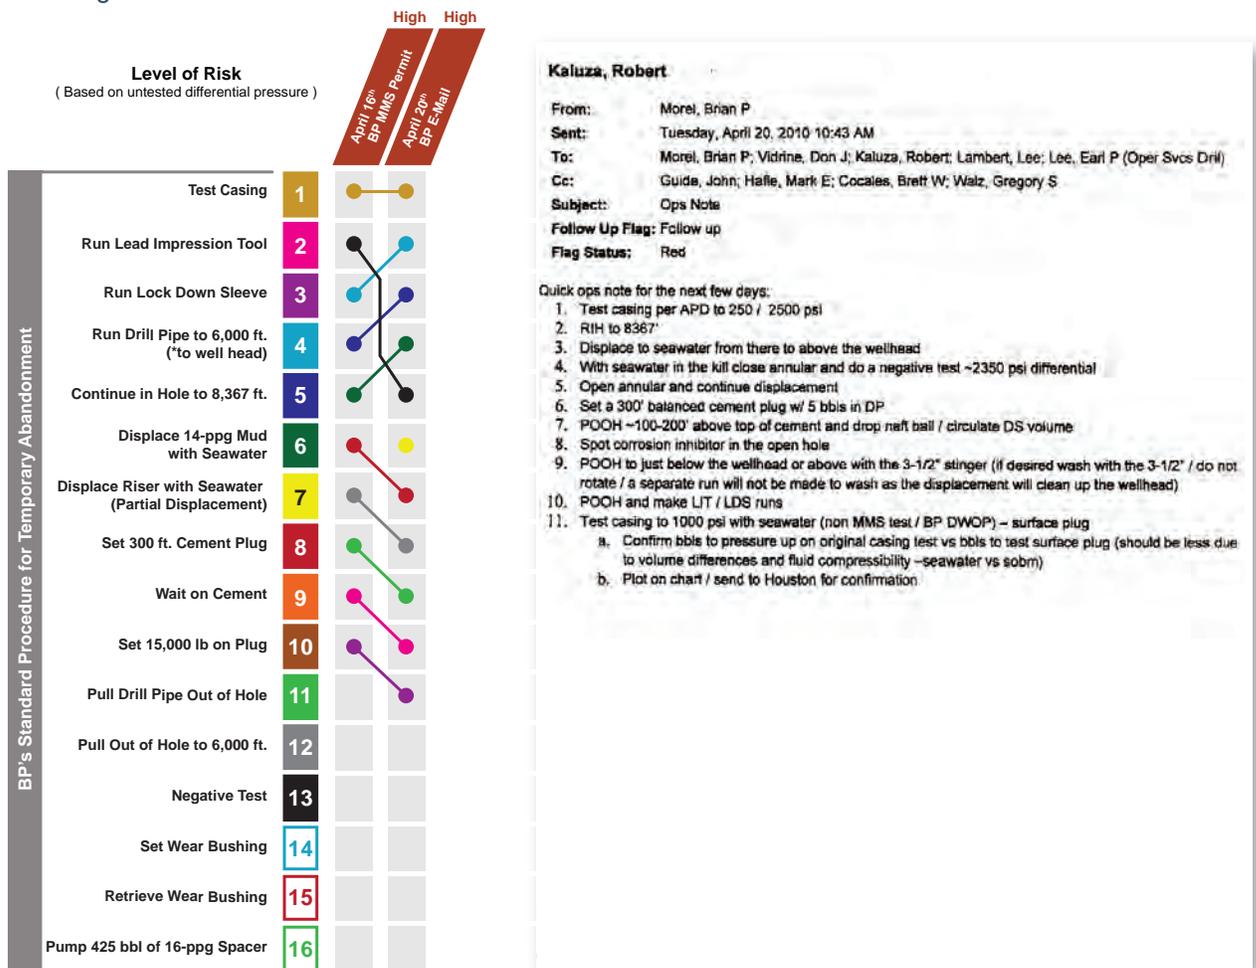
Figure 7 (a) Temporary Abandonment Plan Modifications - April 20 (b) April 20 Temporary Abandonment Plan

On April 20, at 10:43 a.m., after the temporary abandonment operation was underway, a BP engineer e-mailed a final temporary abandonment plan to the well site leader on the *Deepwater Horizon*. This plan was simply a bulleted outline with a minimum level of detail, as denoted by its title, “Quick Ops Note.” A more detailed procedure likely would have aided the well site leader and the drill crew in identifying anomalies during the temporary abandonment operation.

Furthermore, while BP never sought MMS approval for the April 20 procedure that was ultimately used — which included several changes from the MMS-approved April 16 plan — BP still anticipated monitoring the kill line during the negative pressure test as stipulated in the April 16 plan. To simulate and test conditions for the planned displacement depth of 8,367 ft., while also monitoring the kill line, the April 20 plan called for a partial displacement prior to the negative pressure test.^A With seawater in the kill line, the partial displacement would establish a continuous column of seawater to 8,367 ft., thus properly simulating conditions that would allow for the safe removal of the BOP stack and riser.

Despite properly simulating the final temporary abandonment conditions, the following decisions resulted in a procedure that contained unnecessary risk: (See Figure 3e)

- The partial displacement called for the removal of primary well control prior to closing the BOP stack and conducting the negative pressure test, and without a laboratory test confirming the cement setting properties and integrity of the cement barrier at the bottom of the well.
- Seawater displacement to 8,367 ft. (3,300 ft. below the mud line) was unusually deep and resulted in a significantly greater differential pressure across the well's only cement barrier.
- The surface cement plug would not be set until after full displacement, creating a condition where only one cement barrier would be in place while underbalancing the well.

Despite these risks, and the remaining questions about the conversion of the float collar and the laboratory test results for the cement, as noted above, there is no indication that a formal risk assessment was performed to evaluate this final temporary abandonment plan.

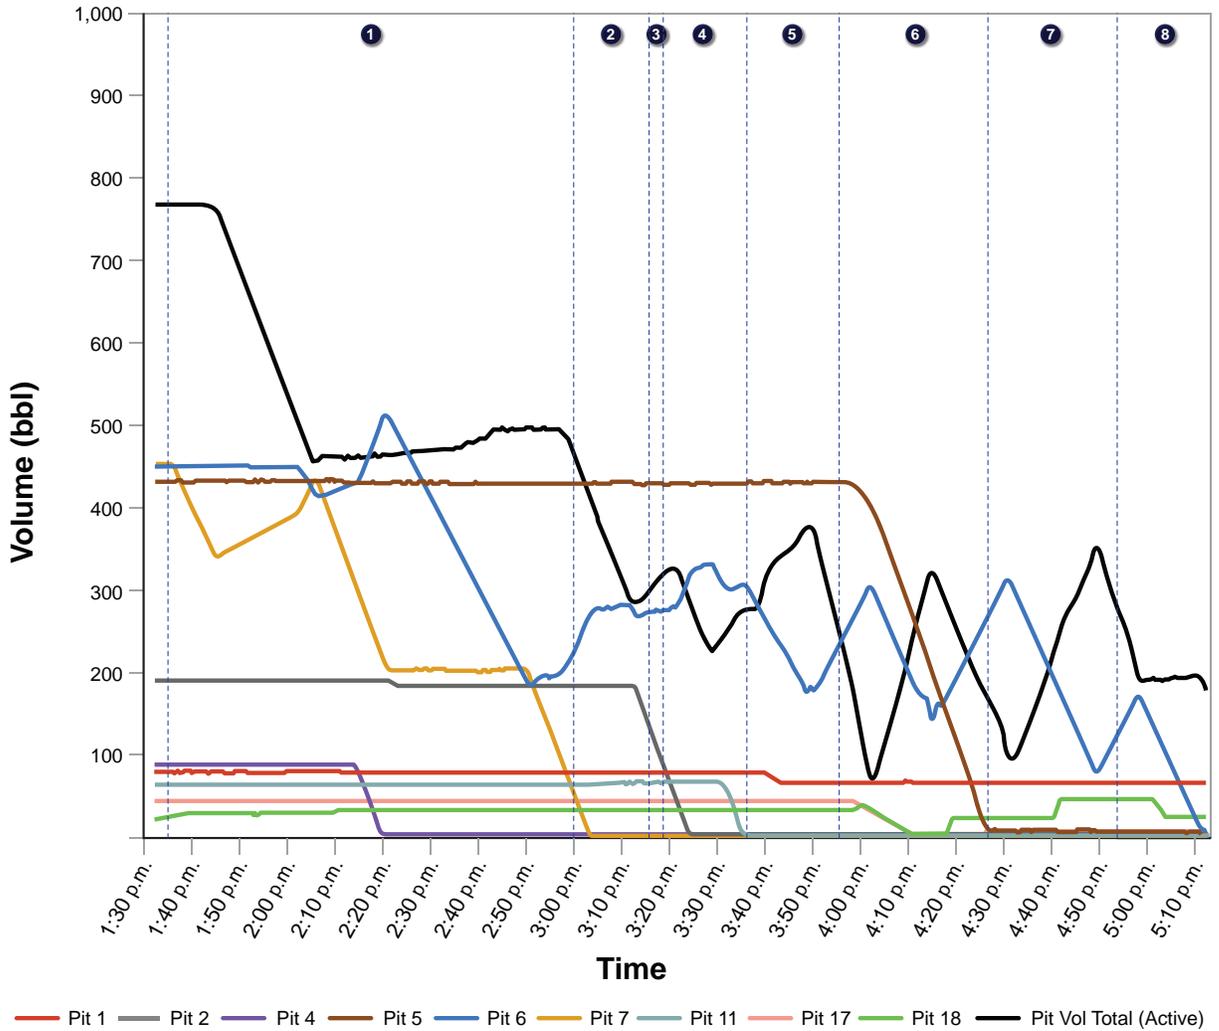
Figure 8 Fluid Transfer Activity from 1:35–5:10 p.m.

Event	Description	Time
1	Began fluid transfers to the <i>Damon B. Bankston</i> to make room for expected displacement volumes.	1:35 p.m. - 3:03 p.m.
2	Fluid transfer activity during boost line displacement.	3:03 p.m. - 3:15 p.m.
3	Fluid transfer activity while testing surface lines and drape hoses.	3:15 p.m. - 3:21 p.m.
4	Fluid transfer activity during choke line displacement.	3:21 p.m. - 3:38 p.m.
5	Fluid transfer activity during kill line displacement.	3:38 p.m. - 3:55 p.m.
6	Fluid transfer activity while pumping 16-ppg spacer.	3:55 p.m. - 4:27 p.m.
7	Fluid transfer activity while displacing 16-ppg spacer with sea water.	4:27p.m. - 4:52 p.m.
8	Final fluid transfers are made to the <i>Damon B. Bankston</i> .	4:52 p.m. - 5:10 p.m.

As shown in Figure 8, mud fluid transfers made it very difficult to accurately monitor the volumes of fluid that returned from the well during the initial displacement. Fluid transfers to the *Bankston* were completed at 5:10 p.m., soon after initial displacement stopped at 4:53 p.m.²⁶ See Figure 8, Event 8. No subsequent transfers from the *Deepwater Horizon* to the *Bankston* were made after 5:10 p.m.²⁷

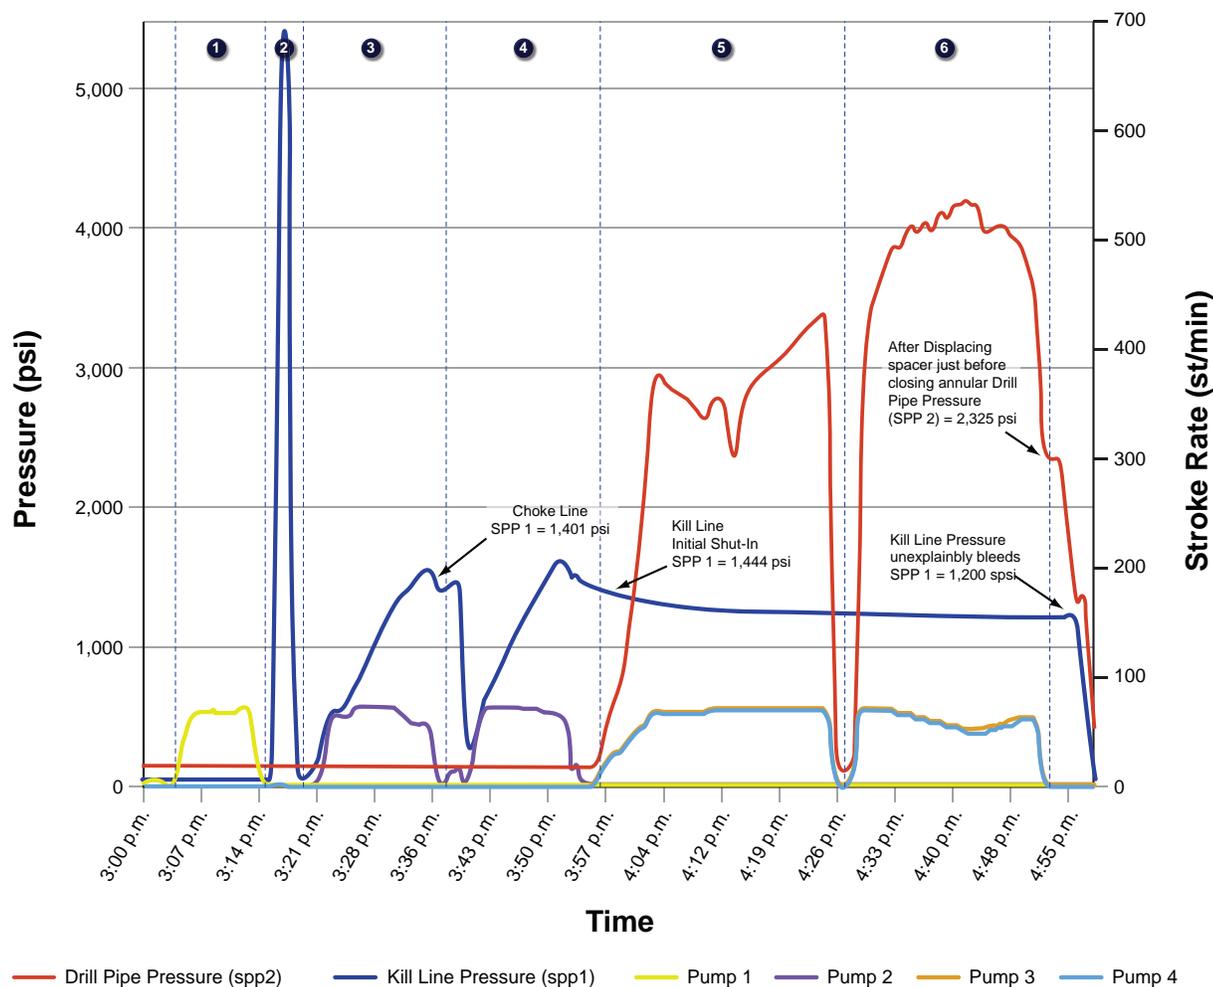
Figure 9 Overview of Events during the Initial Displacement from 3:03–4:53 p.m.

Event	Description	Time
1	Pump 1 was utilized to pump seawater from the sea chest down the boost line to displace the 14.17-ppg mud (no Sperry Sun pressure data available for the boost pump).	3:03 p.m. - 3:15 p.m.
2	Pump 2 (SPP1) was utilized to test the surface lines and drape hoses.	3:15 p.m. - 3:21 p.m.
3	Pump 2 (SPP1) pumped seawater from the sea chest down the choke line to displace the 14.17-ppg mud.	3:21 p.m. - 3:38 p.m.
4	Pump 2 (SPP1) pumped seawater from the sea chest down the kill line to displace the 14.17-ppg mud.	3:38 p.m. - 3:55 p.m.
5	Pumps 3 and 4 (SPP2) were utilized to pump 421 bbls of 16-ppg spacer from Pit 5 into the well displacing 14.17-ppg mud.	3:55 p.m. - 4:27 p.m.
6	Pumps 3 and 4 (SPP2) were used to pump seawater behind the spacer with the objective of displacing it above the BOP. The pumps were stopped and the annular BOP was closed.	4:27 p.m. - 4:53 p.m.

In accordance with the M-I SWACO procedure, the crew first displaced the boost, choke, and kill lines with seawater.³² See Figure 9, Events 1, 3, and 4. Next, the crew pumped the spacer down the drill string^{33 c} (See Figure 8, Event 6 and Figure 9 Event 5) and then followed that with seawater in the well to displace the spacer.³⁴ See Figure 9, Event 6.

Pumps 3 and 4 pumped seawater during displacement of the spacer.³⁷ See *Figure 9, Event 6*. At most, 353 bbl of seawater were pumped.³⁸ This was 3 bbl more than the procedure specified but 32 bbl less than the amount necessary to fully displace the spacer.³⁹ Based on the displacement volume specified in the procedure and amount of seawater that was pumped, 16-ppg spacer was present in the annulus below the closed annular preventer as the crew proceeded into the negative pressure test.⁴⁰

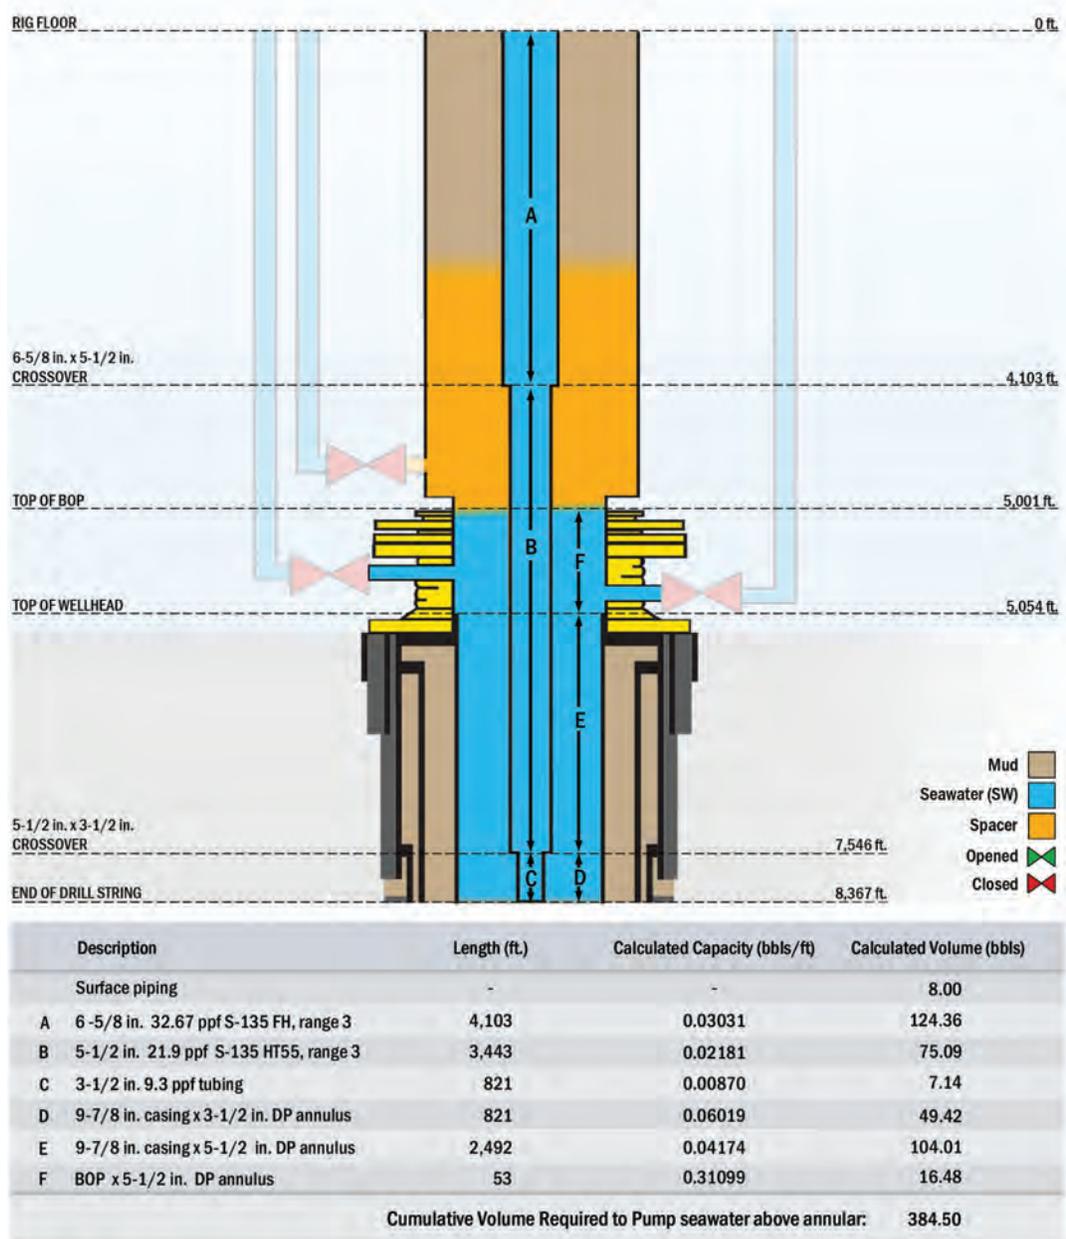
Figure 10 Volume of Seawater Necessary to Displace Spacer

1. The M-I SWACO procedure called for pumping 775 bbl of fluid into the well — 425 bbl of spacer and 350 bbl of seawater — to move the spacer through the well and above the BOP stack.³⁵ (See *Figure 10*) Based on the known geometry of the well and the configuration of the drill string, the M-I SWACO calculation was incorrect; the volume of seawater necessary to displace the spacer was 385 bbl (including 8 bbl to displace surface piping).³⁶ See *Figure 11*. The procedure was 35 bbl short of the seawater required to put the spacer above the BOP stack.

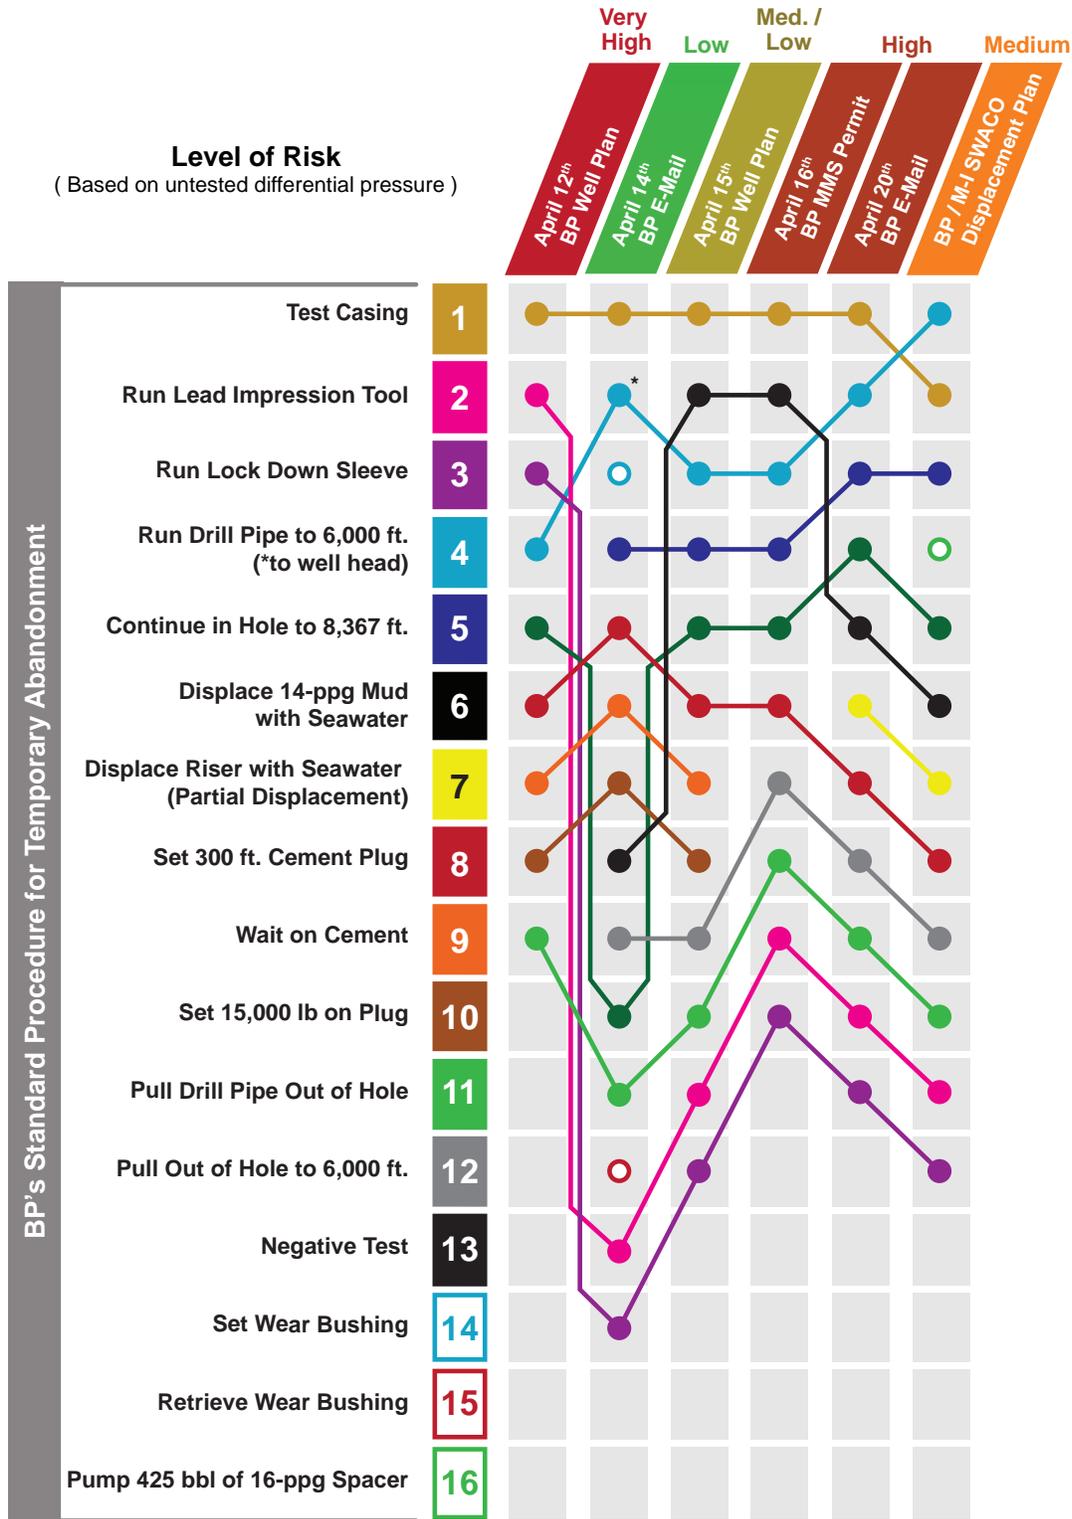
Figure 12 Lifecycle of BP's Temporary Abandonment Plan Modifications from April 12 to April 20, 2010, and MI-SWACO Displacement Plan, as Compared to BP Standard Procedure for Temporary Abandonment

Figure 12 illustrates how BP's five temporary abandonment plans and the M-I SWACO displacement plan changed and compared to BP's standard procedures for temporary abandonment. As can be seen, the plans varied significantly from each other and from BP's standard protocol, and introduced risk and confusion into the final procedure.

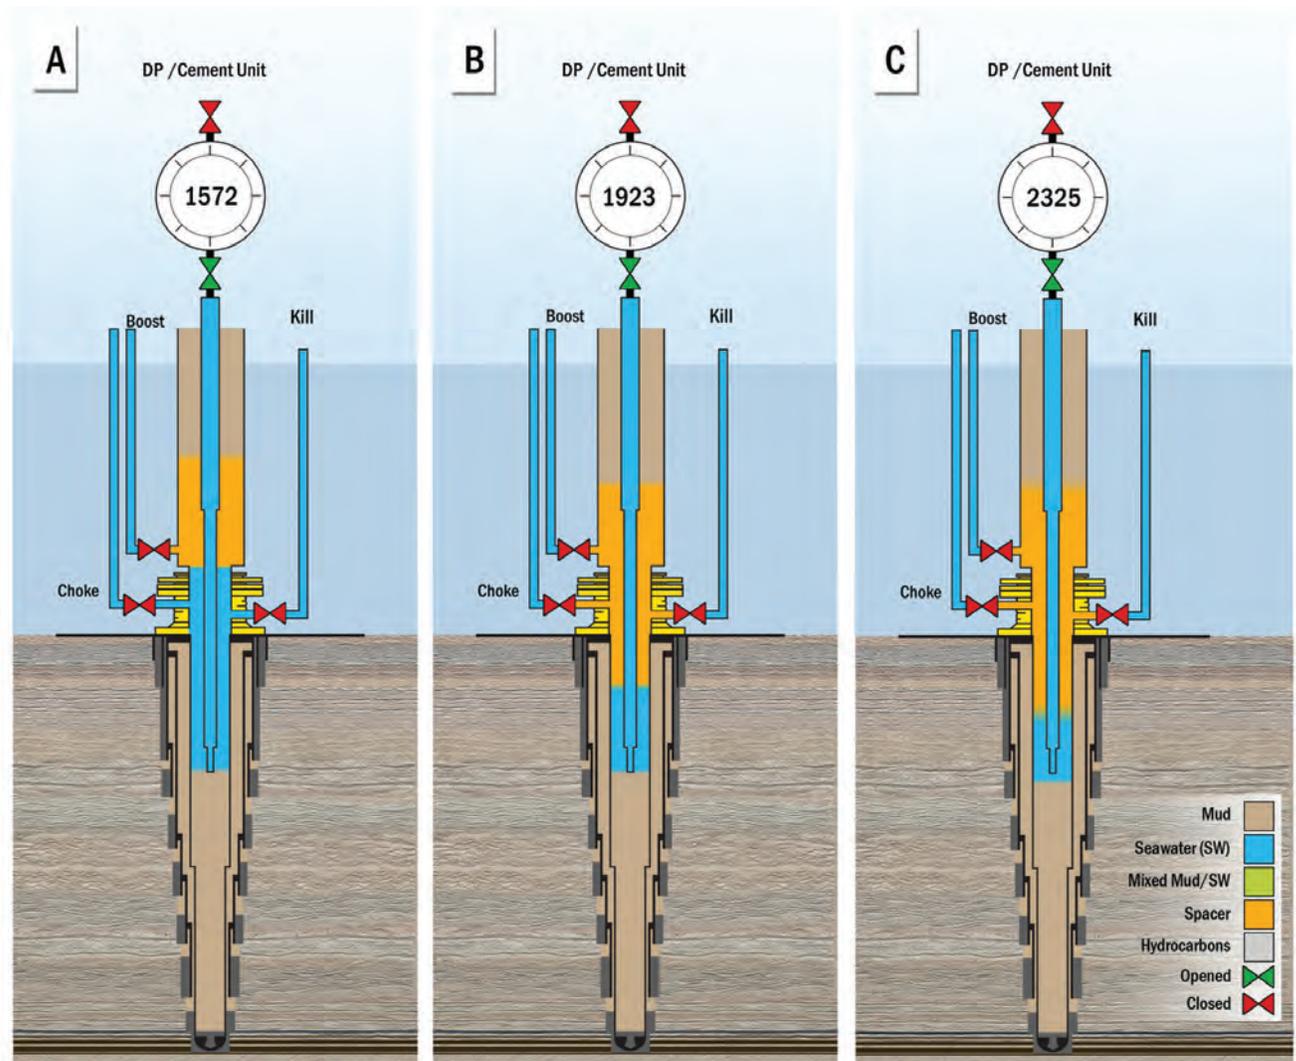
Had the spacer been displaced above the annular BOP, the drill pipe pressure should have been 1,572 psi when the pumps were shut down and the lower annular BOP element was closed at 4:53 p.m.⁴⁸ See *Figure 13a*. Had the underdisplacement been the result of the calculation errors alone, the drill pipe pressure would have been 1,923 psi.⁴⁹ See *Figure 13b*. Instead, the actual pressure recorded was 2,325 psi, which indicates the spacer had been under displaced and suggests that it was not just a result of calculation errors, but also seemingly lower pump efficiencies and potential downhole losses.⁵⁰ See *Figure 13c*. The additional heavy fluid that remained in the well below the annular BOP as a result of the underdisplacement resulted in a higher drill pipe pressure. The displacement procedures gave no guidance as to what the drill pipe pressure should have read when the mud pumps were turned off before the negative pressure test.⁵¹ There also was an apparent inability to track the volume of mud returning from the well compared to the theoretical volume pumped into the well. These factors caused the underdisplacement of the spacer to go unidentified.

Figure 13 (a) Represents the planned partial displacement with the spacer above the BOP. (b) Represents underdisplacing the spacer by 32 bbl as a result of the calculation errors in the displacement procedure. (c) Represents the pressure observed after turning off the pumps and closing the annular, and suggests that the spacer was underdisplaced by more than just 32 bbl as a result of calculation errors, seemingly lower pump efficiencies, and potential downhole losses.

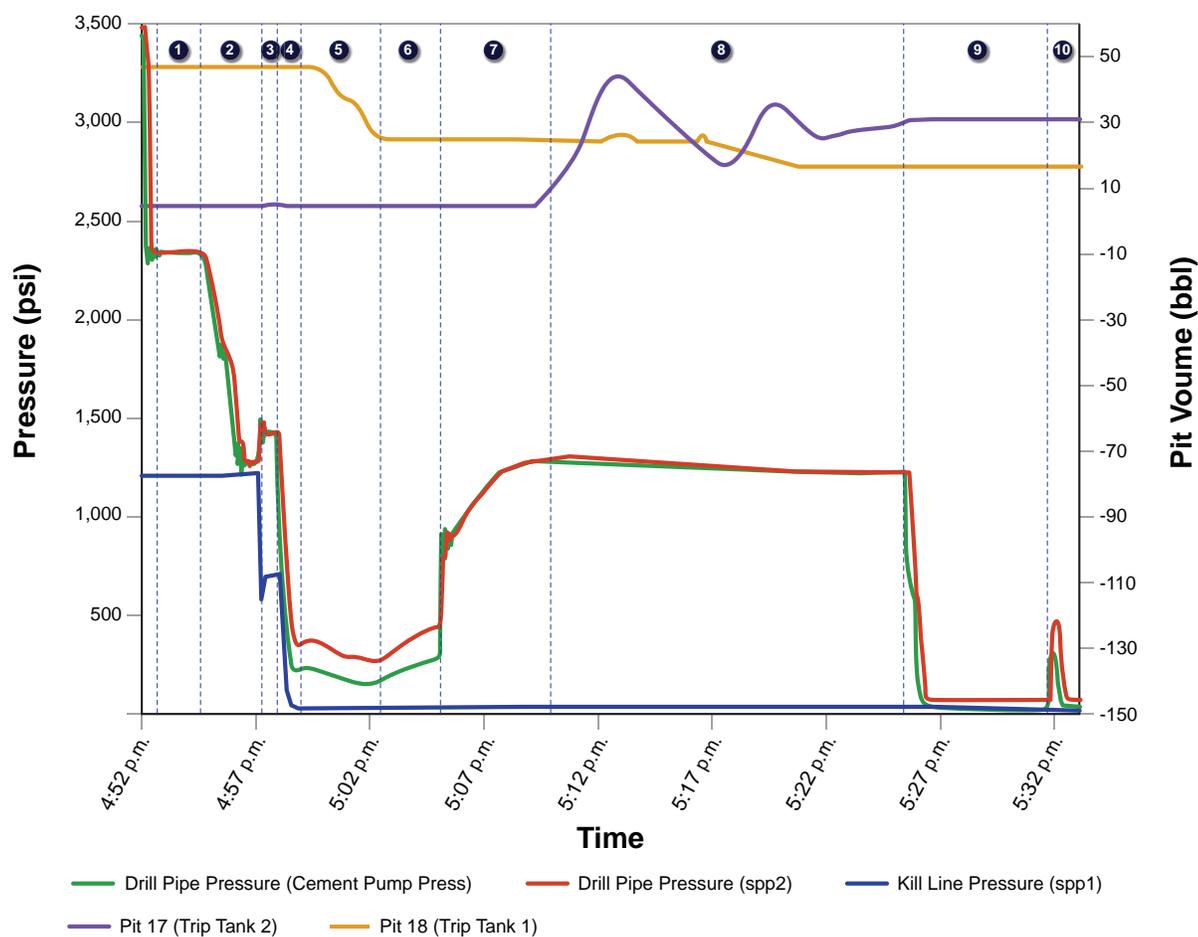
Figure 15 Overview of Events during the Negative Pressure Test from 4:53–5:34 p.m.

After the lower annular BOP element was closed, the pressure on the drill pipe was 2,325 psi, and the pressure on the kill line was approximately 1,200 psi.⁵³ See *Figure 17* and *Figure 15, Event 1*. At this time, the drill pipe and the kill line were closed off from one another by a subsea kill valve at the BOP stack, and the pressure on the drill pipe was bled down to equalize with the kill line pressure. When the drill pipe was opened and 18–25 bbl of fluid were bled from the drill pipe, the drill pipe pressure decreased to 1,250 psi.⁵⁴ See *Figure 15, Event 2*.

The drill pipe was opened and additional fluid was bled from the drill pipe to intentionally underbalance the well and test the barriers in place.⁵⁹ See Figure 15, Event 4. A trip tank, a small mud tank used to monitor fluid levels within the wellbore while the mud pumps are turned off, was lined up to monitor the fluid level in the riser.⁶⁰ Once lined up, the fluid level in the trip tank began to decrease immediately, confirming that fluid in the riser was falling and moving below the lower annular BOP element.⁶¹ See Figure 15, Event 5.

The heavy fluid in the annulus and the continued movement of fluid through the annular BOP prevented the drill pipe pressure from being bled to 0 psi.⁶² As seawater was bled from the drill pipe, fluid continued to move below the annular BOP. The drill crew ceased pumping fluid from the trip tank into the riser.⁶³ See Figure 15, Event 6.

Event	Time	Description
1	4:53 p.m. 4:54 p.m.	After the initial displacement is completed the mud pumps are shut down and the annular is closed.
2	4:54 p.m. 4:57 p.m.	The drill pipe is opened and an estimated 18 -25 bbl of fluid are bled from the drill pipe, and the drill pipe pressure (CPP) decreases to 1,250 psi. The drill pipe is then shut-in.
3	4:57 p.m. 4:58 p.m.	The subsea kill valve is opened to allow the pressure in the drill pipe and on the kill line to equalize. The drill pipe pressure (CPP) increases to 1,395 psi and the kill line pressure decreases to 682 psi (SPP1).
4	4:58 p.m. 4:59 p.m.	Continue bleeding seawater from the drill pipe. The kill line pressure (SPP1) bleeds to 0 psi while the drill pipe pressure (CPP) decreases to approximately 340 psi. The well becomes underbalanced to the formation.
5	4:59 p.m. 5:02 p.m.	Continue bleeding seawater from the drill pipe. The drill pipe pressure (CPP) decreases to approximately 240 psi before increasing. While bleeding pressure the trip tank is lined up to monitor the riser fluid level, and begins to immediately lose fluid indicating the 16 ppg spacer was moving below the closed annular BOP.

6	5:02 p.m. 5:05 p.m.	Continue bleeding seawater from the drill pipe. The trip tank is turned off but the fluid level in the riser continues to fall and move below the annular allowing additional 16 ppg spacer to enter the annulus below the closed annular BOP. The drill pipe pressure (CPP) begins to increase.
7	5:05 p.m. 5:09 p.m.	The drill pipe is shut in and the drill pipe pressure (CPP) rapidly increases to 900 psi. The pressure (CPP) continues to gradually increase to a maximum pressure of 1,250 psi. The annular preventer is sealed preventing any further movement of 16 ppg spacer below the closed annular BOP.
8	5:09 p.m. 5:26 p.m.	The drill pipe pressure (CPP) stabilizes at 1,202 psi. The pit data shows that a total of 65 bbl of fluid were pumped from the trip tanks to fill the riser.
9	5:26 p.m. 5:32 p.m.	The drill pipe is opened and approximately 15 bbl of seawater are bled from the drill pipe. The drill pipe pressure (CPP) decreases to approximately 0 psi and the well becomes underbalanced to the formation.

10	5:32 p.m. 5:34 p.m.	With the drill pipe still open, the subsea kill valve and the surface kill valve are opened. The heavy fluid in the annulus u-tubes resulting in flow out of the drill pipe and an increase in drill pipe pressure. Shortly after bleeding the pressure, valves are closed isolating the drill pipe pressure gauges (CPP, SPP2) and allowing the drill pipe pressure to bleed to approximately 0 psi.

The drill pipe was shut in, and the heavy fluid in the annulus rapidly pushed the drill pipe pressure to 900 psi.⁶⁴ See Figure 15, Event 7. Once the drill pipe pressure stabilized, the pressure gradually increased to 1,250 psi.⁶⁵ See Figure 19 and Figure 15, Event 7. The annular closing pressure was then increased, preventing any further movement of fluid below the closed annular BOP.⁶⁶

Based on the total volume of fluid pumped from the trip tank into the riser, the team calculated that 65 bbl of spacer moved below the annular.⁶⁷ See Figure 15, Events 5 and 8. Estimates of the initial underdisplacement combined with the total volume of fluid that moved below the annular indicate there were 136 bbl of spacer below the annular.⁶⁸

The BP well site leader then directed the drill crew to bleed the drill-pipe pressure to 0 psi.⁷¹ The drill crew underbalanced the well a second time, bleeding approximately 15 bbl of seawater from the drill pipe to bring the drill pipe pressure to 0 psi for monitoring.⁷² See *Figure 15, Event 9*. However, with the drill pipe still open, the BP well site leader instructed the drill crew to switch from monitoring the well on the drill pipe to monitoring on the kill line as specified in the approved MMS plan.⁷³ Consequently, at 5:32 p.m., the drill crew opened the kill valves, and the heavy fluid in the annulus fell, pushing fluid up and out of the drill pipe to the cement unit.⁷⁴ See *Figure 15, Event 10*. The Halliburton cementer called the rig floor, stating that 3–4 bbl of seawater had flowed back to the cement unit.⁷⁵ Upon post-incident review, this data further confirms heavy fluid in the annulus below the closed annular BOP.

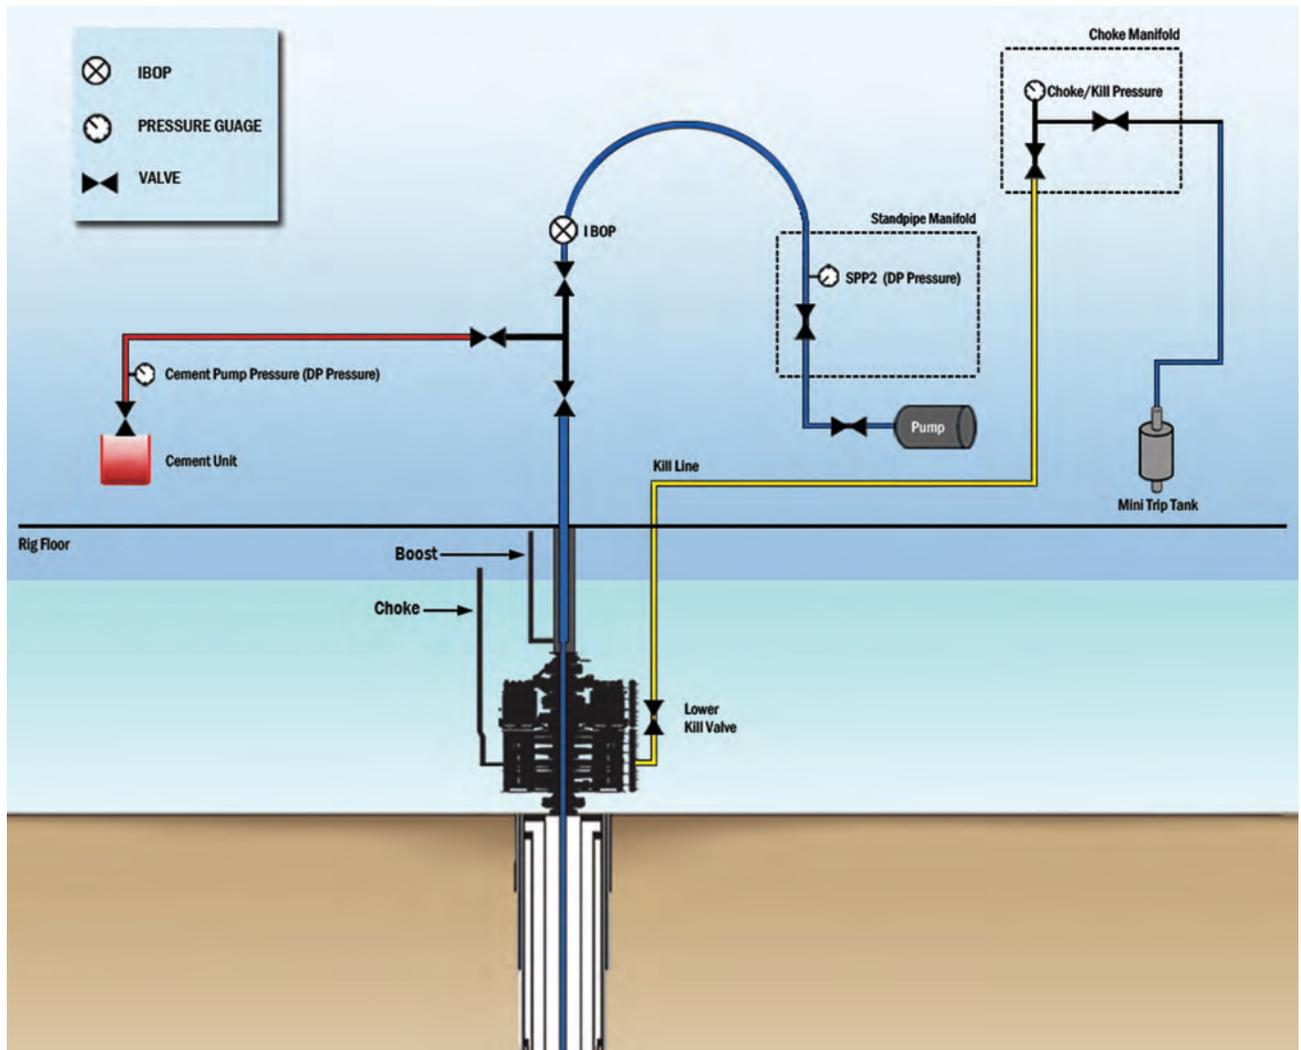
Figure 16 Simplified Schematic of the Assumed Line-up Configuration Used during the Negative Pressure Test

Figure 15 illustrates the events that occurred during the negative pressure test. *Figure 16* shows a simplified schematic of the assumed test setup configuration that was used during the negative pressure test.

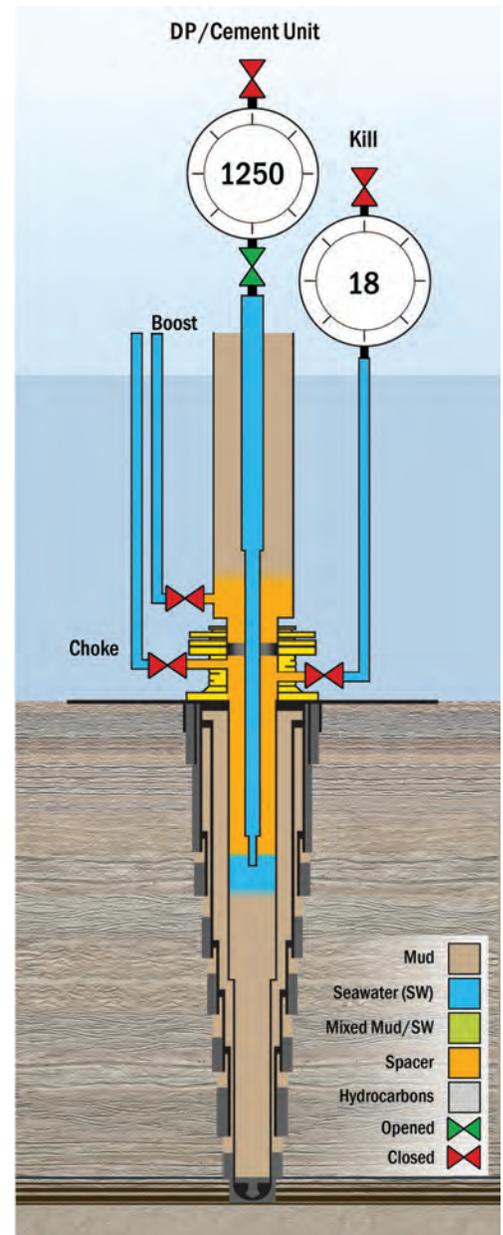
Figure 19 Build in Drill Pipe Pressure Following Initial Bleed

The on-duty BP well site leader arrived on the rig floor while a visual inspection of the riser fluid level was being conducted and shortly after the drill pipe pressure stabilized at 1,250 psi.⁶⁹ In discussions about the drill pipe pressure and the method of conducting the negative pressure test, the BP well site leader stated that the 1,250 psi observed on the drill pipe was likely a U-tube effect.⁷⁰

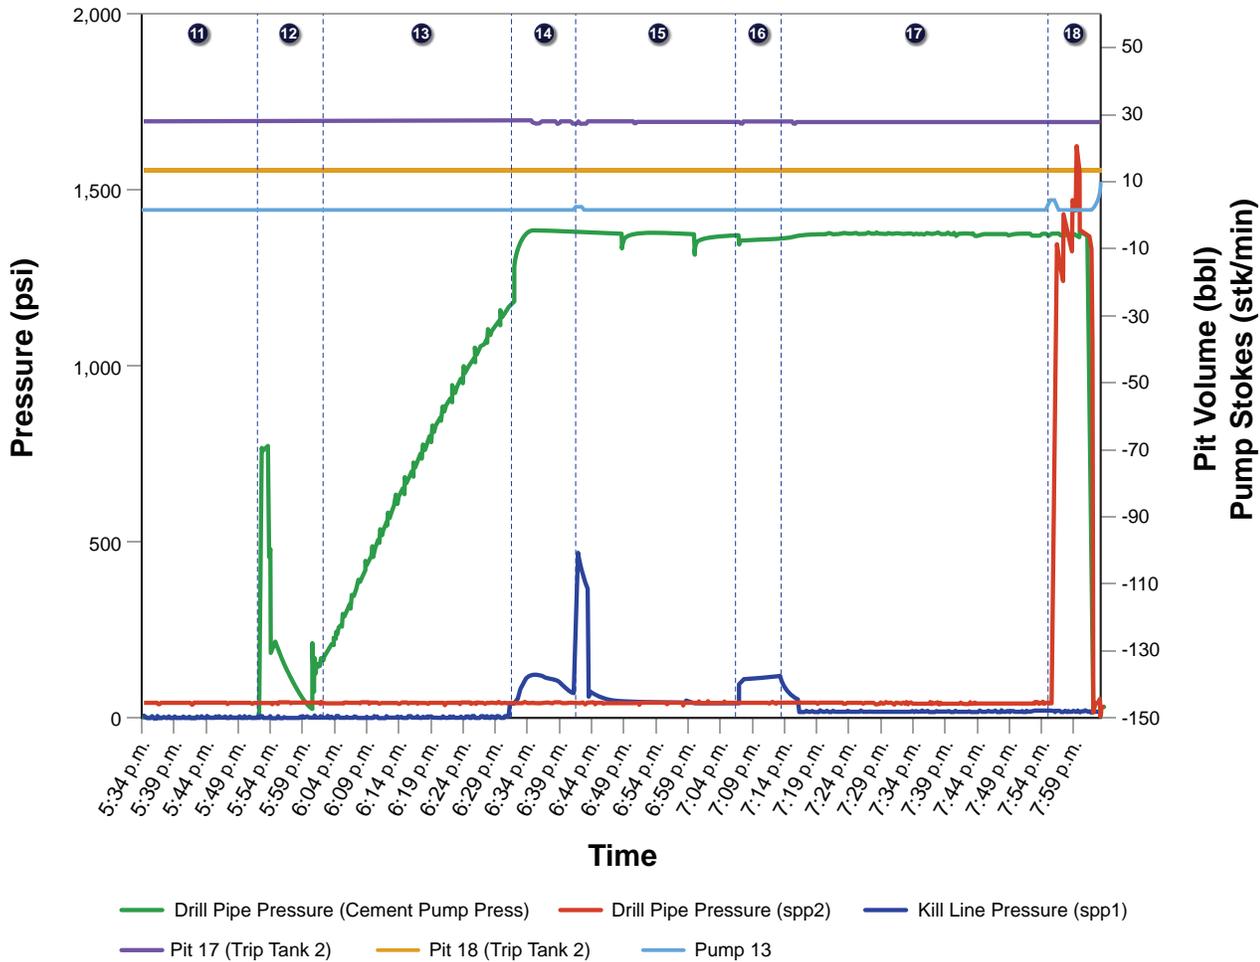
Figure 20 Overview of Events during the Negative Pressure Test from 5:34–8:02 p.m.

The BP well site leader directed the crew to shut in the well and left the rig floor to confer with the off-duty well site leader.⁷⁶ This temporarily isolated the gauges monitoring the drill pipe pressure, thereby preventing detection of a subsequent build up in well pressure.⁷⁷ See *Figure 17 and Figure 20, Event 11*.

At 5:52 p.m., a valve was opened, exposing the drill pipe pressure gauge located on the cement unit to the pressure that had built up in the well.⁷⁸ See *Figure 20, Event 12*. The drill pipe pressure gauge rapidly increased to 770 psi.⁷⁹ The drill pipe pressure then was bled a third time, and the well was shut in at 6 p.m.⁸⁰ The drill pipe pressure increased to approximately 1,182 psi.⁸¹ See *Figure 20, Event 13*. At 6:34 p.m., a slight pressure increase was recorded on the kill line, suggesting the subsea kill valve was open.⁸² Post-incident analysis indicates that within a few minutes, the drill pipe pressure had increased to 1,400 psi, and the kill line pressure had increased to 137 psi.⁸³ This suggests to the investigation team that a barrier had failed, and the well was in communication with the formations.⁸⁴ See *Figure 20, Event 14*.

After the pressure stabilized at 1,400 psi, both BP well site leaders arrived at the rig floor.⁸⁵ One of the BP well site leaders instructed the drill crew to pump down the kill line to ensure that it was full.⁸⁶ At 6:41 p.m., the drill crew pumped approximately 0.25 bbl into the kill line, and the kill line pressure immediately increased to 489 psi, suggesting that the kill line was full.⁸⁷ See *Figure 20, Event 15*.

Discussions resumed regarding the drill pipe pressure anomalies and the method of monitoring the well for the negative pressure test.⁸⁸ See *Figure 20, Events 15 and 16*. One of the BP well site leaders departed the rig floor to call shore.⁸⁹ Although there is disagreement, witnesses have indicated that he spoke to BP onshore engineers or supervisors about the negative pressure test.⁹⁰ The BP well site leader was directed to return to the rig floor and complete the negative pressure test.⁹¹

Event	Time	Description
11	5:34 p.m. - 5:51 p.m.	With the drill pipe pressure gauges (CPP, SPP2) isolated and the well underbalanced to the formation, pressure builds on the drill pipe with no corresponding increase on the drill pipe pressure gauges .
12	5:51 p.m. - 6:00 p.m.	A valve is opened exposing the drill pipe pressure gauge (CPP), located on the cement unit, to the pressure that had built on the drill pipe. After rapidly increasing to 770 psi, the pressure is again bled off.
13	6:00 p.m. - 6:31 p.m.	After bleeding pressure, the drill pipe is shut in and the drill pipe pressure (CPP) gradually increases to approximately 1,182 psi.
14	6:31 p.m. - 6:40 p.m.	The drill pipe pressure increases to approximately 1,182 psi. At approximately 6:31 p.m. a slight pressure increase is recorded on the the kill line, suggesting the subsea kill valve was opened. At 6:35 p.m. the drill pipe pressure increases to 1,400 psi and the kill line pressure increases to 137 psi, suggesting the well is in communication with the formation.

15	6:40 p.m. - 7:06 p.m.	Fluid is pumped into the kill line and the pressure (SPP1) increases to 492 psi, which suggests the kill line was full and that the subsea valve was closed. The kill line pressure (SPP1) is then bled off. A slight reduction in the drill pipe pressure (CPP) is noted on two occasions with no corresponding response on the kill line pressure (SPP1).
16	7:06 p.m. - 7:13 p.m.	The kill line pressure (SPP1) increases while drill pipe pressure (CPP) decreases suggesting the columns of fluid in drill pipe and kill line equalized.
17	7:13 p.m. - 7:54 p.m.	The kill line pressure is bled off and the negative test is conducted by monitoring the kill line for flow.

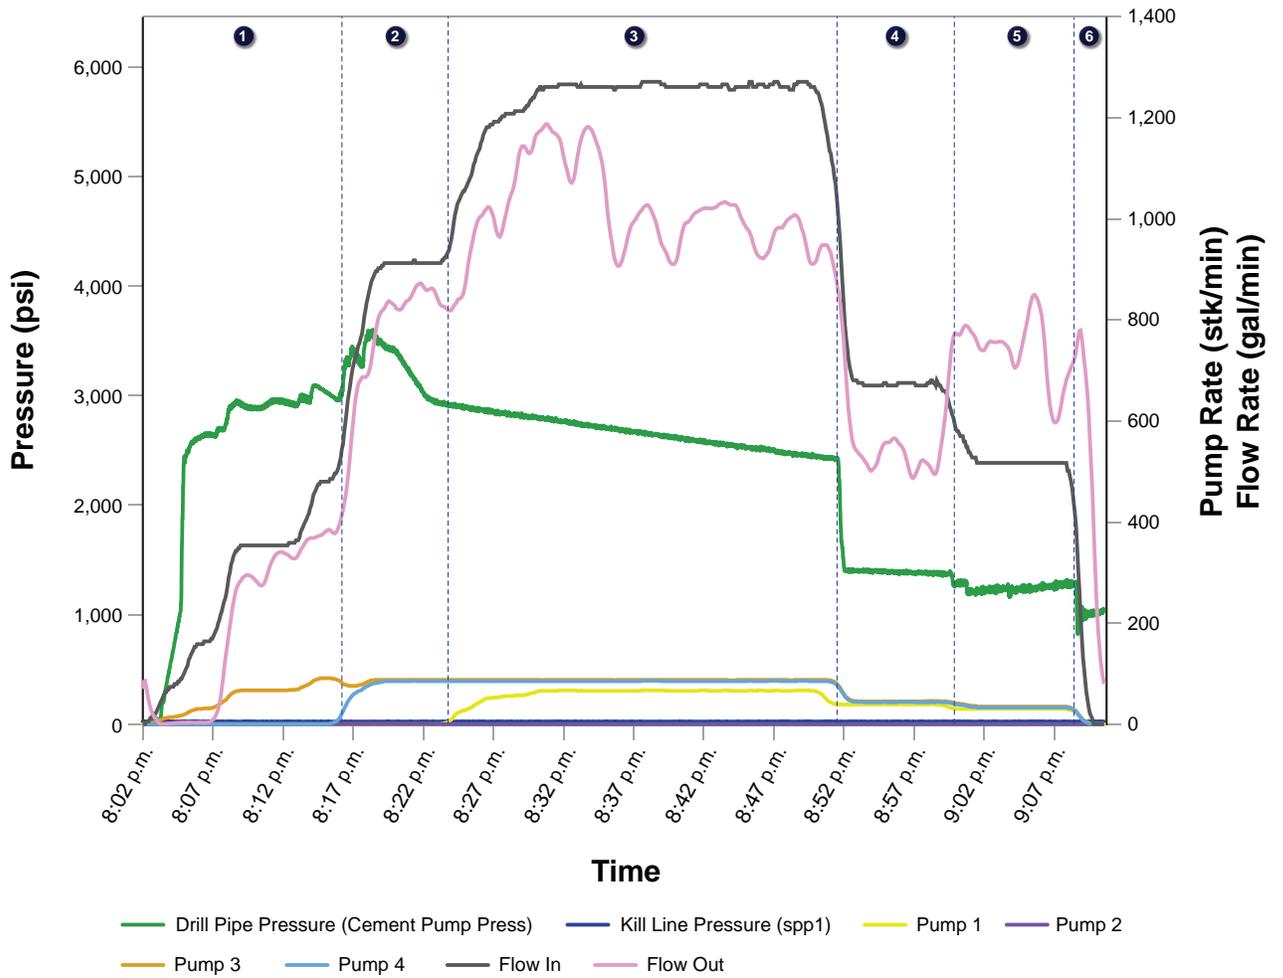
Final	Time	Description
1	8:02 p.m. - 8:16 p.m.	Pump 3 is turned on and pumps from the sea chest down the drill pipe. Shortly after the pump is turned on the lower annular is opened and the well once again becomes overbalanced to the formation.
2	8:16 p.m. - 8:23 p.m.	Pump 4 is turned on and Pumps 3 and 4 pump from the sea chest and down the drill pipe. The drill pipe pressure begins decreasing as seawater begins filling the annulus and 14 ppg mud exits the riser.
3	8:23 p.m. - 8:49 p.m.	Pump 1 is turned on and pumps seawater from the sea chest and down the boost line while Pumps 3, and 4 continue to pump down the drill pipe. The drill pipe pressure continues to decrease as seawater enters the annulus above the BOP and 14-ppg mud exits the riser. From approximately 8:27 p.m. - 8:36 p.m. approximately 43 bbl of fluid are pumped from the trip tank into diverter housing. It is estimated that the well becomes underbalanced sometime between 8:38 p.m. - 8:52 p.m.

4	8:49 p.m. - 8:59 p.m.	The pump rates are slowed in preparation of the spacer reaching the surface and the drill pipe pressure decreases accordingly. The pump rates establish a constant rate and the drill pipe pressure remains constant instead of decreasing.
5	8:59 p.m. - 9:07 p.m.	The pump rates are further reduced and the drill pipe pressure decreases accordingly. After establishing a constant pump rate the drill pipe pressure begins to increase. From approximately 8:58 p.m. - 9:06 p.m. the volume of fluid in the trip tank was again pumped into diverter housing.
6	9:07 p.m. - 9:09 p.m.	A determination is made that the spacer had reached the surface and pumps are shut down to perform a static sheen test.

Figure 21 is a summary of the events that occurred during the riser displacement from 8:02–9:09 p.m.¹⁰¹ Upon continuing with the displacement, at 8:02 p.m., pump 3 was turned on and the lower annular BOP element was opened to continue displacing the riser with seawater (*See Figure 21, Event 1*), in accordance with the displacement procedure.¹⁰² When the drill crew opened the annular BOP, the column of heavy fluid in the riser above the annular combined with the fluids in the well below the annular BOP to exert hydrostatic pressure against the formation pressure. The additional pressure made the well overbalanced to the formation and prevented flow of hydrocarbons into the well bore.¹⁰³

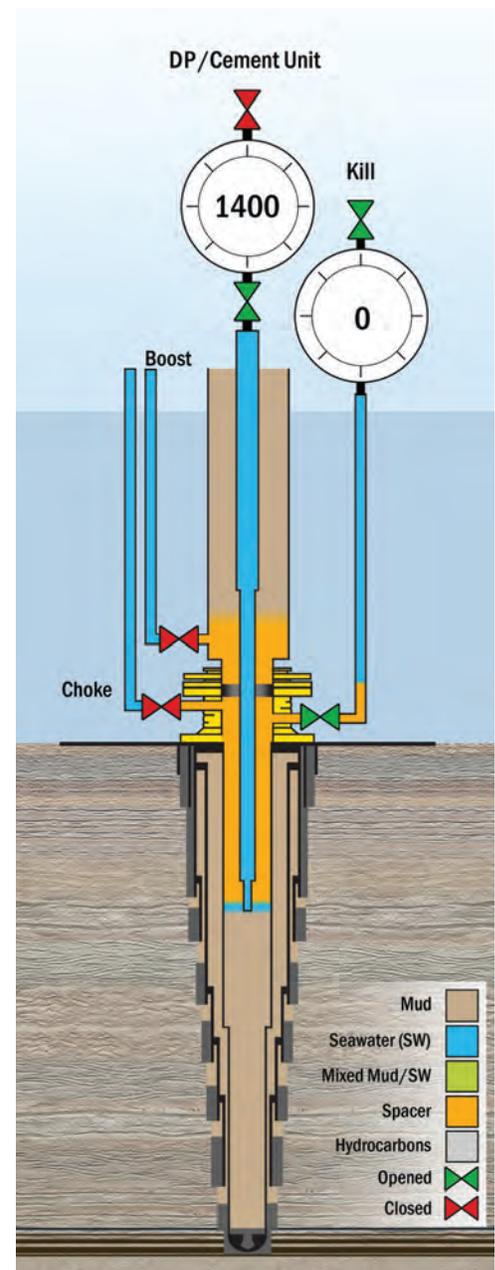
Figure 22 Drill Pipe Pressure at 1,400 psi during Negative Pressure Test

At 7:15 p.m., the drill crew bled pressure from the kill line and conducted the negative pressure test by monitoring the mini trip tank for flow from the kill line, even though the pressure on the drill pipe still registered 1,400 psi.⁹² See *Figure 22 and Figure 20, Event 17*. At this point, post-incident calculations indicate that pressure from the formations would have been greater than the downward pressure of the heavy fluid in the annulus.⁹³ Under such conditions, flow should have been visible from the kill line.⁹⁴ Because flow was not observed, the kill line or subsea kill valve may have been plugged with spacer, or the valve configuration may have prevented the flow to the mini trip tank.⁹⁵

- *Negative Pressure Test:* Despite the 1,400 psi of pressure observed on the drill pipe during the negative pressure test, no flow was observed from the kill line, and the test was interpreted incorrectly as being successful. Pressures observed during the negative pressure test confirm that the cement barrier had failed, pressure was being transmitted past the float equipment, and the well was in communication with the formation.
