MACONDO WELL INCIDENT
Transocean Investigation Report
Volume I

June 2011

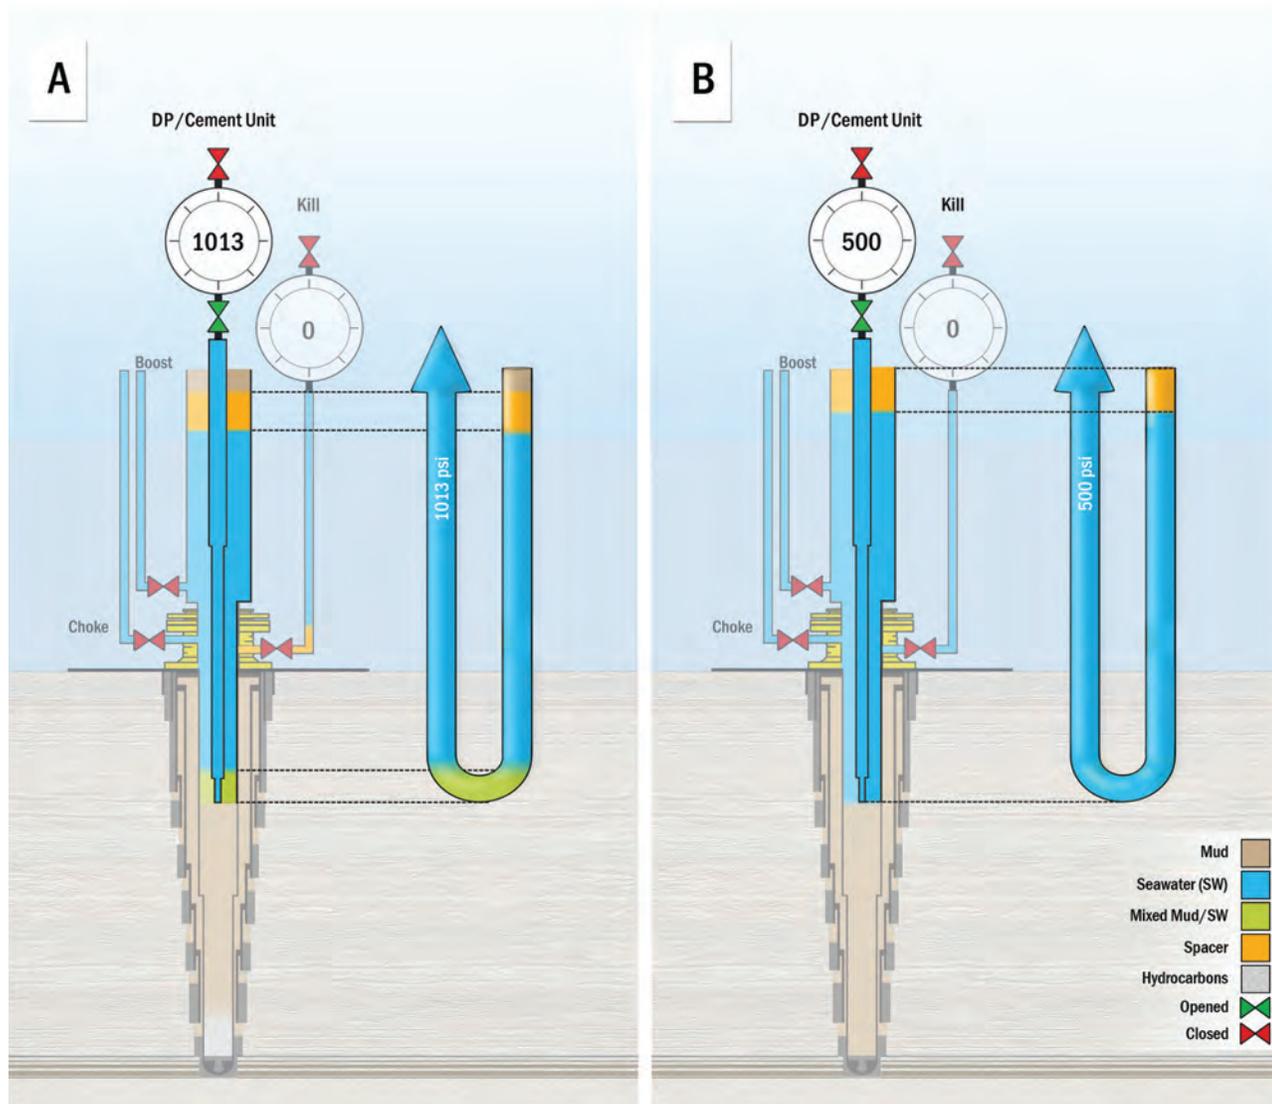
Although the compliance engineer concluded that the sheen test was successful, and the BP well site leader accepted his conclusion, analysis of the data indicates that the spacer had not reached the surface.¹¹⁸ The primary indicator is the initial hydrostatic pressure of 1,013 psi, which was measured when the pumps were shut down at 9:09 p.m.¹¹⁹ See Figure 23a. Had the spacer arrived at the surface by this time, the actual pressure should have been closer to 500 psi.¹²⁰ See Figure 23b. Additionally, the measured fluid weight for the sheen test sample was 15.4 ppg, between the weight of the mud and spacer, indicating approximately 30% oil based mud in the sample. With this weight, the sample should not have passed a sheen test, and operations should have continued displacement to the mud pits.

Figure 23 (a) Represents the actual pressure that was observed when the pumps were shut down to conduct the sheen test. (b) Represents the theoretical pressure that should have been observed had 16-ppg spacer been at the surface when the pumps were shut down to conduct the sheen test.

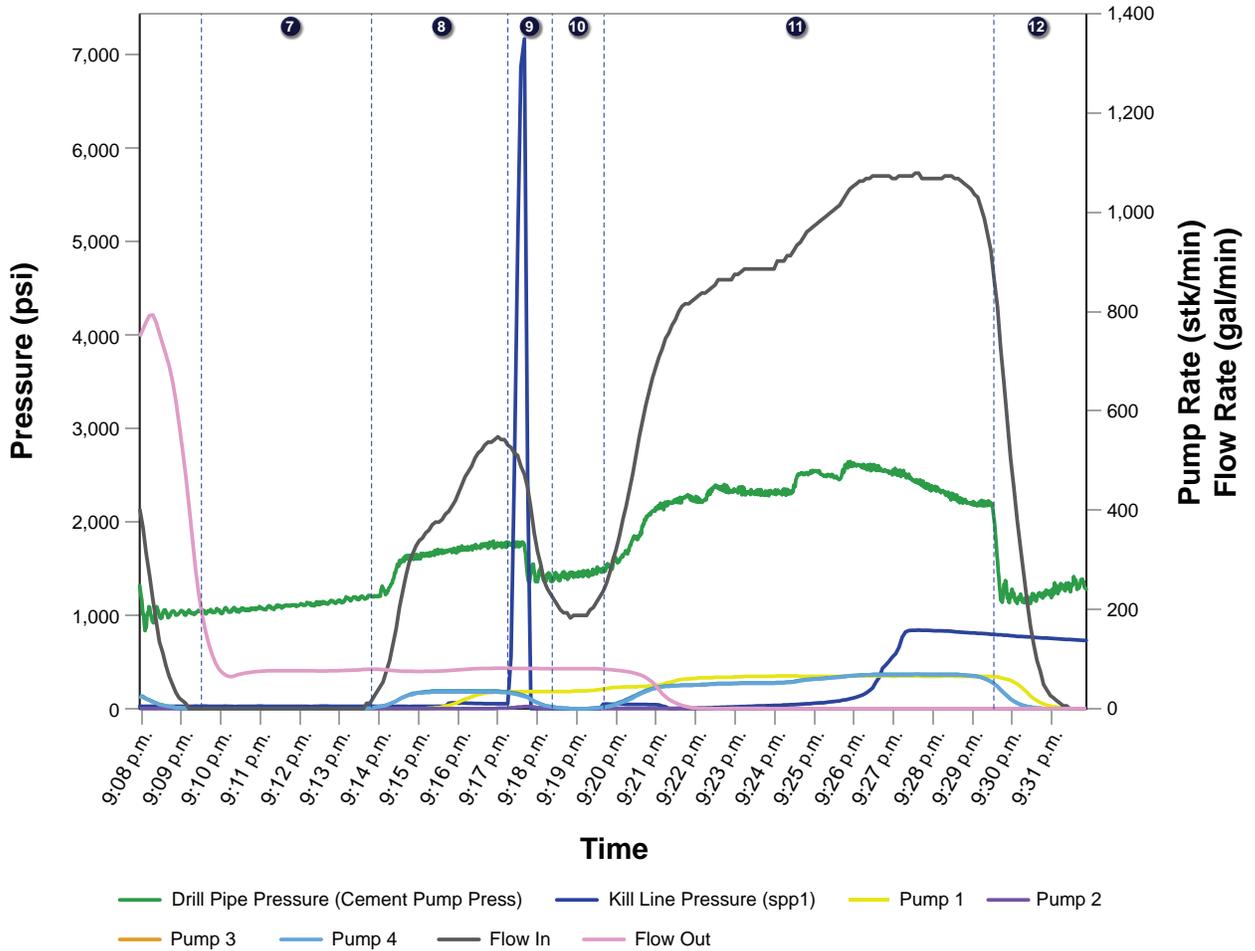
Event	Time	Description
7	9:09 p.m. - 9:13 p.m.	After the pumps are shut down and while the sheen test was being performed, the drill pipe pressure increased from 1,013 psi - 1,202 psi.
8	9:13 p.m. - 9:17 p.m.	Pumps 3, 4 and then 1 are turned on to continue the displacement with the return flow diverted overboard.
9	9:17 p.m. - 9:18 p.m.	Pump 2 is turned on and lined up to pump down the choke/kill line. The kill line pressure quickly increases to 7,126 psi and the pressure relief valve opens. Pumps 2, 3, and 4 are shut down while pump 1 continues pumping.
10	9:18 p.m. - 9:19 p.m.	The drill pipe pressure slowly increases while pumps 3 and 4 remained shut down. Pump 1 continues pumping at a constant rate down the boost line (no Sperry Sun pressure data available for the boost pump).
11	9:19 p.m. - 9:29 p.m.	Pumps 3 and 4 are turned on to continue the displacement. The kill line pressure begins a gradual increase to 833 psi before declining at a constant rate.

12	9:29 p.m. - 9:31 p.m.	Pumps 1, 3 and 4 are turned off to diagnose anomalous pressure readings. The drill pipe pressure begins to increase.

The BP well site leader directed the drill crew to continue with the displacement, and pumping resumed at 9:13 p.m.¹²⁷ Pumps 3, 4, and 1 were turned on, with the returns being pumped overboard.¹²⁸ See Figure 24, Event 8. At 9:17 p.m., pump No. 2 was brought online, and the kill line pressure rapidly increased to 7,126 psi.¹²⁹ See Figure 24, Event 9. At this time, pump 2 was lined up to pump down the choke and kill lines but was turned on prior to opening the kill line valve.¹³⁰ Pumping against the closed valve caused the pressure to build and the pressure relief valve to open.¹³¹ While pump 1 continued to pump down the boost line, pumps 2, 3, and 4 were shut down to assess the situation and to identify the affected pump. During this time, the drill pipe pressure

Between 9:22 p.m. and 9:27 p.m., a gradual and unusual increase in the kill line pressure occurred.¹³⁴ See Figure 24 Event 11. The pressure slowly increased to 833 psi and then decreased at a constant rate.¹³⁵ Kill line pressure is not unusual; however, in this instance, the gradual build in pressure suggests that the kill line may have been plugged or that a valve was partially opened. At 9:30 p.m., the drill crew, recognized an anomaly in the pressure readings and shut down the pumps to investigate.¹³⁶ See Figure 24, Event 12 and Figure 25.

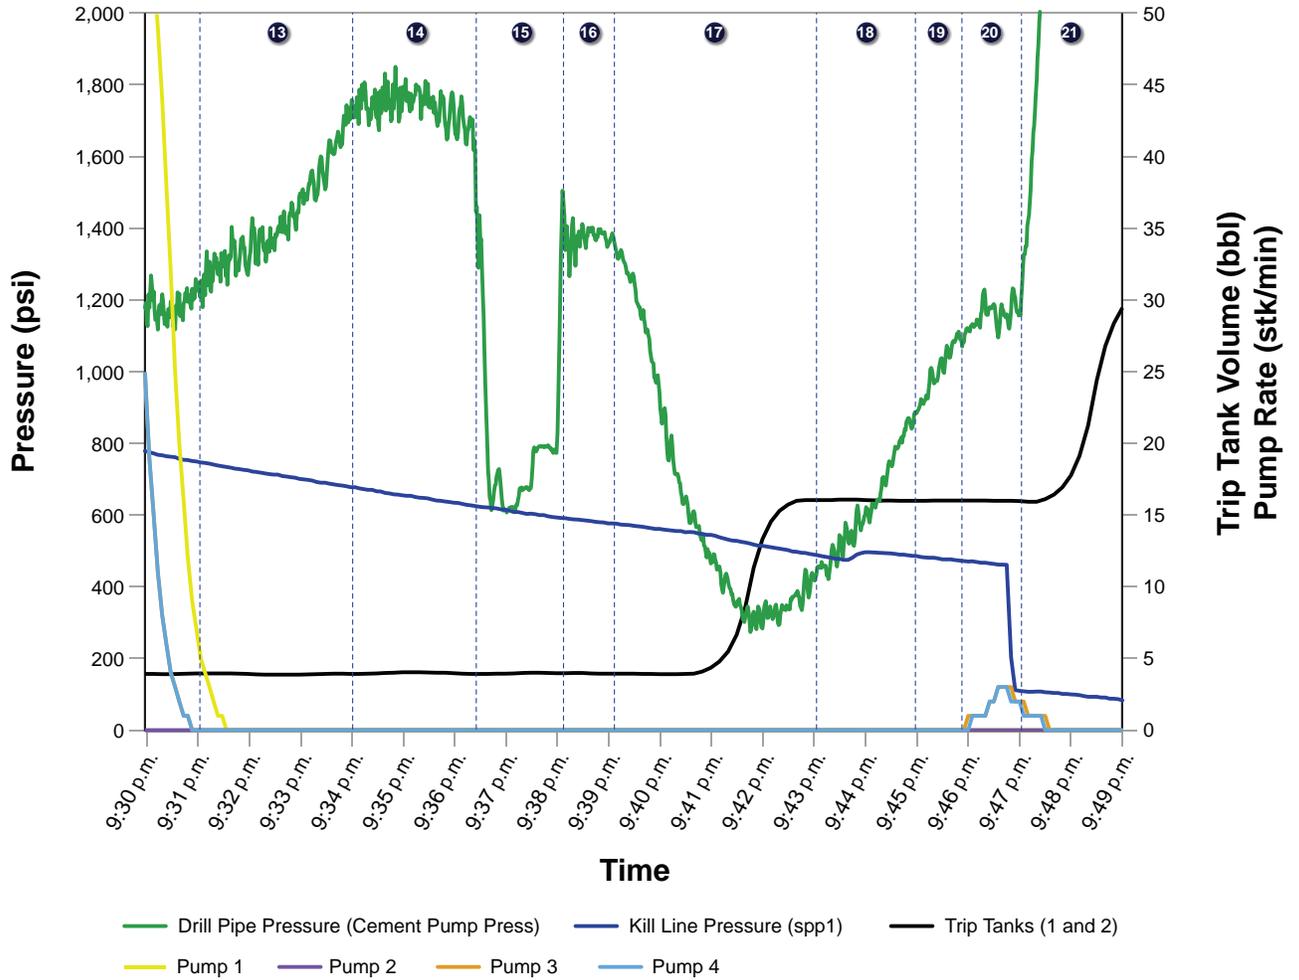
Figure 26 Overview of Events during the Riser Displacement from 9:31–9:49 p.m.

Hydrocarbons continued to flow into the well after the pumps stopped, pushing heavy fluid into the annulus above the end of the drill string and causing increased drill pipe pressure.¹³⁷ See Figure 26, Event 13. At about 9:34 p.m., the drill pipe pressure stabilized as heavy fluid was pushed into the riser.¹³⁸ See Figure 26, Event 14.

By 9:42 p.m., post-incident analysis indicates that hydrocarbons reached the top of the casing and began to flow into the riser.¹⁴³ At that time, the drill crew was changing the flow path to the trip tank to check for flow.¹⁴⁴ See Figure 28. The rapid increase in volume in the trip tank alerted the drill crew to an influx.¹⁴⁵ See Figure 26, Event 17.

The drill crew activated the upper annular BOP element at 9:43 p.m.¹⁴⁶ See Figure 26, Event 18. At that time, the well was flowing at an estimated 92 bbl per minute at the surface.¹⁴⁷ An increase in kill line pressure at this time indicates that the annular did close.¹⁴⁸ The subsequent decline in pressure indicates, however, that the annular did not hold a seal.¹⁴⁹ See Chapter 3.4, for a detailed discussion of the BOP.

Post incident analysis confirms that the flow of hydrocarbons accelerated and reached the rig floor between 9:43 p.m. and 9:45 p.m.¹⁵⁰ The drill crew activated the diverter to direct fluid to the mud-gas separator (MGS), and called the BP well site leader,¹⁵¹ the senior toolpusher, and the bridge¹⁵² to alert them that a well-control event was occurring. See Figure 26, Event 18.

Initially, the crew stopped the flow on the rig floor by diverting to the MGS.¹⁵³ However, the volume and force of the flow overwhelmed the MGS, and fluid began pouring out of its outlet lines.¹⁵⁴ See Figure 26, Event 19.

Event	Time	Description
13	9:31 p.m. - 9:34 p.m.	With the pumps shut down, the drill pipe pressure increases from 1,227 psi - 1,721 psi and the kill line pressure decreases at a constant rate.
14	9:34 p.m. - 9:36 p.m.	The drill pipe pressure stabilizes and the kill line pressure continues to decrease at a constant rate.
15	9:36 p.m. - 9:38 p.m.	The drill crew opens the drill pipe and bleeds the drill pipe pressure. The drill pipe is shut-in and the drill pipe pressure returned, but increased to a lower pressure than before.
16	9:38 p.m. - 9:39 p.m.	The drill pipe pressure stabilizes and remains relatively constant while the kill line pressure continues to decline.
17	9:39 p.m. - 9:43 p.m.	The influx of hydrocarbons reach the end of the drill string and begin to rapidly fill the annulus causing the drill pipe pressure to decrease. At about the same time that hydrocarbons reach the top of the casing and begin to flow into the riser, the trip tank is lined up and flow from the well causes the volume to increase rapidly.

18	9:43 p.m. - 9:45 p.m.	The annular is closed but does not seal. The gas in the riser continues to expand pushing mud onto the rig floor and the flow is diverted to the mud-gas-separator (MGS).
19	9:45 p.m. - 9:46 p.m.	The flow exceeds the capacity of the MGS and mud begins to flow out of the MGS outlet lines.
20	9:46 p.m. - 9:47 p.m.	The gas reaches the surface and begins to flow through the MGS onto the rig. One or more of the variable bore rams (VBR) are activated.
21	9:47 p.m. - 9:49 p.m.	One or more of the VBR's are sealed and well is temporarily shut-in.

Between 9:46 p.m. and 9:47 p.m., the crew activated one or more of the BOP variable bore rams (VBRs) to seal the annular space.¹⁵⁵ See Figure 26, Event 20. At 9:47 p.m., the drill pipe pressure increased and the kill line pressure decreased,¹⁵⁶ indicating that a ram had successfully closed and sealed the annular space.¹⁵⁷ See Figure 26, Event 21. At approximately 9:49 p.m., the real-time Sperry Sun data feed to shore ended.¹⁵⁸ It is assumed that the rig lost power at this time.

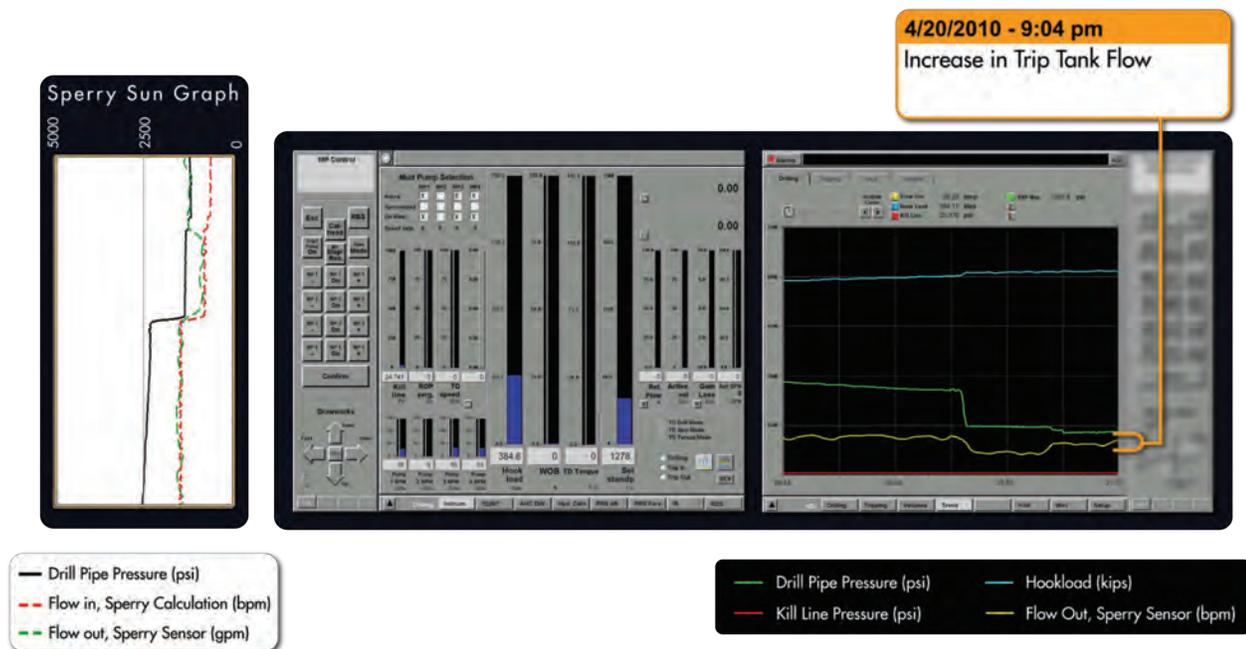
Figure 7 9:04 p.m. Increase in Flow during Trip Tank Dump

the well.¹⁵ It is believed that the driller saw an expected flow increase and subsequent decrease as the trip tank pump was turned on and off, respectively, which masked evidence of the influx. Based on post-incident calculations, the investigation team determined that approximately 16.5 barrels (bbl) of hydrocarbons entered the well during the course of the trip tank dump. See Figure 7.

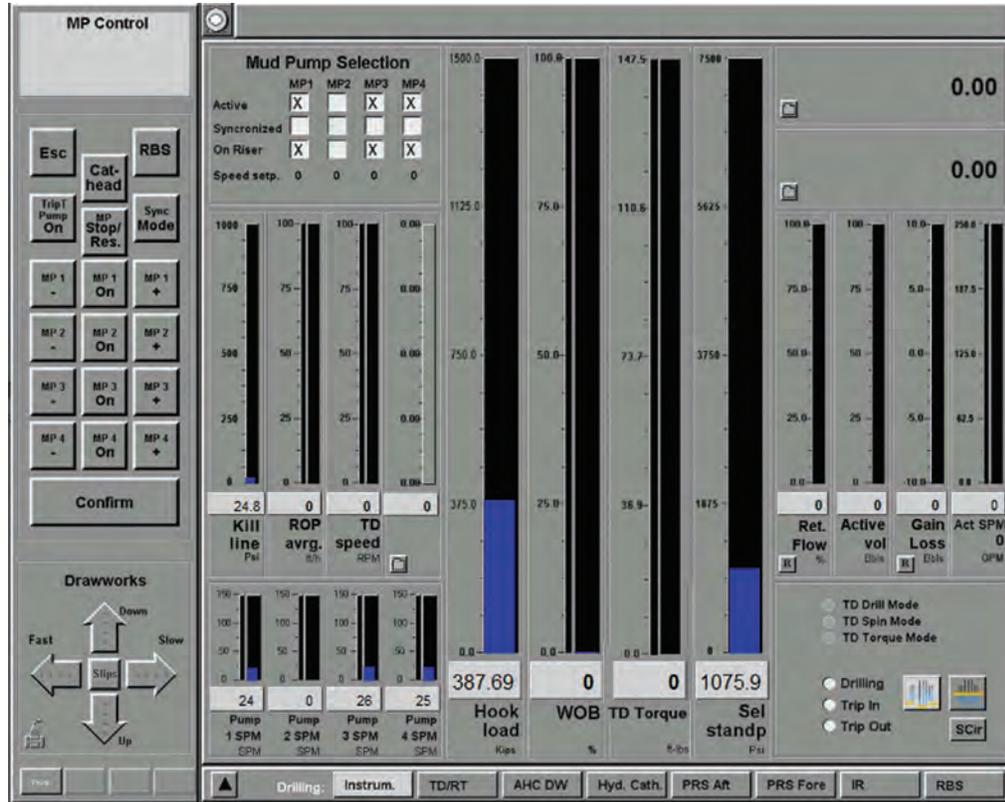
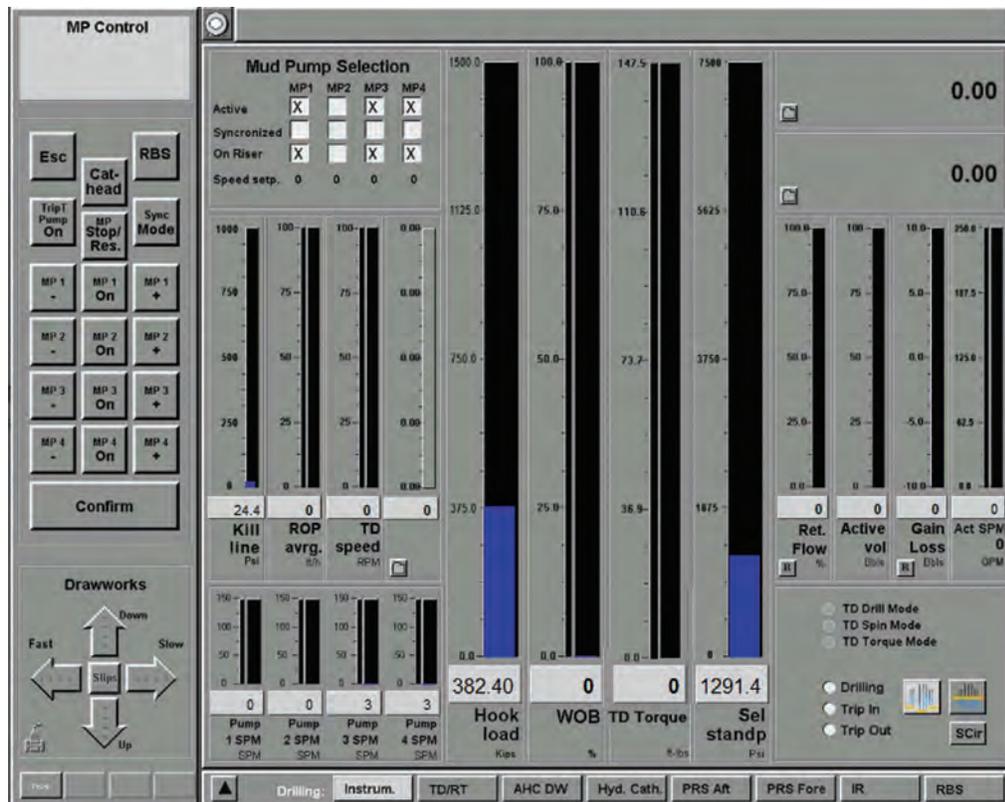
Figure 8 Change in Drill pipe Pressure from 9:08–9:14 p.m.

During the sheen test, post-incident analysis reflects that pressure gradually increased by 189 psi. The investigation team believes this may not have been readily observed on the 0–7,500-psi display monitored by the drill crew, as explained previously.²² See *Figures 8 and 9*. Post-incident analysis of the data shows that for the first 30–40 seconds after the pumps were shut down, the pressure appeared stable. Given stable pressure readings and confirmation of no flow from the shaker room, the driller would have then likely prepared for the next displacement phase by setting up mud pump 2 to pump down the kill and choke lines.

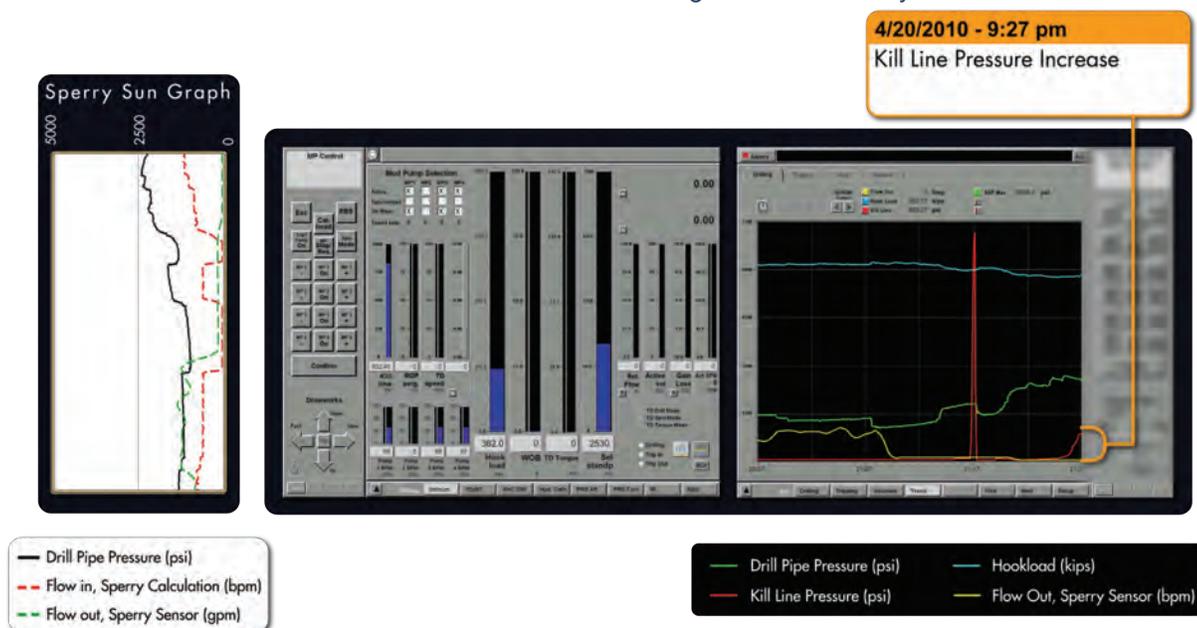
Figure 10 9:27 p.m. Kill Line Pressure Climbs to 833 psi.

The pressure on the kill line began to increase very gradually at 9:22 p.m. after the valve had been opened. From 9:26–9:27 p.m., pressure increased to 833 psi.³² See Figure 10. The investigation team could not determine a reason for the erratic pressure build — initially slow and then more rapid in the kill line pressure reading. The kill line could have been plugged with spacer material. Within the next two minutes, the drill crew likely discussed the anomalous differential pressure readings between the kill line and drill pipe.³³ The investigation team believes this is the first indication that the drill crew recognized an anomaly in the well.

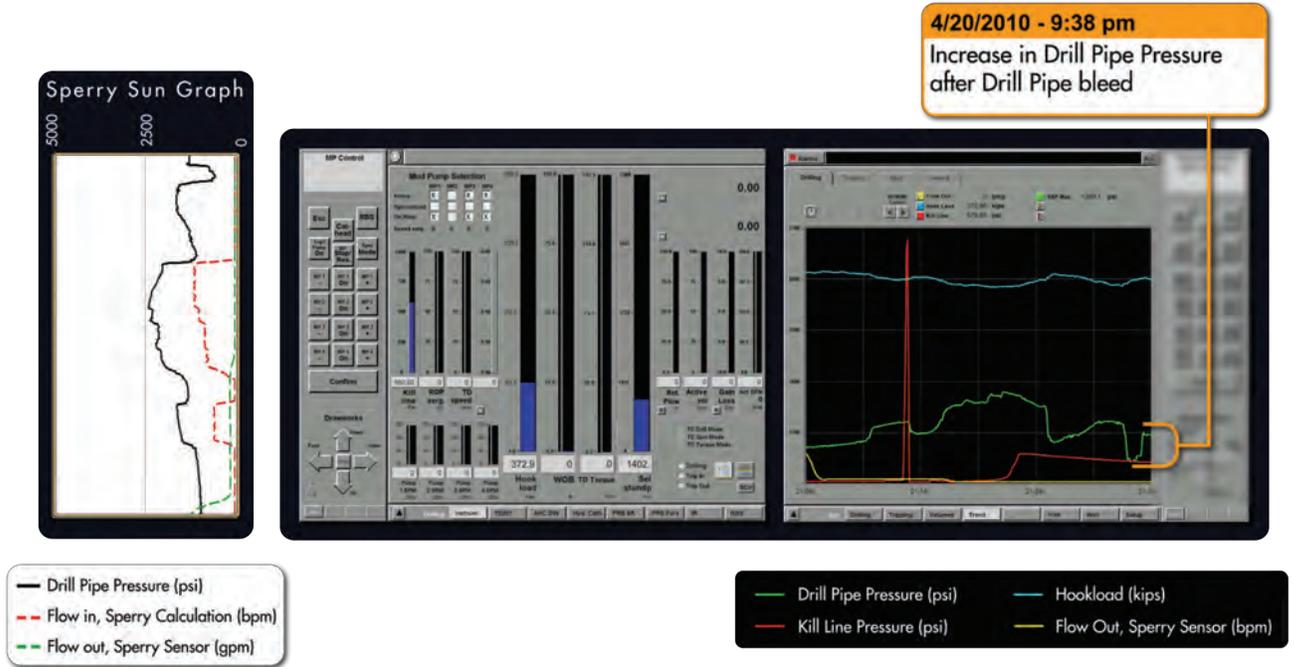
Figure 13 Drill Pipe Pressure Builds after Bleed

At 9:36 p.m., the driller instructed a floor hand to bleed the drill pipe on the standpipe manifold, and for the next one-and-a-half minutes, flow was taken from the drill pipe.³⁷ Based on the experience and work of the investigation team, the team concluded that the action taken to bleed pressure from the drill pipe is consistent with a belief by the driller that a plug existed. At this time, the well had taken more than 385 bbl of fluid from the formation and was flowing at more than 38 bpm with mud and hydrocarbons still below the drill string.³⁸ The driller instructed the floor hand to close the valve when the drill pipe pressure approached the kill line pressure.³⁹ Once the drill pipe was shut in, the drill pipe pressure immediately built to 1,400 psi, 300 psi lower than before the bleed off, and then remained constant until 9:39 p.m.⁴⁰ See Figure 13. It is apparent the drill crew was taking measures to understand the well condition. From analysis work by the investigation team, the lower pressure after the bleed-off indicates that mud was still below the drill string at this time, as it was sucked into the drill pipe and caused a lower pressure reading when the valve was closed.

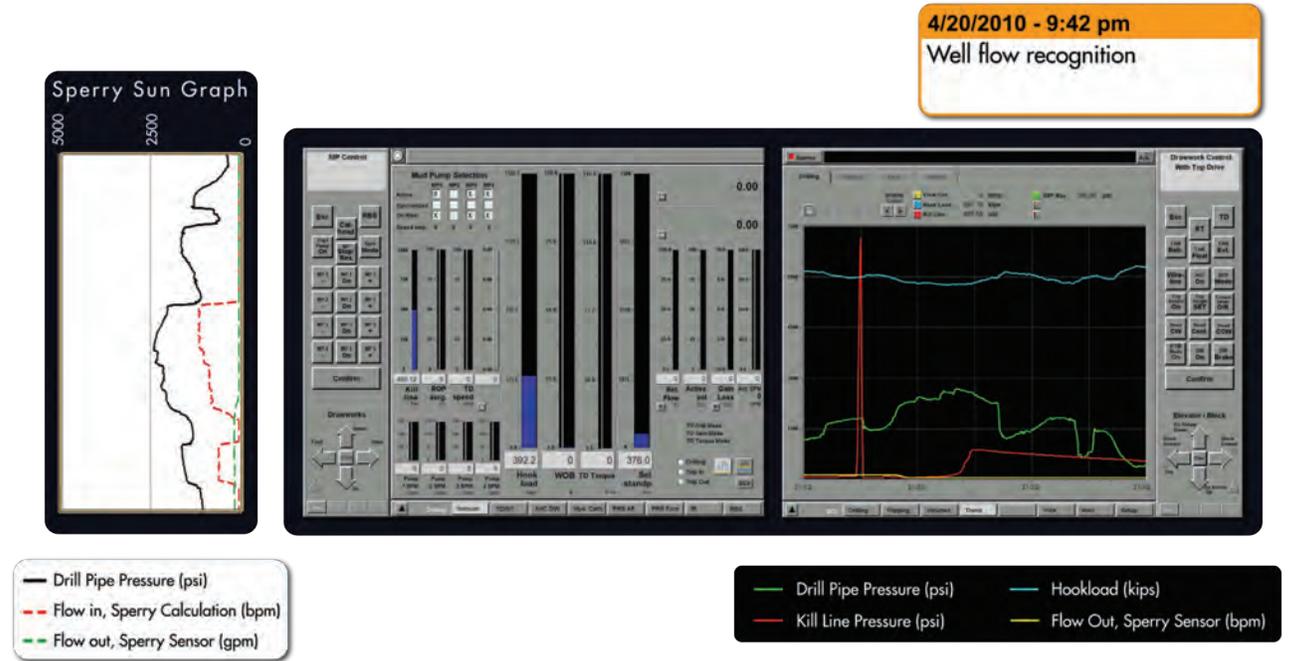
Figure 14 9:42 p.m. Trip Tank Fills

At 9:39 p.m., the drill pipe pressure began to decline as hydrocarbons began to move upward past the end of the drill pipe. The pressure drop is a clear signal to a driller of a kick as, under normal drilling conditions, when hydrocarbons enter the well, they will lower pressure readings. The driller routed the well returns to the trip tank to check for flow. By 9:42 p.m., the trip tank began to fill rapidly, and the driller recognized the well was flowing.⁴¹ See Figure 14.

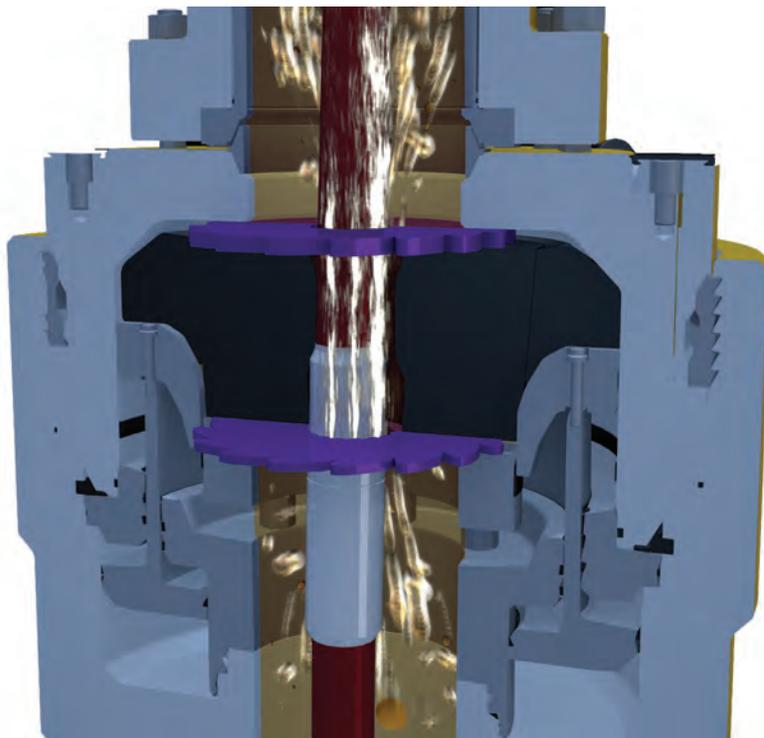
Figure 11 Drill Pipe Tool Joint Lifted by Flow into Upper Annular

At the time of the incident on April 20, 2010, the extreme flow rate from the well created sufficient force to lift the drill string, moving the tool joint up and partly into the upper annular BOP element.⁷⁰ This position of the tool joint was confirmed from the pipe sections recovered with the riser joint at the NASA Michoud facility. The analysis compared the distance between the BOP rams and annulars to the drill pipe from the BOP stack and riser, along with markings on the drill pipe. See Appendix L.⁷¹

Figure 11 shows the drill pipe tool joint in the upper annular BOP element stack as a result of the upward force from the flowing well.

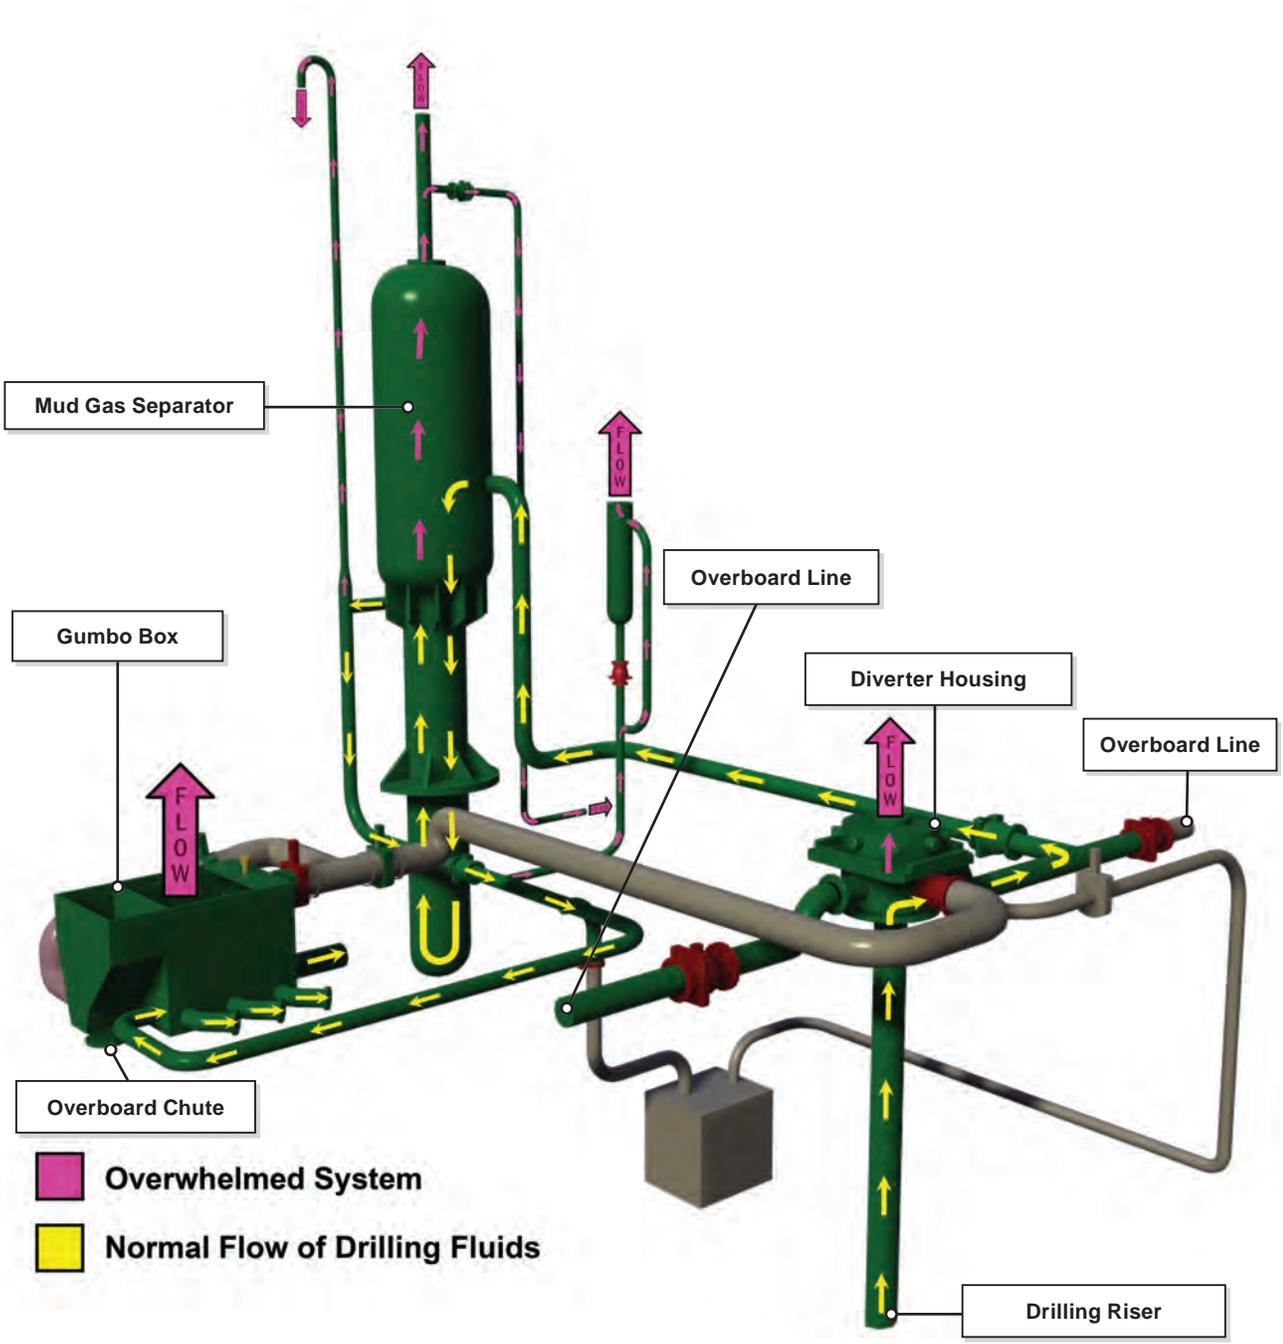
Figure 13 Path of Return Flow after Diverter was Closed and then Overcome

The gas expanded as it moved up the riser, pushing mud onto the drill floor.⁷⁶ The drill crew closed the diverter packer to redirect the flow from the well to the MGS pursuant to BP and Transocean standard practice.⁷⁷ As the flow from the well increased due to the rapid expansion of gas in the riser, the flow rate exceeded the capacity of the MGS.⁷⁸ At approximately 9:48 p.m.,⁷⁹ witnesses said mud began flowing out of the MGS vacuum breaker line located halfway up the derrick, and fluid overflow from the MGS filled the mini trip tank.⁸⁰ See *Figure 13*.

Figure 13 illustrates the path of return flow to the MGS after the diverter was closed.

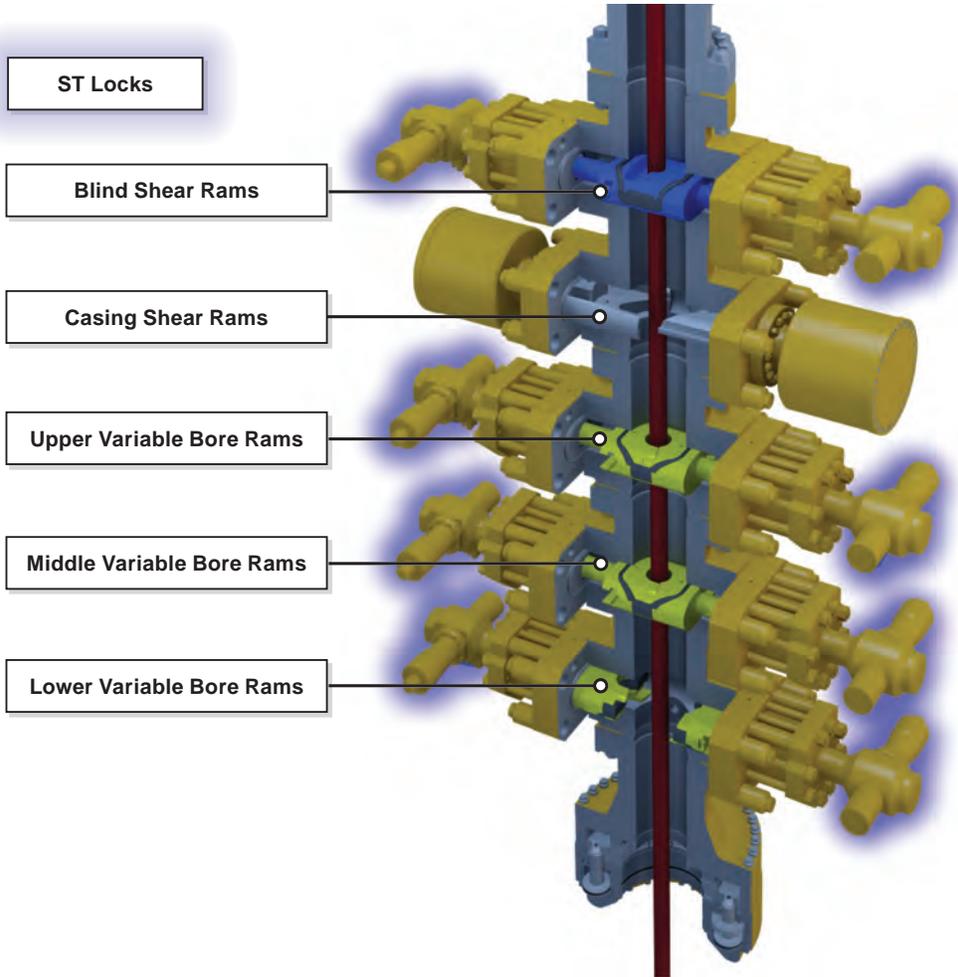
Figure 16 Position of Blind Shear Rams and VBRs Following AMF Activation.

The explosions and fire subsequently damaged or destroyed the BOP secondary hydraulic supply line hose and the BOP MUX control cables, resulting in the loss of hydraulic supply pressure and electrical power to the BOP. This, in turn, automatically activated the AMF system in both the blue and yellow pods. The AMF activated the high-pressure shear circuit to close the blind shear rams utilizing the stored hydraulic pressure in the accumulator bottles mounted on the lower BOP stack. Pressure from the accumulators closed the blind shear rams (BSRs) and activated the ST Locks on all of the closed rams (BSRs, upper VBR, and middle VBR). See *Figures 16 and 17*. When the BOP is operated from the surface via the control panels, the ST Locks are not automatically engaged; this is a manual function performed by the drill crew. The fact that the ST Locks were engaged on the BSRs and both VBRs confirms that the high-pressure shear circuit was activated by the AMF.^G

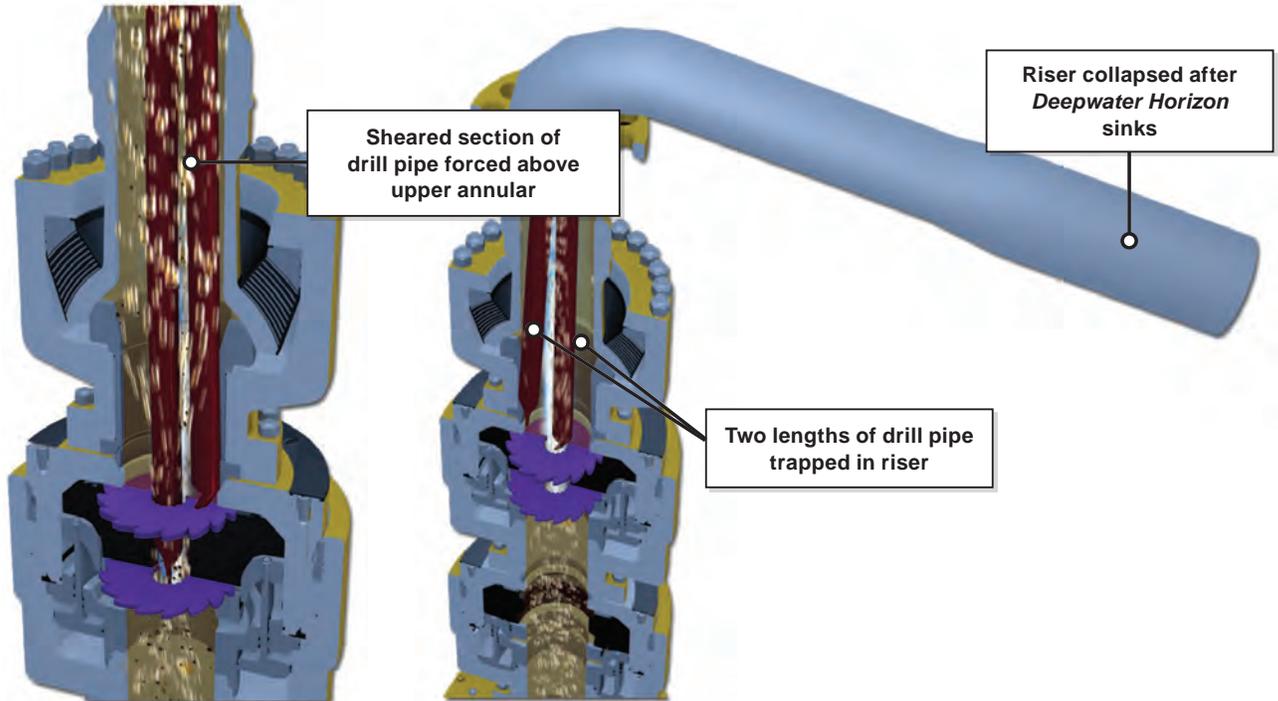
Figure 19 Sheared Drill Pipe Forced through Upper Annular

Within minutes after the first explosion, communication from the rig to the pods was lost, and the AMF activated the high-pressure shear function to close the BSRs. Forensic evaluation by DNV revealed that a portion of the drill pipe cross section was outside of the BSR shearing blades and became trapped between the ram block faces, preventing the blocks from completely shearing the pipe and fully closing and sealing. This also prevented upward movement of the drill pipe and exposed it to further flow wash at the upper annular.¹⁰⁹ The resulting flow path allowed the high-pressure fluid to wash around and through the BSR ram blocks, the BOP stack, and the drill pipe.¹¹⁰ The erosion around the BSR from the washout is shown in *Figure 18*. Hydrocarbons flowed up through the drill pipe held in the VBRs, around the flow-washed areas of the BSRs, around the tool joint in the annular BOP element, and up the drilling riser.

Figure 19 illustrates the sheared pipe being forced above the annular from the flow of hydrocarbons.

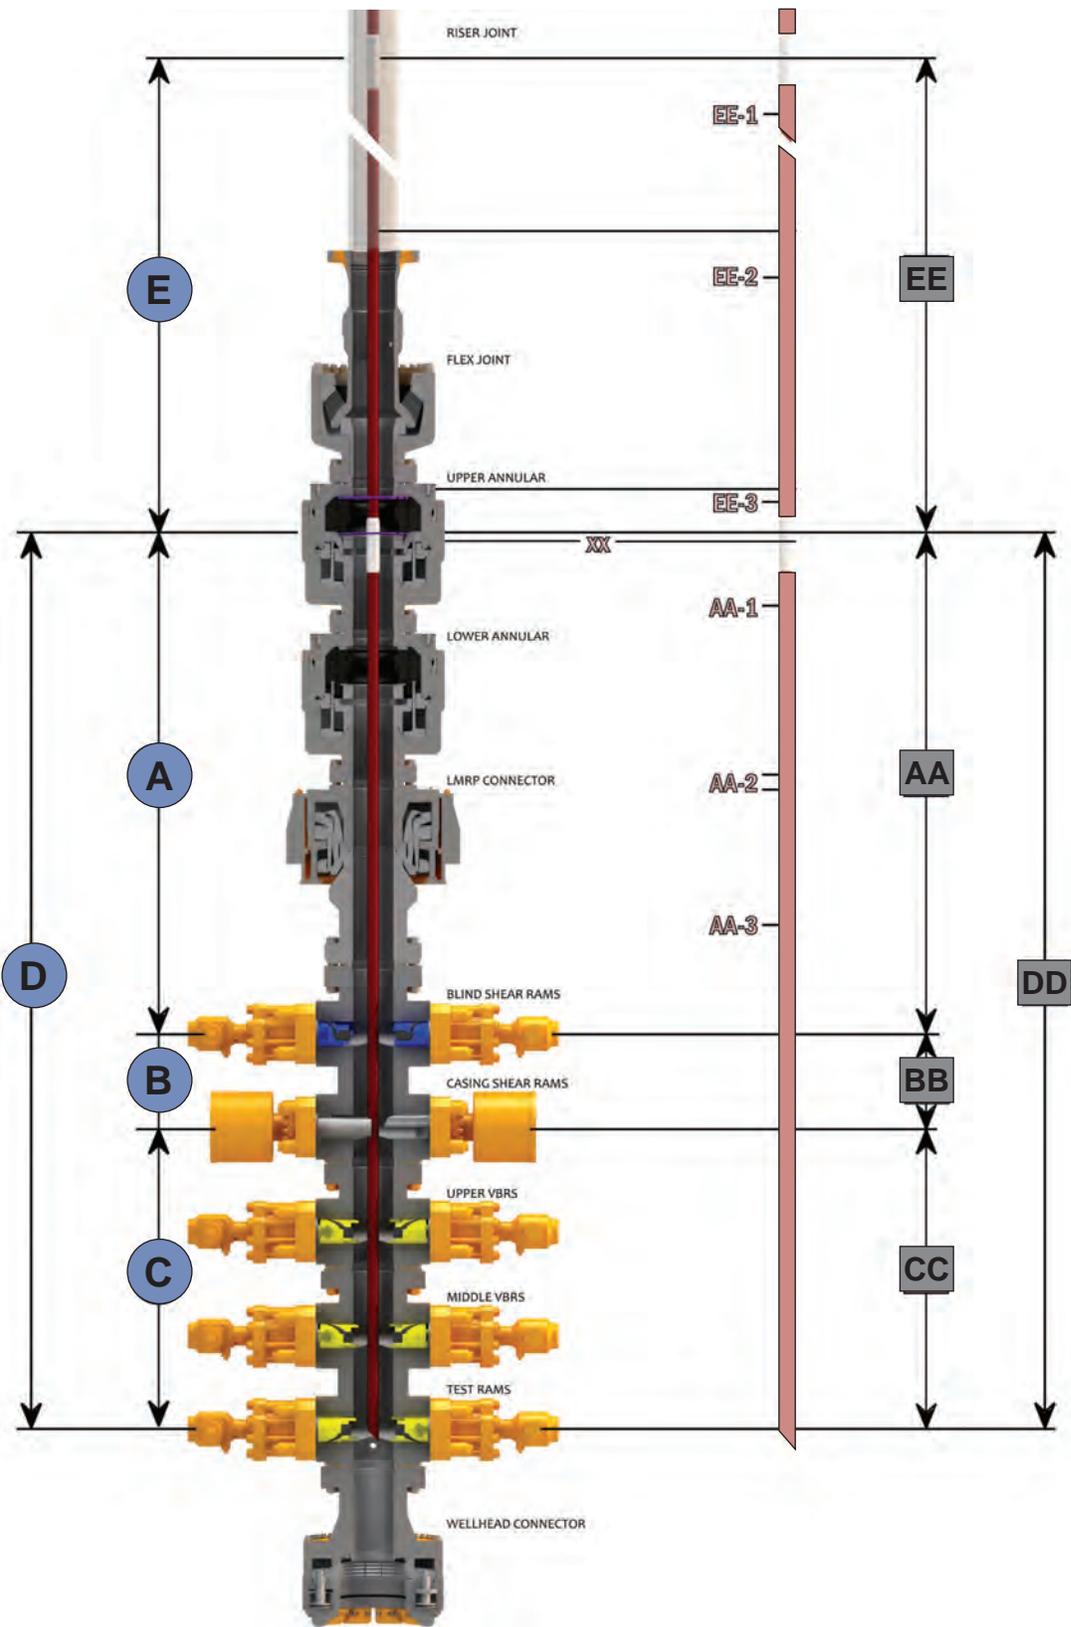
Figure 21 Drill Pipe Location in the BOP at the Time the BSR Cut the Pipe

At 10:30 a.m. on April 22, 2010 the *Deepwater Horizon* sank, and the riser pipe buckled 4 ft. above the riser adapter, trapping the two sections of drill pipe in the bent section of riser. *Figure 20* shows the final position of the riser. *Table 2* and *Figure 21* show the details of the drill pipe segments recovered from the riser and the BOP during the forensic analysis of the *Deepwater Horizon* BOP by the JIT at the NASA Michoud facility. See *Appendix L*.

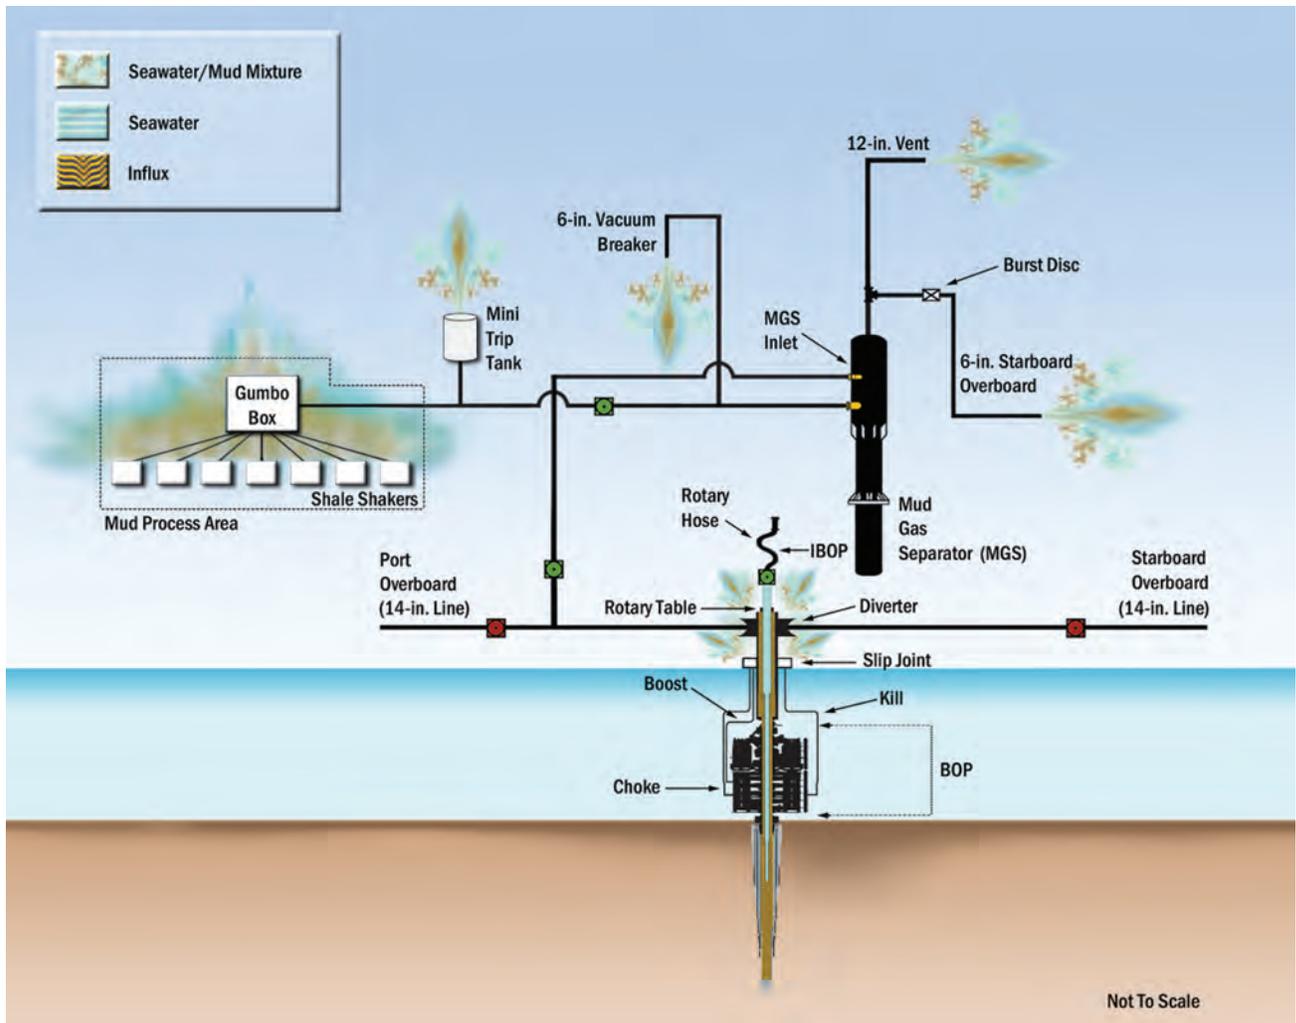
Figure 1 Gas Release Points

The crew diverted flow to the MGS. See *Figure 2* for the location of the MGS on the rig floor. When the drill crew detected flow on the trip tank, the flow rate was within the capacity of the MGS, as measured on the trip tank. After flow was diverted to the MGS, the increasing rate of flow exceeded the design capacity of the MGS.⁶ The flow likely exited the MGS at a number of points as shown in *Figure 1*, including the following:

1. *The main 12-in. gas vent line up the derrick:* This line directs separated gas to the top of the derrick, where it exits to the atmosphere through an angled rain deflector. The 12-in. vent line is not goose-necked and would have directed flow to the port side of the rig.⁷ See *Figures 1 and 3*.
2. *The 10-in. return line to the gumbo box:* This line returns separated mud from the MGS into the gumbo box and then to the shale shakers. The MGS is rated for 2,000 gpm; when this is exceeded, the mud seal is pushed out and allows gas and liquids through the lines to the shaker house. Gas would have dispersed into the gumbo box and then into the shale shaker room. See *Figure 1*.

3. *The 6-in. pressure relief line:* This line protects the MGS from over-pressure by providing a relief flow path. It is activated by a rupture disk that gives way at 15 pounds per square inch (psi), directing flow overboard to starboard through a 6-in. line.⁸ The pressure relief rupture disk likely opened when mud was forced upward in the 12-in. gas vent line, increasing internal pressure in the MGS. The witnesses who reported seeing flow diverted overboard during the incident may have observed it exiting the relief line.⁹ See Figure 1.

5. *Mini trip tank connection:* When the mini trip tank receives excess mud during filling, it overflows into a 6-in. overflow line. When the MGS was overwhelmed, flow likely proceeded through the mini trip tank overflow line and exited the top of the tank onto the rig floor.^A See Figure 1.

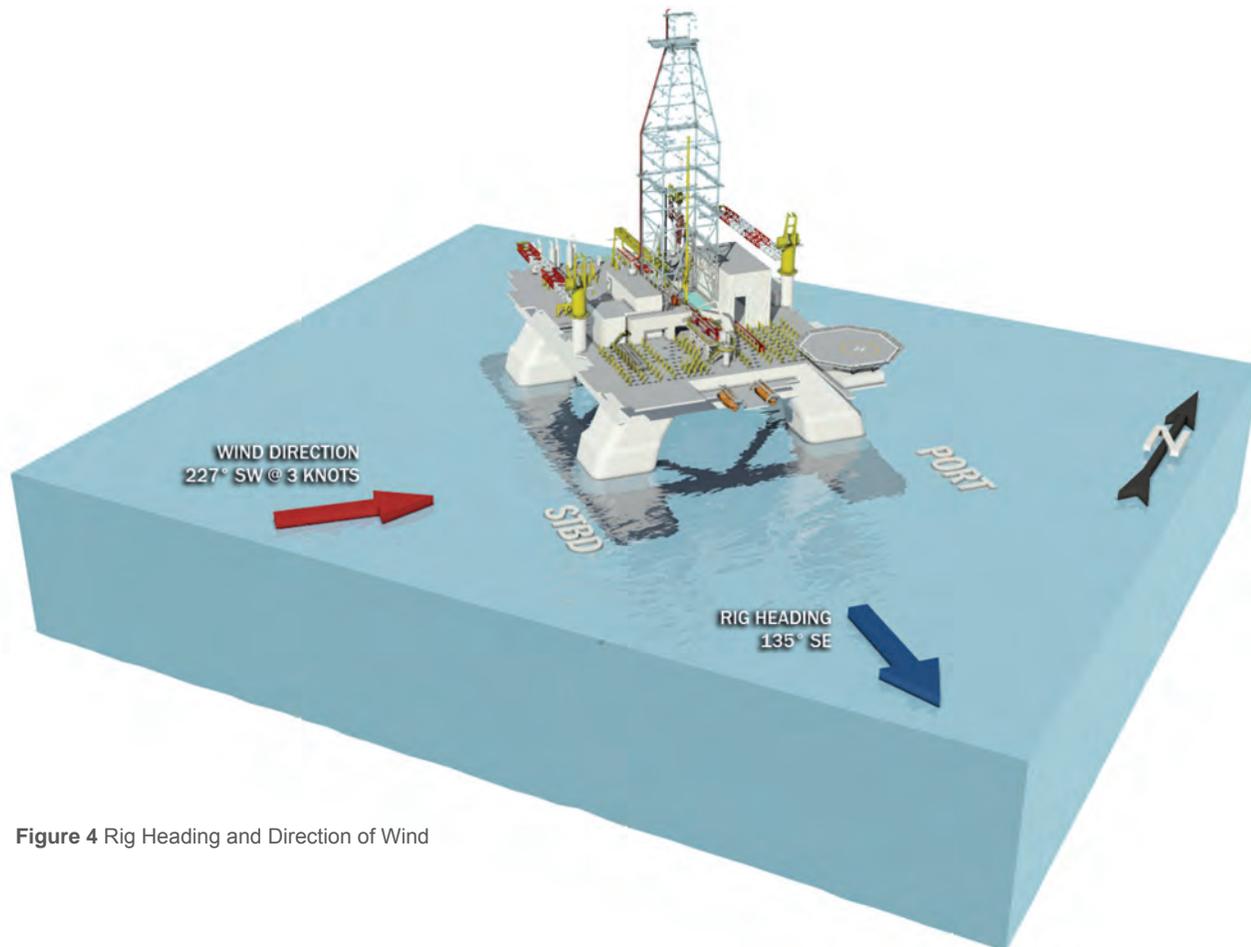
Figure 4 Rig Heading and Direction of Wind

Environmental conditions, particularly wind speed and direction, often have a significant impact on the migration and dispersion of gas in open areas. At the time of the incident, the *Deepwater Horizon* was on a 135-degree southeast heading with a slight breeze from the southwest at 227 degrees blowing starboard to port at approximately 3 knots.¹⁴ See Figure 4. These weather conditions did not significantly impact the migration and dispersion of gas; because of benign ambient wind condition, gas did not disperse on the aft deck and therefore reached the ventilation intakes to internal spaces such as engine rooms 3 and 4.
