MACONDO WELL INCIDENT
Transocean Investigation Report
Volume I

June 2011

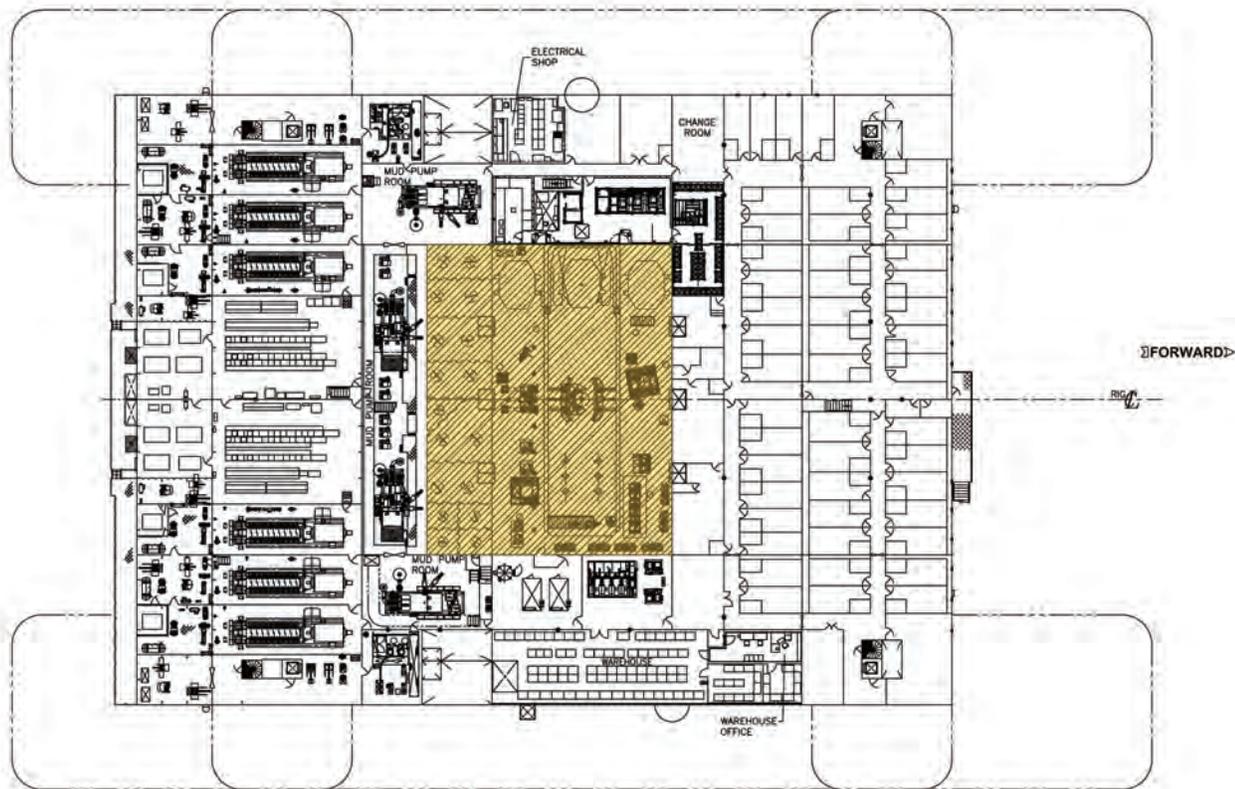
Figure 14 Third Deck Zone 2 - Yellow

- Zone 0: Explosive gas/air mixture is continuously present or present for long periods of time. There were no Zone 0 areas on the *Deepwater Horizon*.
- Zone 1: Explosive gas/air mixture is likely to occur during normal operations.
- Zone 2: Explosive gas/air mixture is not likely to occur or, if it does occur, will exist only for a short period of time.

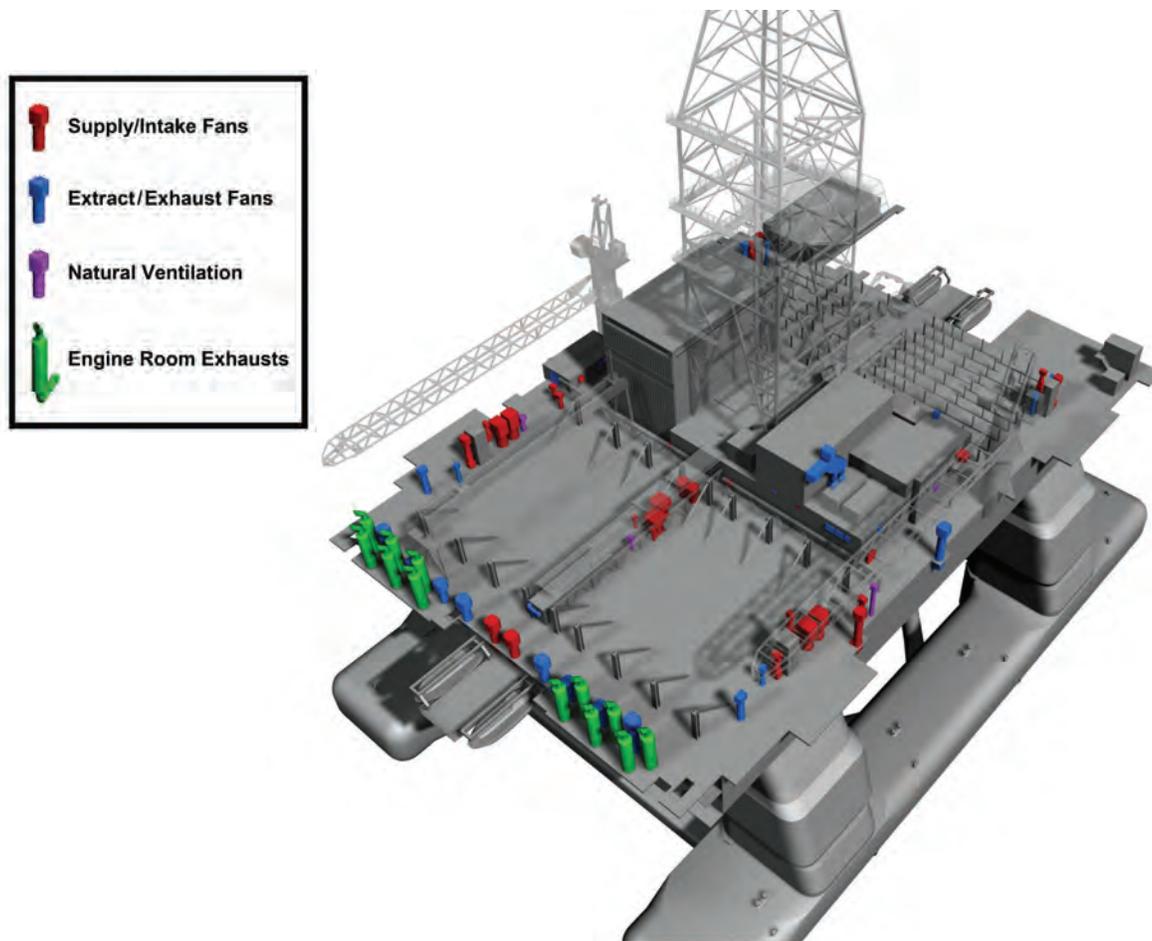
Figure 16 Principal Ventilation Inlets and Exhaust (Viewed from Starboard Aft)

The HVAC system on the *Deepwater Horizon* had a number of constituent parts.³⁰ The HVAC system was interconnected with the fire and gas detection system and emergency shutdown (ESD) system.³¹ The HVAC system was maintained under the *Deepwater Horizon* planned maintenance system and was independently inspected by ABS for rig classification and to ensure compliance with its MODU code requirements. It also was inspected separately by the MMS.³² The principal ventilation inlets and exhaust for areas (excluding the living quarters) are shown in *Figures 16 and 17*.

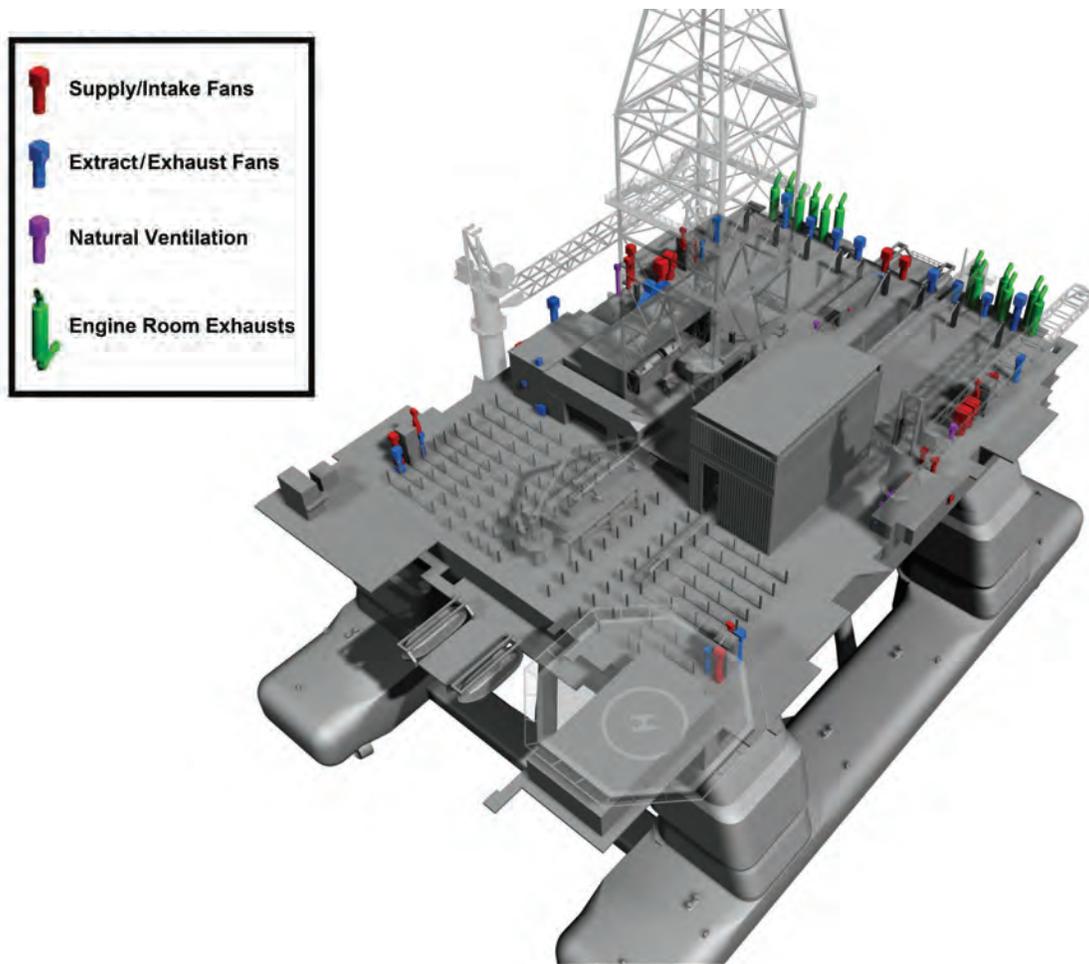
Figure 17 Principal Ventilation Inlets and Exhaust (Viewed from Port Forward)

The investigation team believes that, at the time of the incident, both the supply and exhaust fans were running in accordance with normal operating practice. The gas alarms activated in the shale shaker area at about 9:47 p.m.³⁹ As a designated hazardous area, the ventilation in the shale shaker room was not designed to shut down automatically.⁴⁰ Instead, the system was designed to sweep gas from the room by exhausting gas/air mixture from the room while replacing it with fresh air.⁴¹

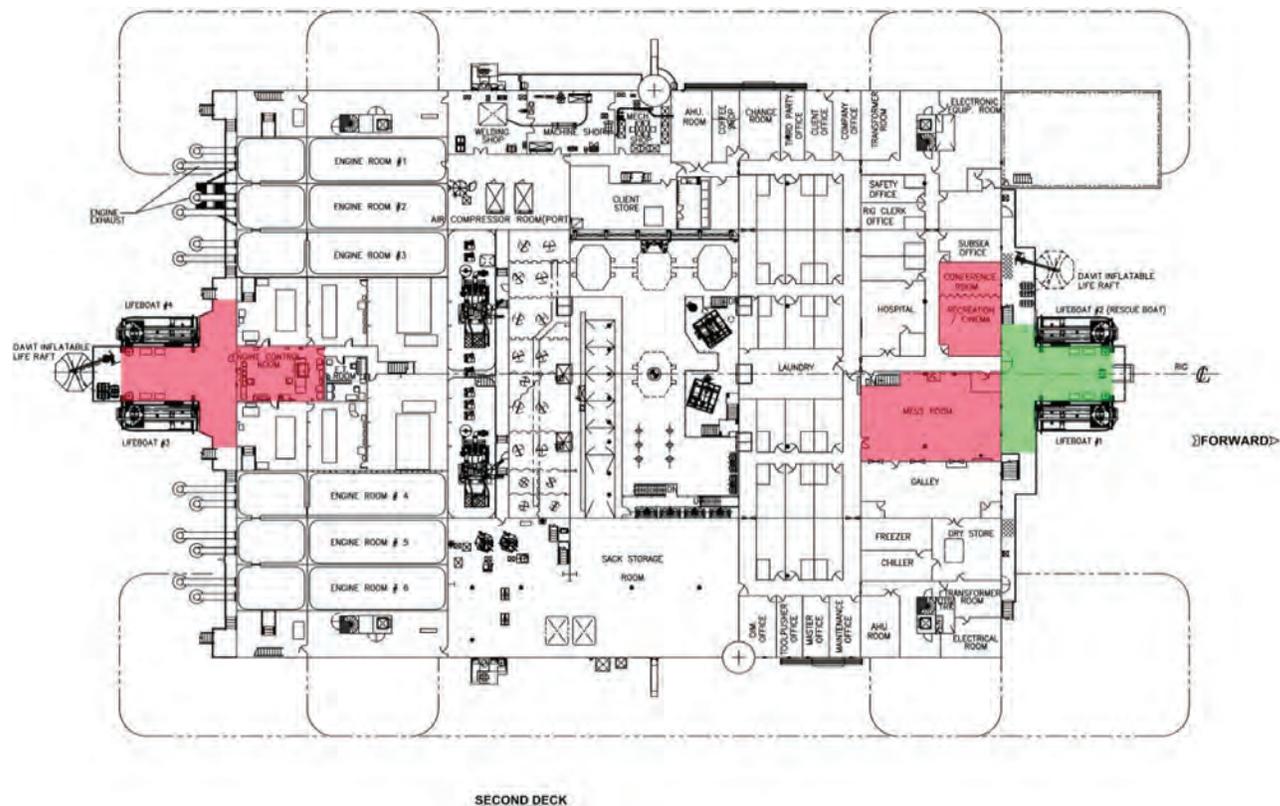
Figure 1 Muster Stations – Available Highlighted in Green; Impaired Highlighted in Red

that some of the alarm-signaling devices were damaged by the explosions and subsequent fire.

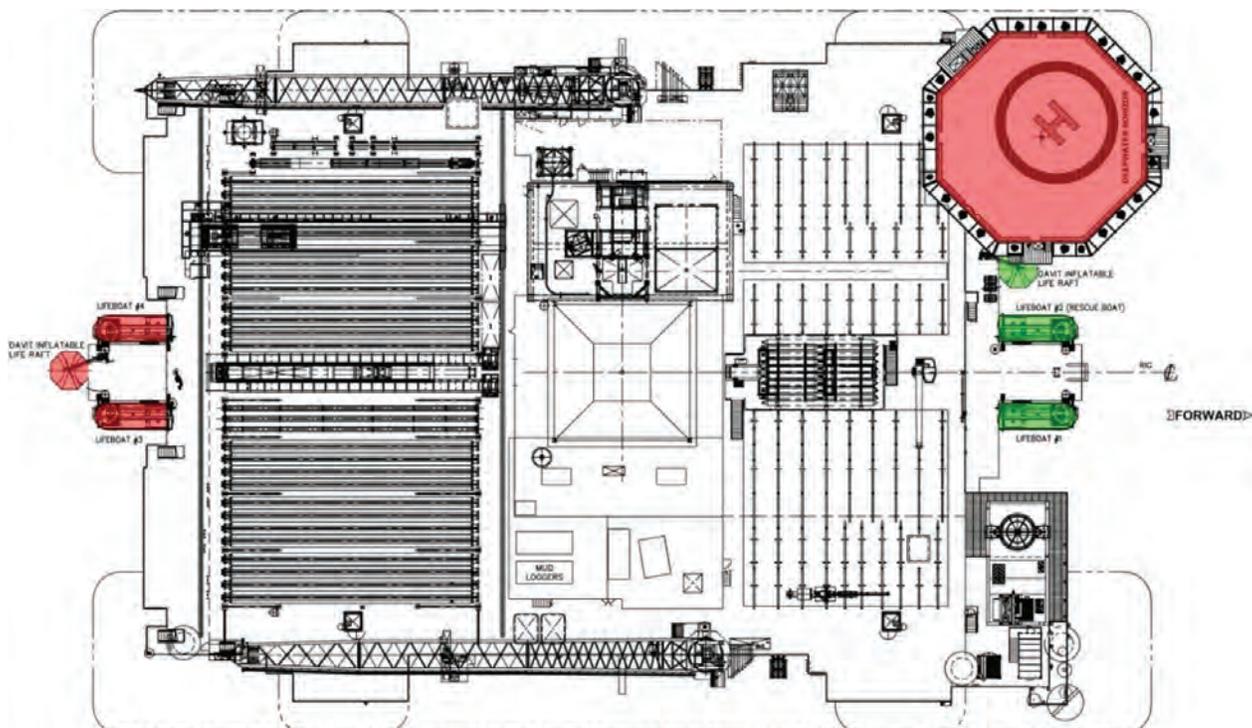
Figure 2 Evacuation Points – Lifeboats and Life Raft Used in Evacuation Highlighted in Green; Impaired Evacuation Systems Highlighted in Red.

1. **Lifeboats:** The *Deepwater Horizon* had four lifeboats — two located at the forward end of the rig adjacent to the living quarters and two at the aft on the second deck level. See Figure 2. Each lifeboat was designed and certified to carry 73 people so that even if the rig had been at its full capacity of 146 (instead of the 126 onboard that day), every person could have been evacuated using only the two accessible lifeboats.⁵¹
2. **Life Rafts:** The *Deepwater Horizon* was equipped with six self-inflating life rafts. The life rafts were located next to the lifeboats, three forward and three aft, on the second deck level. See Figure 2. The
