Civil Aviation Authority – Safety review of offshore public transport helicopter operations in support of the exploitation of oil and gas

CAP 1145

20 February 2014

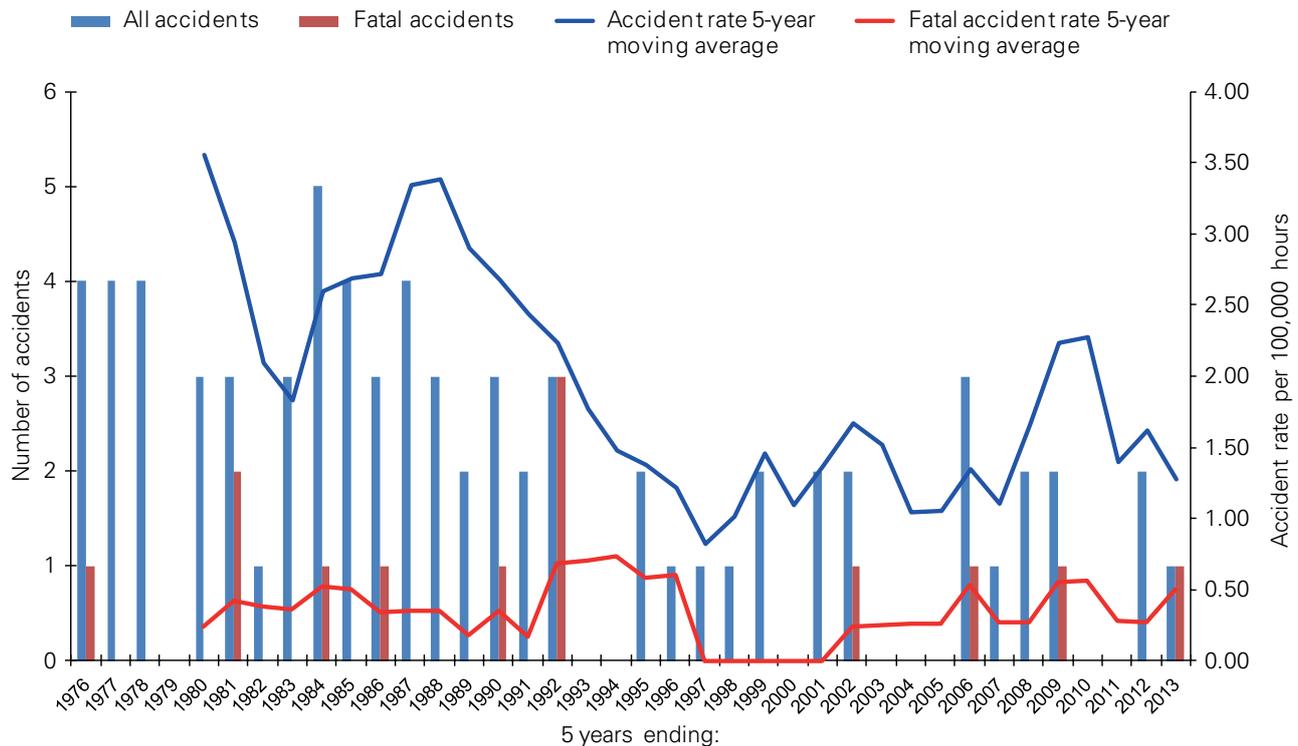
- 5.4 The overall results presented in Figure 1 below. Five year moving averages are used to smooth the accident rate per flight hour data and help to identify any underlying trends. Plots based on accident rates per flight sector were also produced but, in the interests of brevity, are not presented as they did not identify any different patterns in the data.

Figure 1: Chronology of reportable accidents (rate per 100,000 flight hours)

- 5.5 The variation in the 'all accident' rate throughout the period is largely driven by variations in the technical cause accident rate. The operational and external cause accident rates are relatively constant, and the reduction in the 'all accident' rate from the early 1990s is driven by the corresponding reduction in the technical cause rate. The reduction in the technical cause rate accidents in the early 1990s is coincident and consistent with the introduction of Health & Usage Monitoring Systems (HUMS).

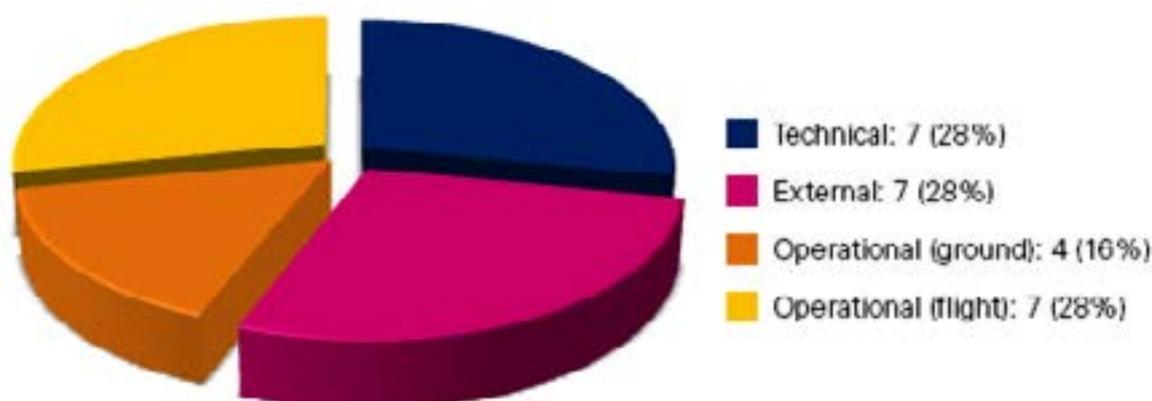
- 5.7 There were a total of 25 reportable UK offshore helicopter accidents during the period 1992 to 2013. The overall accident rate is just over one per year. This equates to 1.35 accidents per 100,000 flight hours or 0.66 per 100,000 flight sectors. The breakdown of the accidents during the period 1992 to 2013 by top level grouping is presented in Figure 2 below.

Figure 2: Offshore helicopter accidents for the period 1992 to 2013 by grouping

- 5.8 Overall, operational causes of accidents (flight and ground combined) dominate, accounting for 11 out of the 25 (44%) accidents. Technical and external cause accidents each account for seven out of the 25 (28%) accidents.

- 5.9 Most of the operational causes of accidents (73%) related to pilot performance issues such as flight crew perception and decision making (see Annex C for more detail). Most technical cause accidents (86%) related to rotor and transmission failures, and there is evidence of a tendency towards faults caused by deficiencies in the design and/or certification process in newer aircraft; this is explained further in Section F – Airworthiness and in Annex F. Most external cause accidents (86%) relate to lightning strikes.

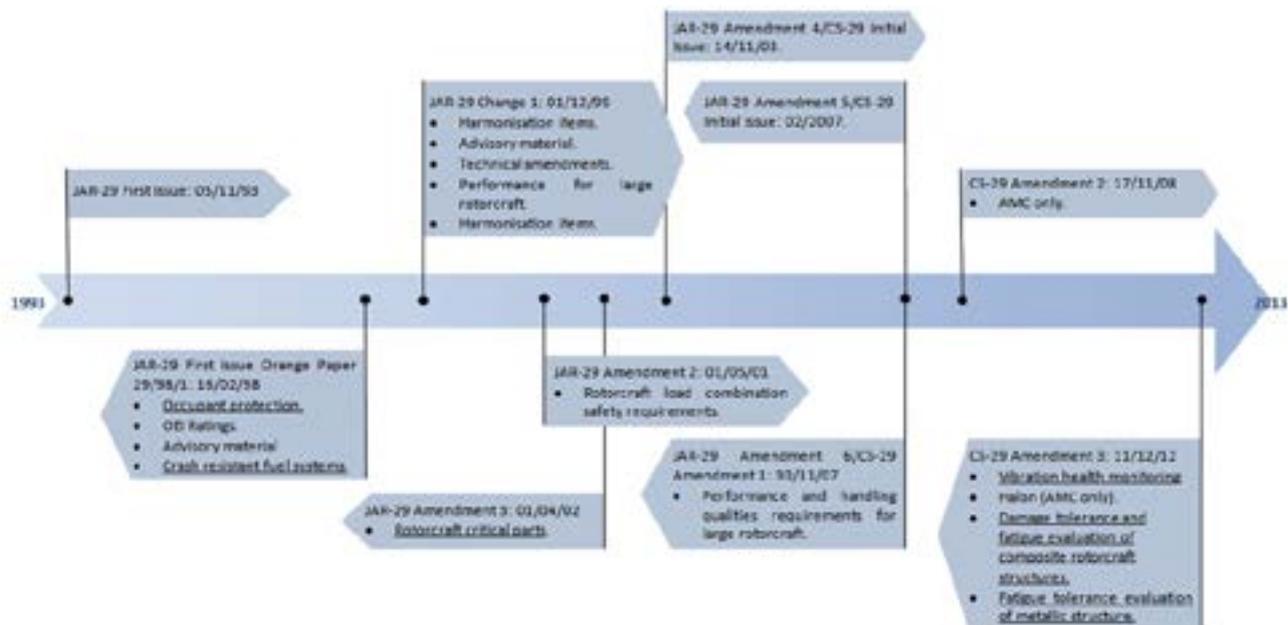
- 20.1 This chapter provides a baseline for the Certification Specifications (CS) achieved by the aircraft types that operate in the North Sea. A brief history of these standards is provided and a brief description of what has changed as they have developed through the 1990s to the present day. A summary 'timeline' is given below, with the information reduced to just the titles of the Notice of Proposed Amendments (NPAs) and with those changes of particular relevance to offshore operation highlighted by underlining.
- 20.2 It is important to note that not all helicopters operating in the North Sea are certificated to the latest standard of requirements. Many are 'derivatives' whose original certification basis may have been set many years prior to their entry into service, it being associated with an original version of the helicopter type.

Figure 3: History of airworthiness certification standards

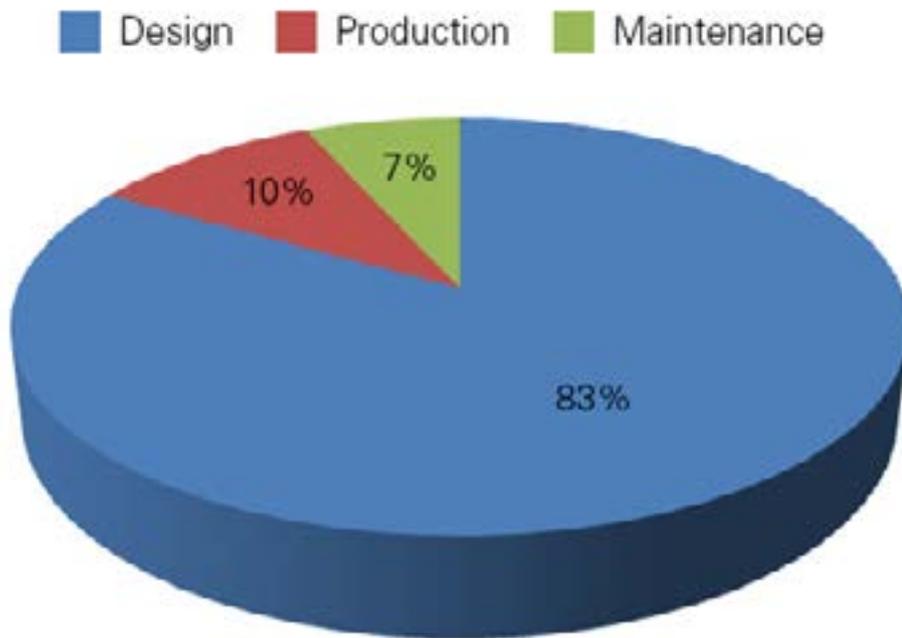
- 21.2 Figure 4 below gives a schematic picture of how the technical causes of these accidents can be partitioned into their general subject areas. It should be noted that this data differs from that discussed in Section C and Annex C because the range of accident reports considered in this element of the review included reports worldwide, as opposed to only those associated directly with the UKCS operation. From the data in Annex C, there is a clear step change in the accident rate that coincided with the introduction of Health and Usage Monitoring Systems (HUMS) in offshore operations.

Figure 4: Causal factors

21.4 This group has not been ranked according to their severity, and they range from minor incidents to catastrophic accidents. From this high level review, although it is clear that causes arising from design aspects account for the major share of the target group of accidents, it is not possible at this time, therefore, in lieu of a more detailed analysis, to draw specific conclusions as to the real contribution made by design causes to offshore safety. Of the events attributed to design causes, the top five areas that have contributed are:

- Main Gear Box and transmission system - 20%
- Electrical - 20%
- Engines - 15%
- Horizontal Stabiliser - 11%
- Main Rotor Blade - 11%

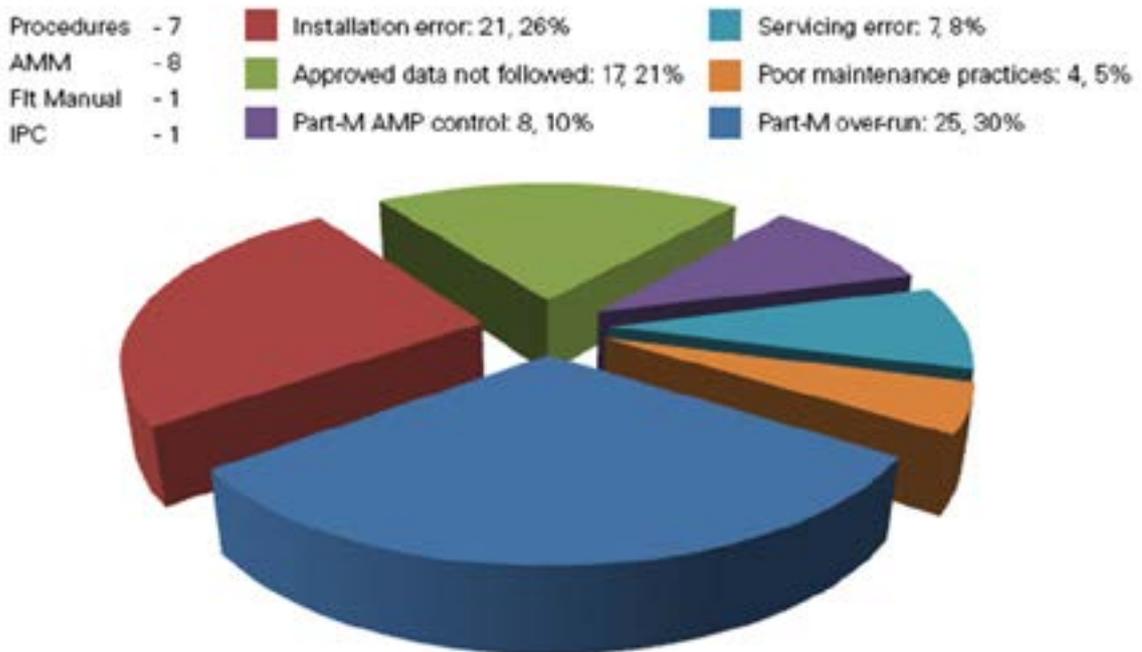
- 26.4 The CAA has been carrying out a wider review of MOR data between 2005 and 2011. This has been assessed by Confidential Human Factors Incident Reporting Programme (CHIRP) personnel, to identify and extract maintenance error occurrences from the data. The chart below indicates that Part-M overrun has the largest number of reported errors (30%). These are typically life-controlled items which have overrun their scheduled replacement date. However, this is a relatively small number of errors in comparison to the large number of life-controlled items managed on helicopters. The next issue identified is installation error (26%), of which over half were related to errors that would have been subjected to either a second inspection by an independent person, or a duplicate or independent inspection.

Figure 5: MOR Human Factors Errors reported in the North Sea organisations

- 26.5 It is clear from Figure 5 that the safety and quality system within the approved maintenance and continuing airworthiness approvals has an important part to play in reducing human error. Some of the contributing factors that affect human error include: distraction, lack of knowledge, lack of communication, complacency, lack of team work, fatigue, lack of resources, pressure, lack of assertiveness, stress, and lack of awareness. Human Factors training alone is not considered sufficient to minimise maintenance error. Most of the above can be attributed to the safety culture and associated behaviours of the organisation.

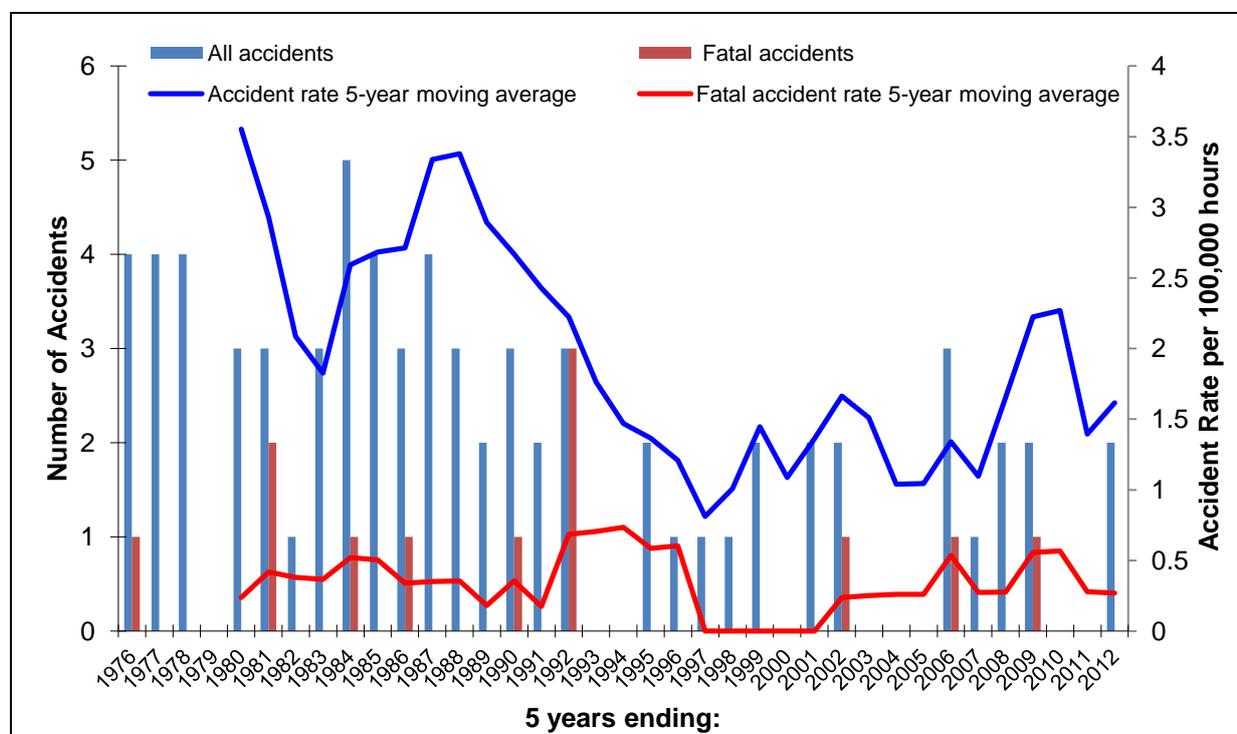
- 2.2 The accidents are presented as rates per flight hour in order to remove the effect of exposure; a rise in the number of accidents could reflect an increase in flying activity rather than a reduction in safety performance. The accident rate in the 1970s was very high, but gradually decreased thereafter reaching a minimum in 1997. Since then, however, there has been a slight upward trend. The fatal accident rate appears to have been relatively constant over the entire period.
- 2.3 Plots based on rates per sector did not identify any different patterns in the data and so are not presented; the variation in sector length does not appear to be significant in this data set.
- 2.4 The numbers of all accidents (blue columns) and fatal accidents (red columns) for each year of the review period are also presented for information/completeness.

Figure C1 Chronology of reportable accidents (rate per 100,000 flight hours)

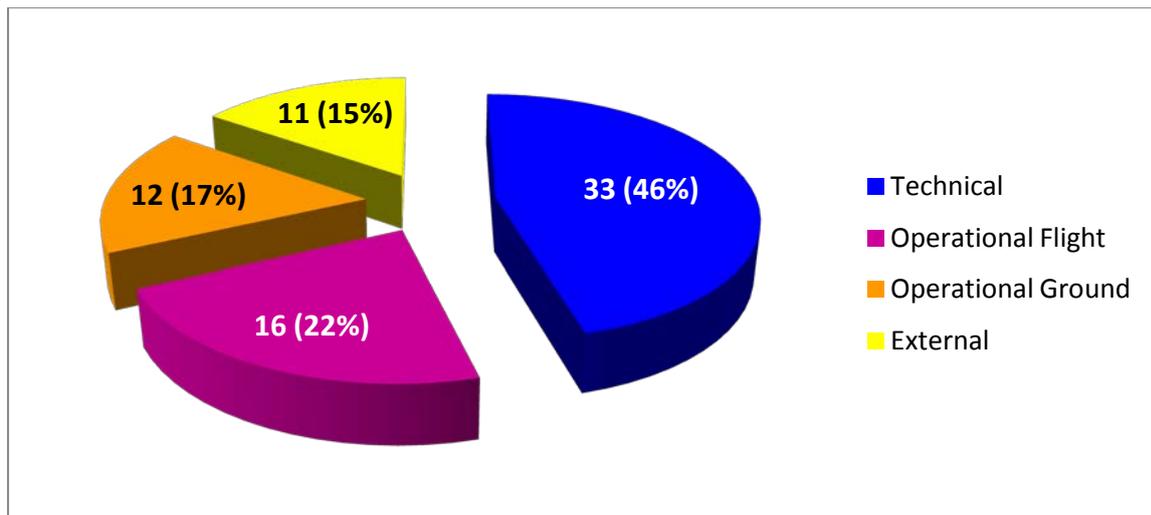
3.4 The results of the classification are presented in Figure C2 and Figure C3. The very high proportion of SCF-NP (system/component failure non-powerplant) is very apparent, but this should be viewed in the context of the very broad scope of this code. Nevertheless, technical accidents do represent the largest single grouping (even larger than operational flight and ground combined) and account for 46% of the accidents during this period.

Figure C2 Offshore helicopter accidents for the period 1976 to 2012 by CICTT operational groupings

- 5.4 Comparing these results with those for the period 1976 to 2012 (see Figure C2 and Figure C3), SCF-NP (system/component failure non-powerplant) is again the most common code. Also of note is the large number of WSTRW (windshear or thunderstorm) accidents and the corresponding increase in the proportion of these from 8.3% of the total number of accidents (1976 to 2012) to 25% (1992 to 2012). This is mainly because all of the lightning strike accidents occurred during the latter period, i.e. post the G-TIGK accident in 1995.
- 5.5 Taking the operational groupings as a whole, however, operational (flight and ground combined) dominate accounting for 10 out of 24 (42%) of the accidents. Technical and external cause accidents each account for seven out of 24 (29%) of the accidents.

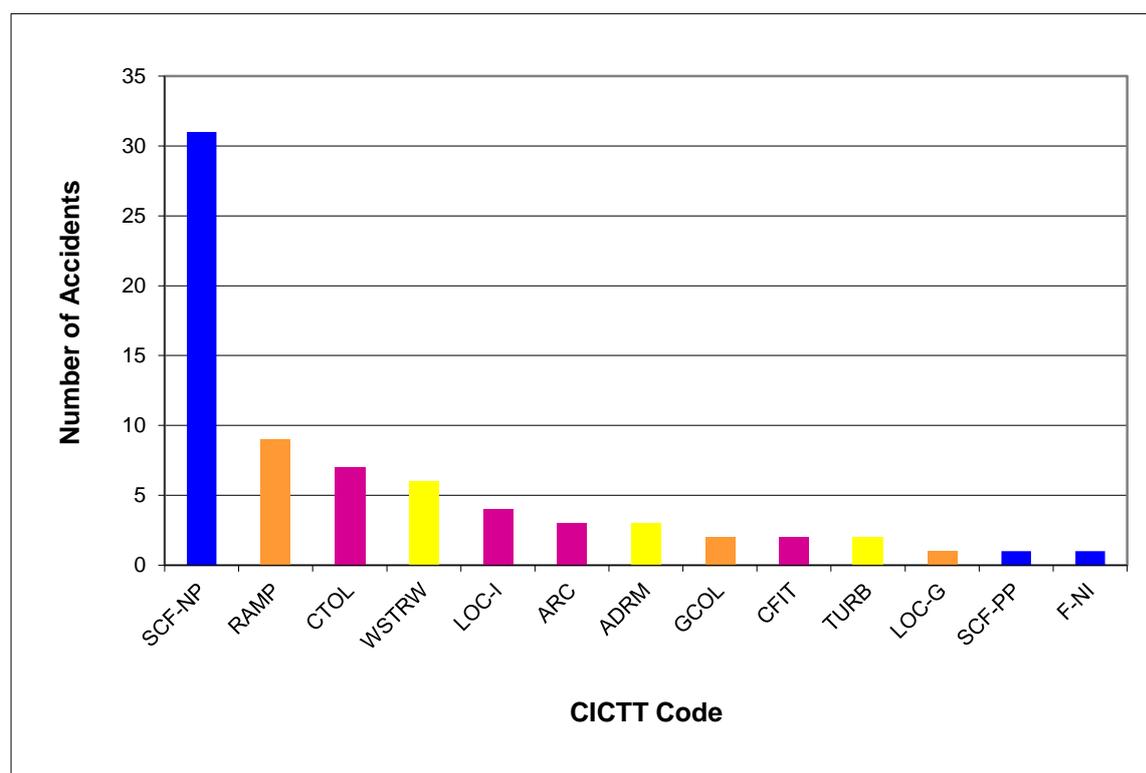
Figure C3 CICTT classification of offshore helicopter accidents for the period 1976 to 2012
(NB: Colour coding per Figure C2)

7.2.2 It is immediately apparent that SCF-NP (system/component failure non-powerplant) accidents dominate, as is the case for all accidents over the same period (see Figure C3). The same considerations apply, however, and applying the CICTT operational groupings of Section 3 shows an even split between technical and operational accidents, and no external cause fatal accidents.

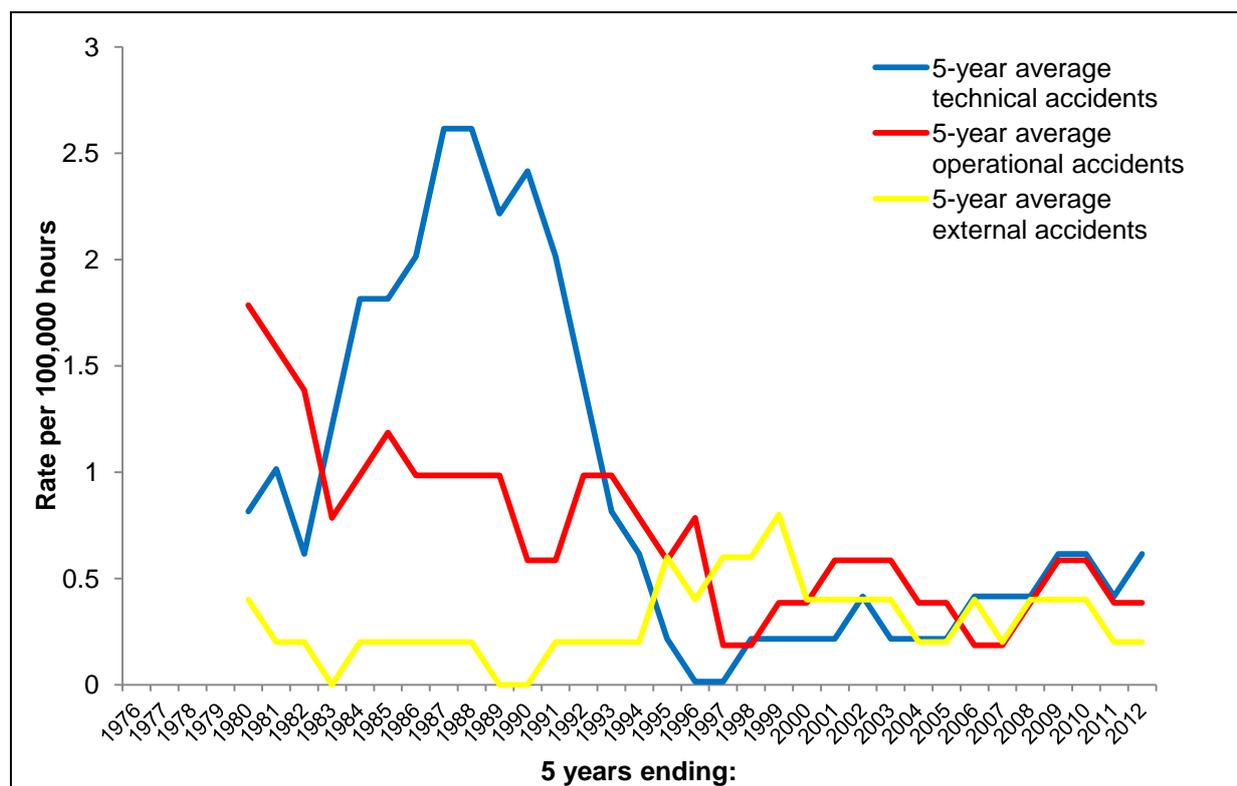
- 4.1 The chronology of the groupings is plotted in Figure C4 in the form of five-year moving averages. Note that the two operational groups (flight and ground) have been combined for simplicity.

- 4.3 Also of note is the step up in external accidents from 1995 onwards which coincides with the lightning strike to G-TIGK in 1995. This strike was especially severe and a catastrophic outcome was only narrowly avoided. As will be presented later, the majority (86%) of external cause accidents are related to lightning strikes which have occurred at a relatively steady rate over the entire period. It is thought, therefore, that the increased awareness of the potential consequences of lightning strikes following the G-TIGK strike in 1995 may have led to higher grades being awarded to the associated MORs, and that this could explain the step.

Figure C4 Chronology of offshore helicopter accidents for the period 1976 to 2012 by CICTT operational groups (5-year moving averages)

- 5.6 The characteristics of the underlying data change significantly from the early 1990s with operational, technical and external cause accident rates converging and stabilising (see Figure C4 in Annex C). Consequently, the period from 1992 to the end of 2012 is considered to be most representative of current operations and therefore formed the main focus of the review.

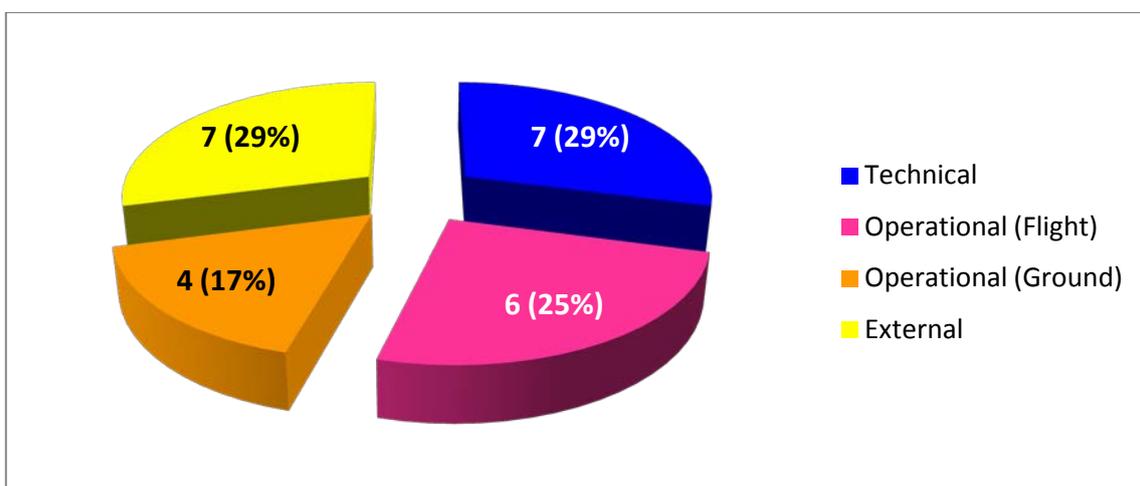
5.3 The results of the classification for this period are presented in Figure C5 and Figure C6 below.

Figure C5 Offshore helicopter accidents for the period 1992 to 2012 by CICTT operational groupings

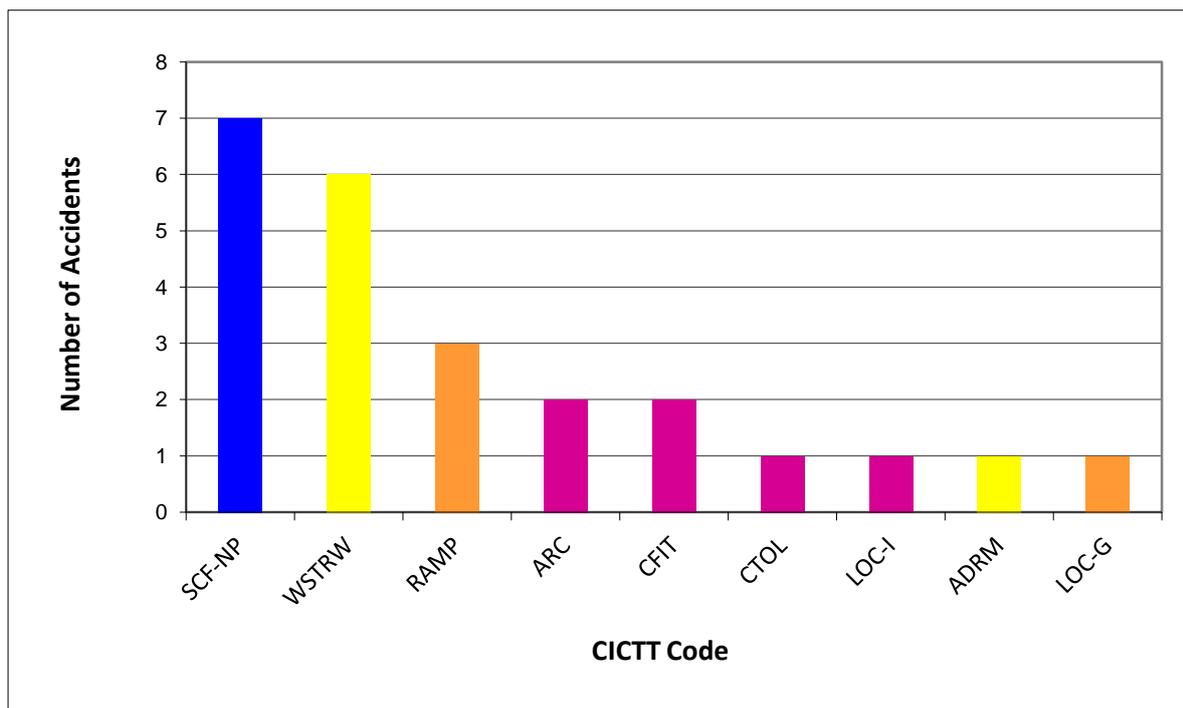
Figure C6 CICTT classification of offshore helicopter accidents for the period 1992 to 2012 (NB: Colour coding per Figure C5)

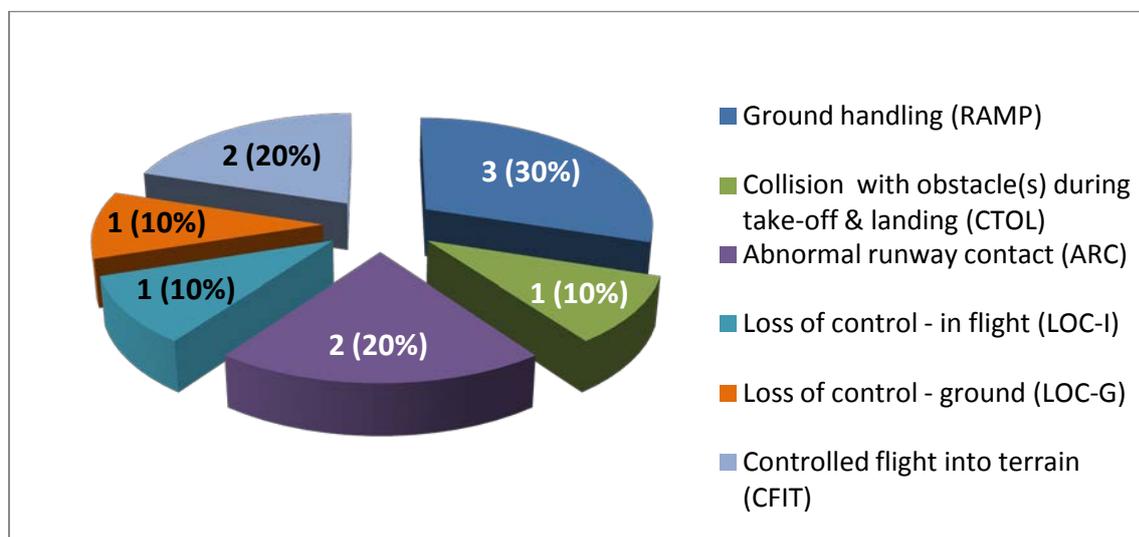
- 6.2.1 Operational causes accounted for 10 out of 24 (42%) of the accidents during the period 1992 to 2012. The classification of these accidents by CICTT occurrence code is shown in Figure C7 below.

Figure C7 CICTT classification of operational cause offshore helicopter accidents for the period 1992 to 2012

- 6.2.2 The largest single category is ground handling (RAMP), of which most (two out of the three) relate to operations to moving decks where the issue is the lack of appropriate operating criteria (G-BOND, 18/04/1992 and G-BKZE, 10/11/2001). The research into operations to moving helidecks is addressing this issue. The third (G-BLEZ, 22/09/1992) involved a fatal rotor strike to a ground crew member on a non-moving helideck for which no definitive explanation could be found.
- 6.2.3 The remaining seven operational accidents cover a range of accident scenarios but all involve a flight crew performance related factor. The classification of these

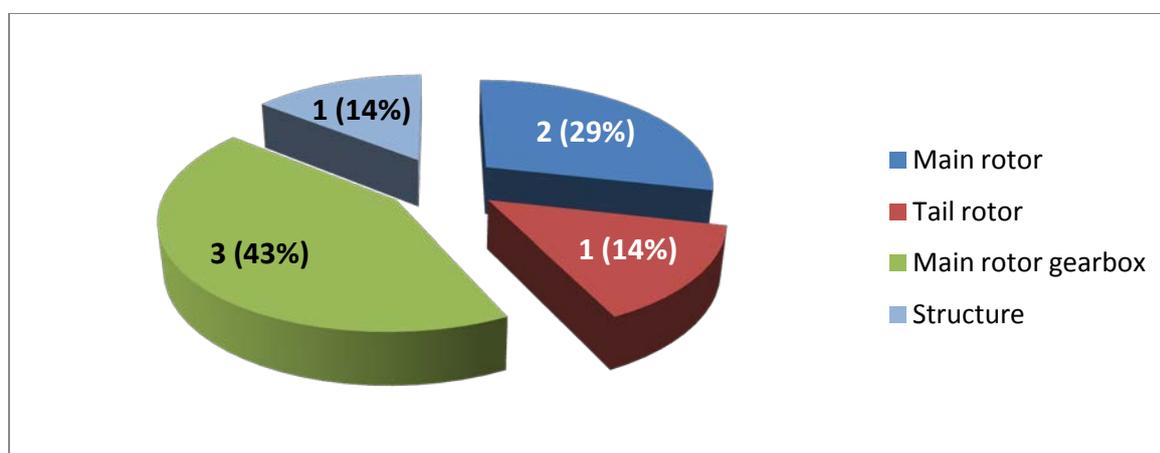
6.3.1 Technical causes accounted for seven out of 24 (29%) of the accidents during the period 1992 to 2012. The CICTT classification scheme is not especially discriminating where technical accidents are concerned and, in fact, all seven accidents are associated with the same code of SCF-NP (system/component failure non-powerplant). In order to gain further insight, these seven accidents were classified according to which system/component failed to cause the accident. The results are presented in Figure C8 below.

Figure C8 Classification of technical cause offshore helicopter accidents by failed system/component for the period 1992 to 2012.

6.3.2 Rotors and transmission account for all but one of the technical cause accidents, which is perhaps unsurprising in view of the criticality of these systems.

6.3.3 The main rotor gearboxes of offshore helicopters are all monitored by HUMS. Although of undoubted benefit, HUMS is not perfect and some sections of the gearbox are harder to monitor than others. One of the failures (G-REDL, 01/04/2009) was in an epicyclic stage which are very challenging to health monitor due to their mechanical complexity and number of gears turning at the same speed. The other two, virtually identical failures (G-REDW, 10/05/2012 and G-CHCN, 22/10/2012) were in the shaft that drives the oil pumps. This shaft is only lightly loaded resulting in relatively weak reactions in the vibration signatures to defects making detection more difficult. Nevertheless, room for improvement in the analysis of HUMS data for transmissions has been identified and enhanced analysis techniques have been developed and demonstrated (i.e. Advanced Anomaly Detection – AAD) under a CAA research project. This technology is presently being introduced under a voluntary initiative led by Oil & Gas UK.

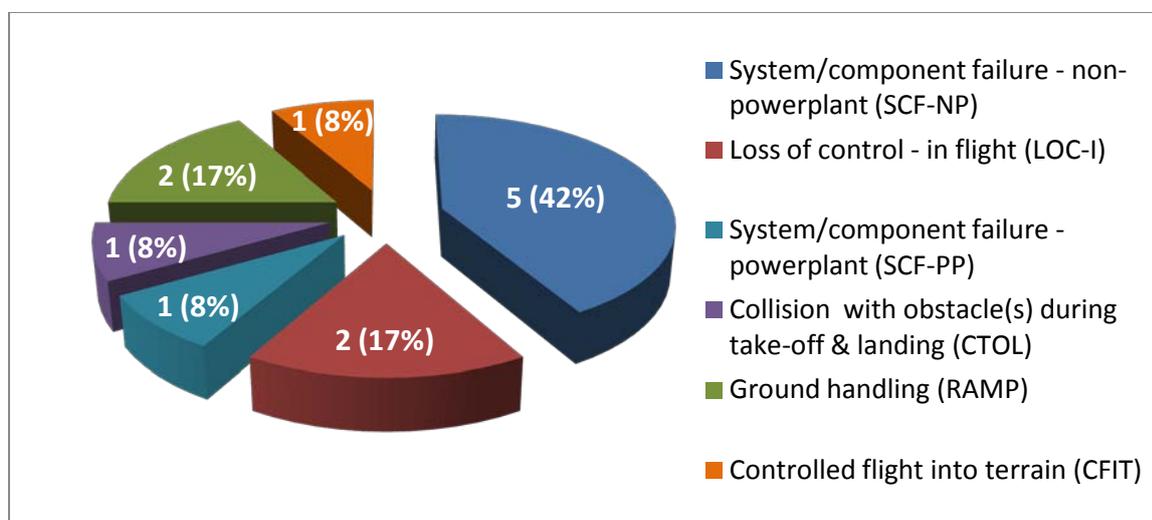
7.2.1 The classification of the fatal accidents by CICTT occurrence code is presented in Figure C9 below.

Figure C9 CICTT classification of fatal offshore helicopter accidents for the period 1976 to 2012

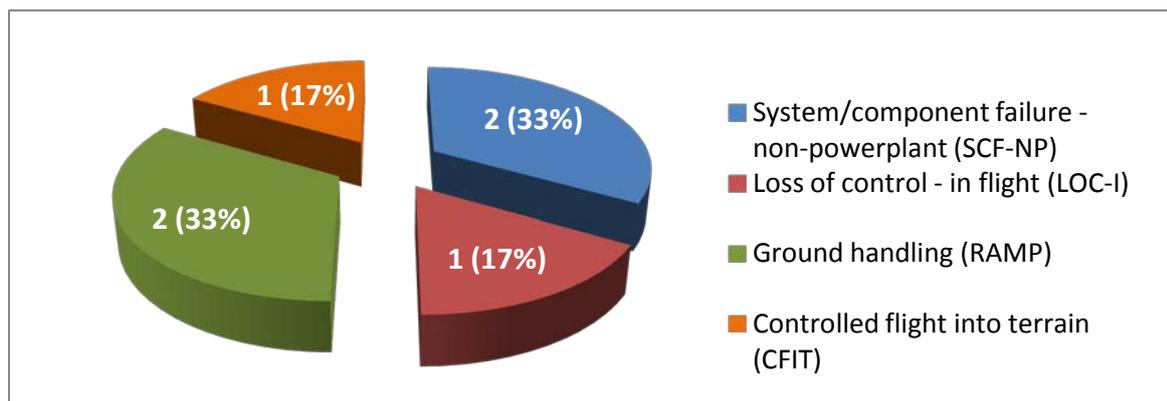
Figure C10 CICTT classification of fatal offshore helicopter accidents for the period 1992 to 2012

7.2.3 For completeness the classification of the fatal accidents by CICTT occurrence code for the more recent period of 1992 to 2012 is presented in Figure C10 below.

7.2.4 This suggests the same shift in emphasis from technical cause accidents to operational cause accidents seen in the data for all accidents, although it should be noted that three of the operational cause fatal accidents occurred on the boundary of the period in 1992. As ever, care is needed when working with small sample sizes.

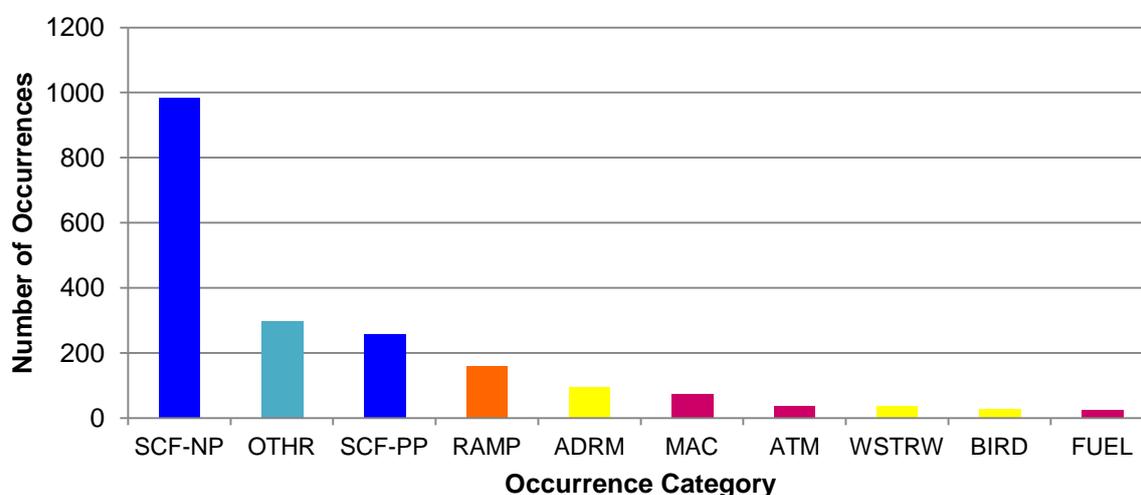
Figure C11 Norwegian occurrence categories for the period 2008 – 2012 (NB: Colour coding per Figure C13 and C14)

8.4.1 In recognition of the likely under reporting in Norway during the period 2003 to 2007, Figure C11 and Figure C12 present breakdowns of the occurrences by CICTT code for Norwegian and UK operations, respectively, for the period 2008 to 2012.

- 8.4.2 Note that both the Norwegian and UK occurrence data was supplied already coded to CICTT but, unlike the analysis reported in Sections 3 through 7, each occurrence could be allocated more than one CICTT code, and some occurrences were not coded. Hence, in both the UK and Norwegian data sets the total number of CICTT codes is different to the total number of occurrences.

- 8.4.3 For both sectors, 'System/Component Failure – Non-Powerplant' (SCF-NP) was the most commonly assigned occurrence category. The second most commonly assigned occurrence category for Norway was 'Other' (OTHR). This category included, but was not limited to, level busts, infringements, incorrect/misread charts/information, callsign confusion, and ash encounters. For the UK the second most commonly assigned occurrence category was 'System/Component Failure – Powerplant' (SCF-PP).

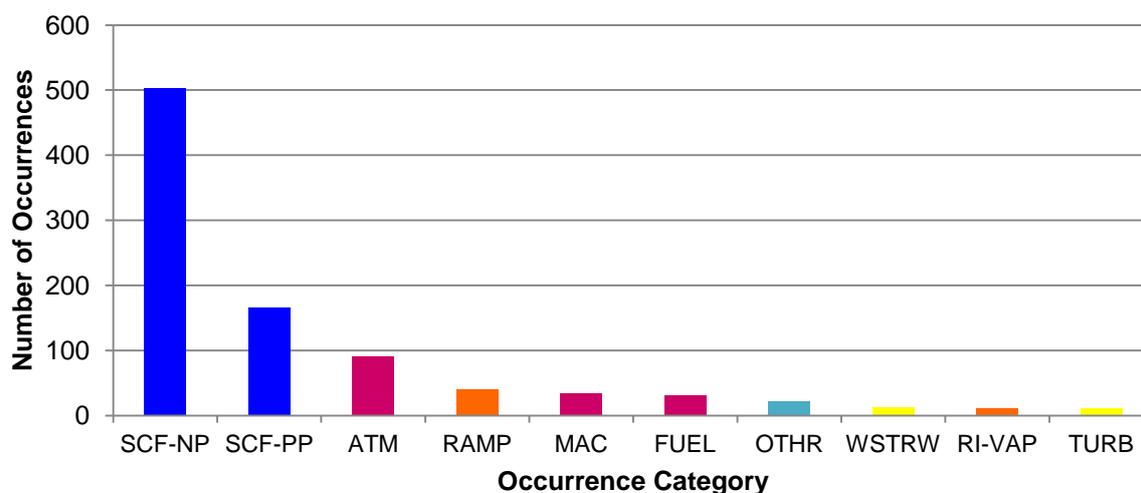
Figure C12 UK occurrence categories for the period 2008 – 2012 (NB: Colour coding per Figure C13 and C14)

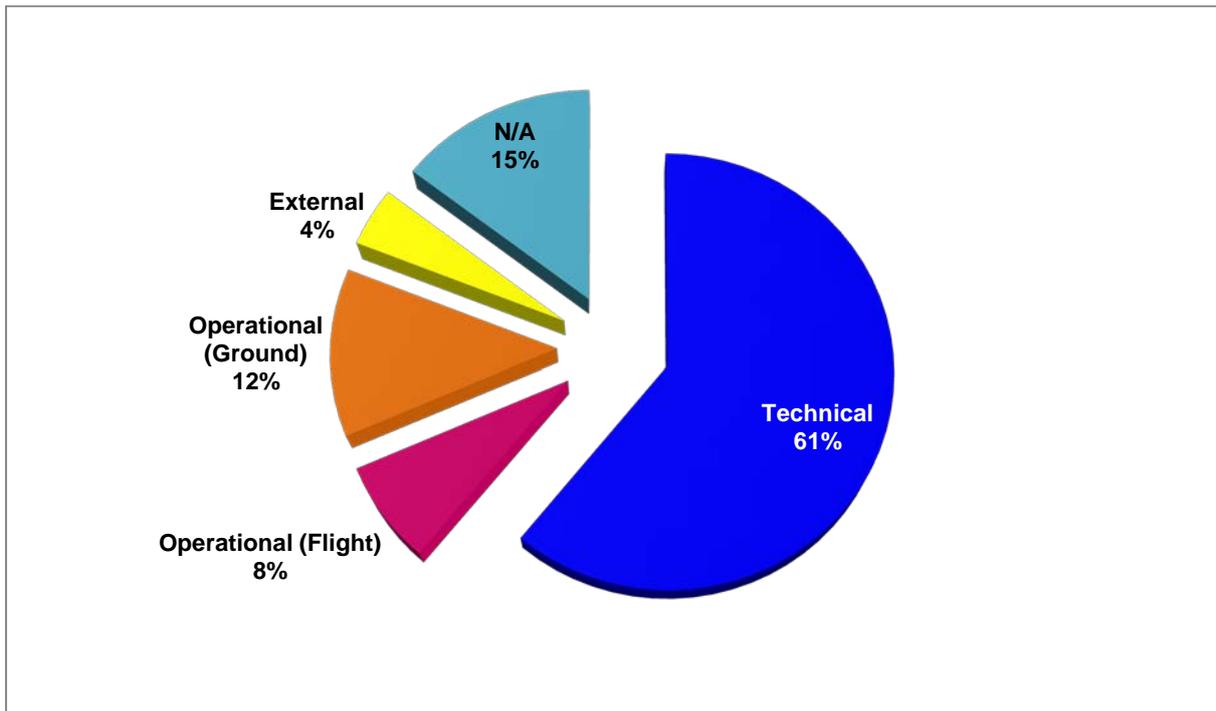
Figure C13 Occurrence Category Groups for Norwegian Events for the period 2008 – 2012

- 8.4.4 Using the same grouping as in Section 3, the occurrence categories have been grouped into 'Technical', 'Operational – Flight', 'Operational – Ground', 'External', and 'Not Applicable'. Figures C13 and C14 show the results for Norwegian and UK data respectively. Note that, in this case, the data is presented as a percentage of the total number of CICTT codes rather than total number of occurrences; this is considered to represent the most robust comparison that can be made with the data available.

8.4.5 For the Norwegian data presented in Figure C13, of the 1984 occurrences, 1905 occurrences had one CICTT code, and 79 had two codes. Therefore, the pie chart shows the groupings as a percentage of 2063 (1905 + (79 x 2)).

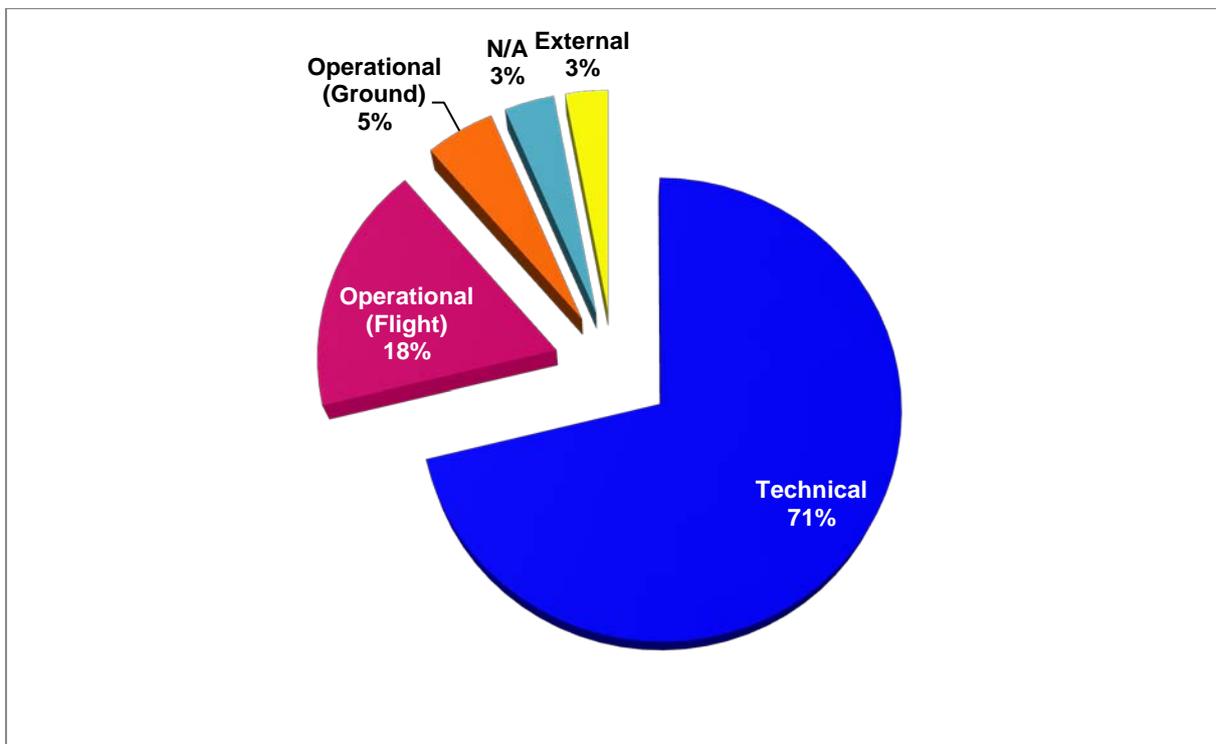
Figure C14 Occurrence Category Groups for UK Events for the period 2008 – 2012

8.4.6 For the UK data presented in Figure C14, of the 1294 occurrences, 419 had no code, 803 had one code, and 72 had two codes. Therefore, the pie chart shows the groupings as a percentage of 947 (803 + (72 x 2)).

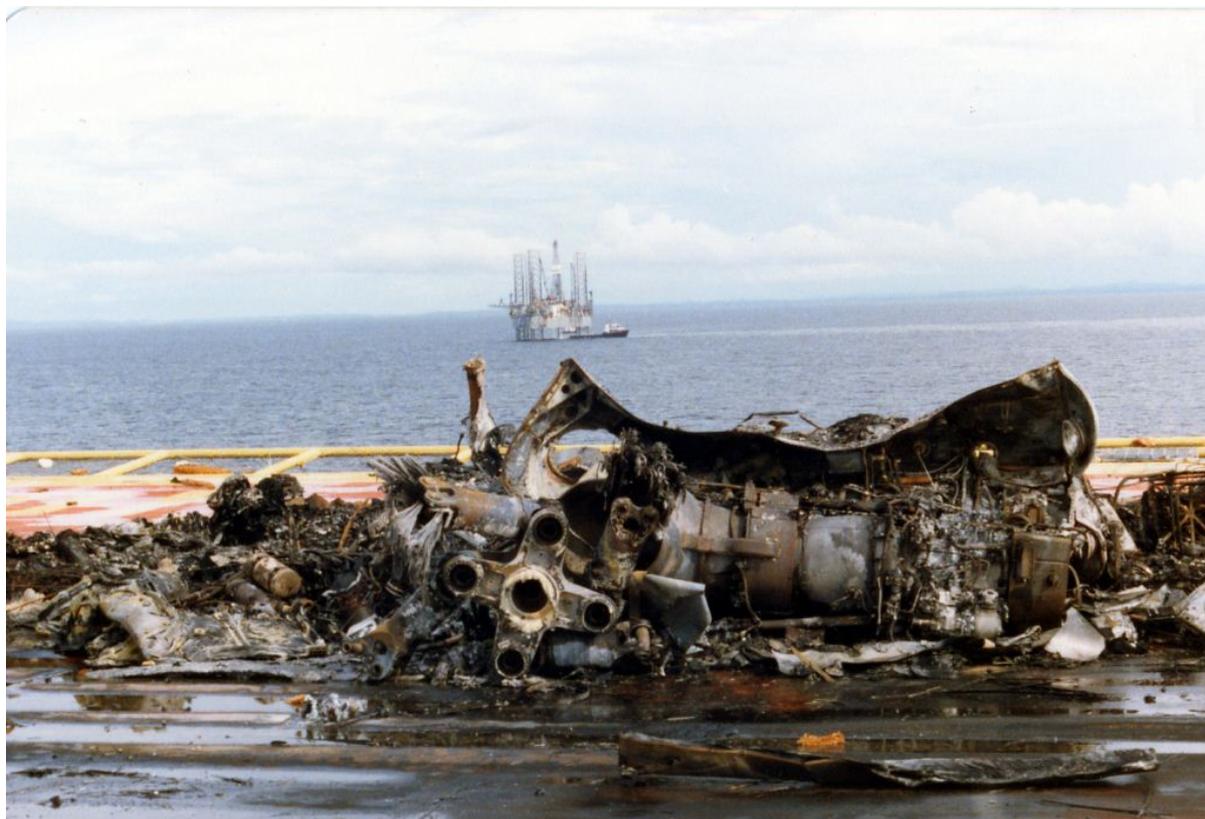
Figure E1 Remains of Puma 330J on Temena E Platform

- 1.1.3.9 It is evident for this issue that, supported by the goal-setting requirements of the HSE PFEERs, with their endorsement of the prescriptive requirements of CAP 437, and if helidecks are to be certificated, there is good support from the HSE's suite of goal setting regulations to enable the application of CAP 437 minimum standards for the certification of offshore helidecks.
- 1.1.3.10 A post-crash fire is a major hazard for offshore helideck operations and as a reasonably foreseeable event needs to be appropriately mitigated. Major fires with the consequential loss of the helicopter have occurred on offshore helidecks outside the UKCS. Figure E1 below shows a crash and burn incident on the Temena E platform in the South China Sea which occurred in 1985. The helicopter pictured is the remains of a Puma 330J.

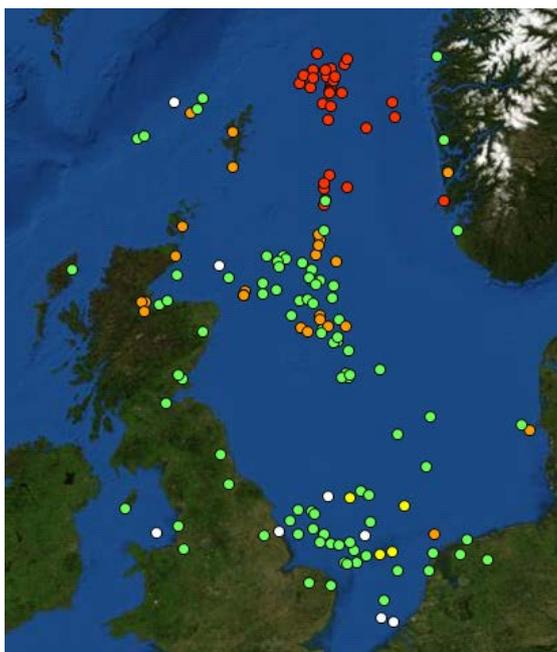
Figure E2 Screen shot from Helimet showing installations providing real time information

- access to live weather information from over 105 installations mainly in the North Sea and shown in graphical and tabular forms;
- map based information highlighting where weather may be below (or above) certain limits;
- a facility for the weather observer to complete and issue the weather report form; and
- an archive of weather report forms.

2.5.5 The Helimet system has been designed for two main users, firstly those who wish to see the output from cloud and visibility sensors from a neighbouring installation to assist in the assessment of the weather conditions and secondly to enable an efficient method of submitting the weather report to the helicopter operators. Additionally it provides situational awareness of weather conditions across the North Sea for helicopter operations staff.

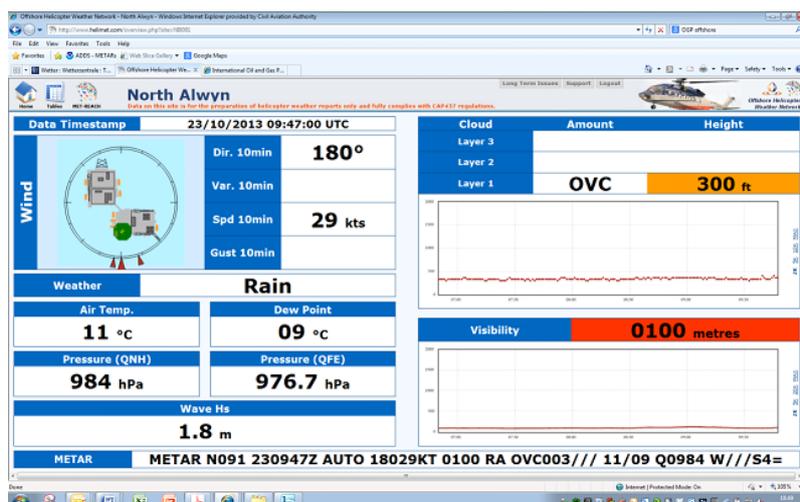
Figure E3 Screen shot from Helimet showing live weather information for the N Alwyn

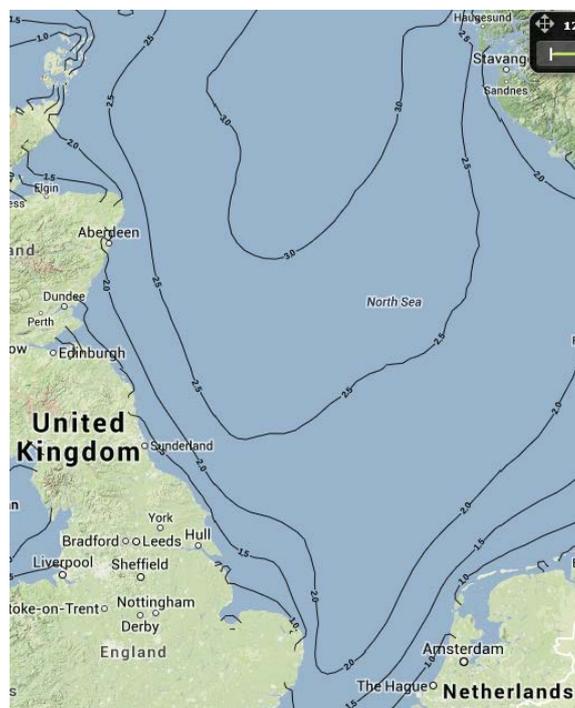
Figure E4 Forecast Significant Wave Height – Screen Shot from OHWeb

2.10.3 In addition forecast significant wave height information is provided on OHWeb.

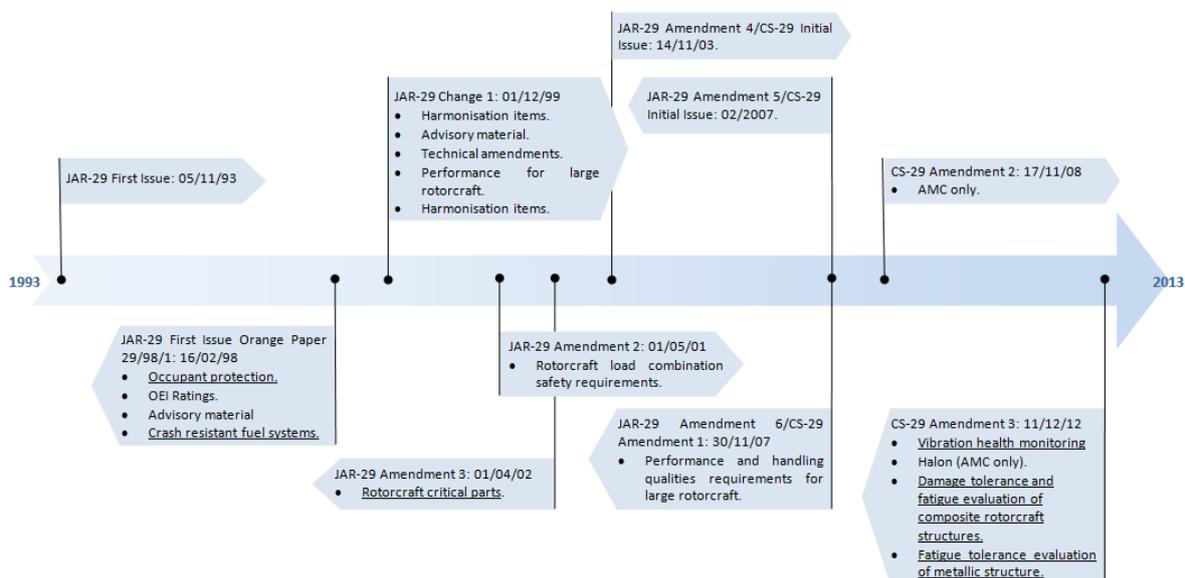
Figure F1 Summary Timeline of Helicopter Certification Regulatory Developments

2.2.6 As demonstrated in Figure F1, significant rulemaking and changes have taken place but the benefits of these new certification requirements will take a while to show tangible benefits as they are mainly applicable to new designs (not derivatives, unless the applicant for a derivative elects to comply with a later requirement or the change itself is deemed significant). These requirement developments are not applied retrospectively to already certificated aircraft.

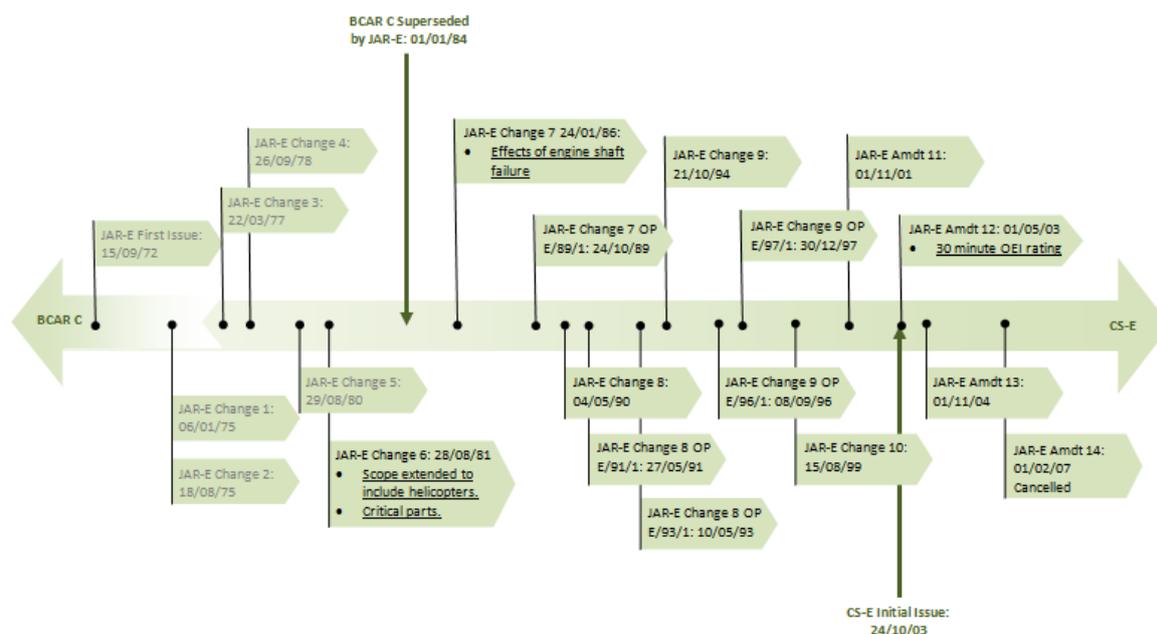
Figure F2 Summary Timeline of Engine Certification Regulatory Developments

- 2.5.1 For completeness, engine types fitted to the current offshore fleet are listed below with their reference dates and nominal applied certification code.
- 2.5.2 Helicopter engines were not specifically addressed by JAR-E before amendment 6 in August 1981. Thus, in the period between JAR-E's initial issue in September 1972 and amendment 6, use was made of existing national codes such as the UK's BCAR Section C. A regulatory change of particular relevance to the offshore helicopter fleet (the 30-minute OEI rating/NPA E-19) was introduced at JAR-E Amendment 12, just before the code transitioned into CS-E (which was equivalent to JAR-E Amendment 13).
- 2.5.3 Due to the low number of purely engine-related occurrences offshore in the period when compared to those for the aircraft as a whole, details of developments to the European Engine code CS-E (formerly JAR-E) are not included.
