Civil Aviation Authority – Safety review of offshore public transport helicopter operations in support of the exploitation of oil and gas

CAP 1145

20 February 2014

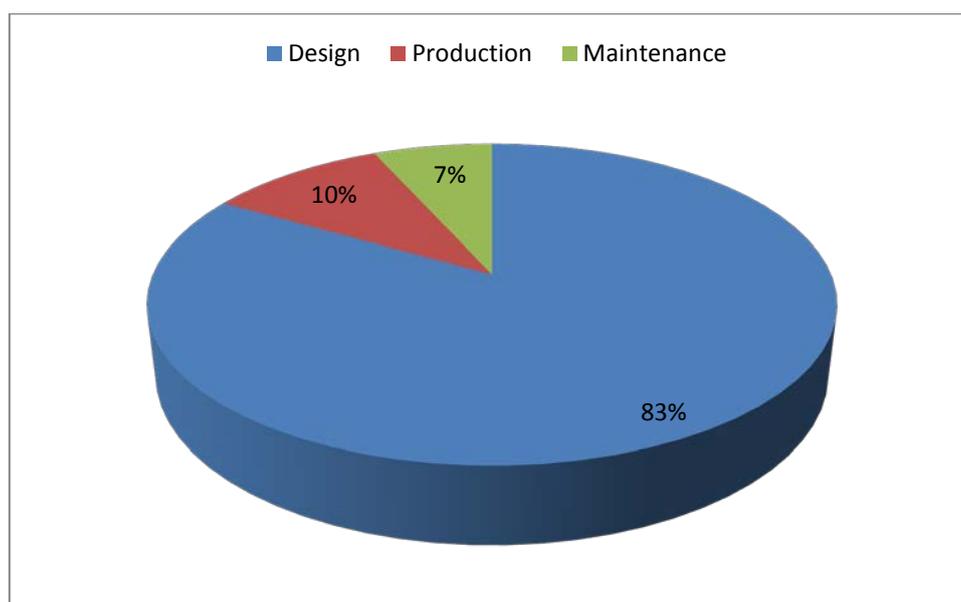
Figure F3 Causal factors

- Design - the cause was related to a failure in some aspect of the design, which when changed, for example by modification or amendment to instructional information, should prevent a recurrence of the incident
- Maintenance - related to some failure in the maintenance of the aircraft, such as bolts not being replaced in a fairing, this therefore includes Engineer Performance
- Production - Components / parts / fabrications not conforming to the design drawing or other deviations in the process.

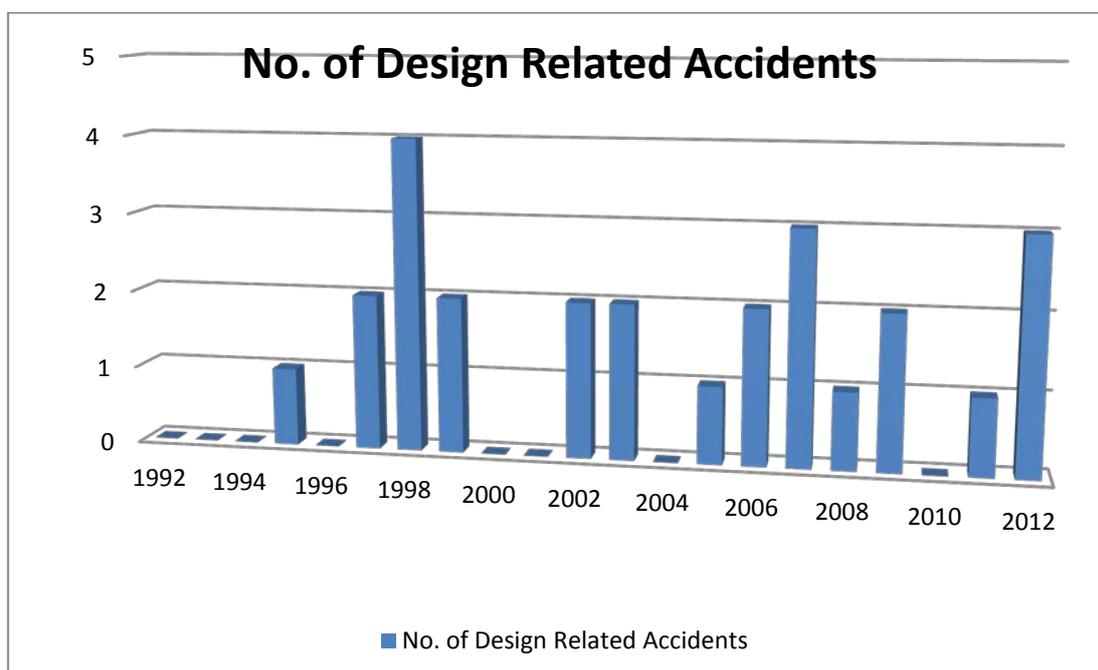
Figure F4 Number of Design-Related Helicopter Accidents Per Year

3.3.5 Figure F4 is a simple chart of number of design related accidents which does not take into account parameters such as operating hours / cycles etc, hence does not indicate normalised rates. This simple view therefore does not indicate any specific trending.

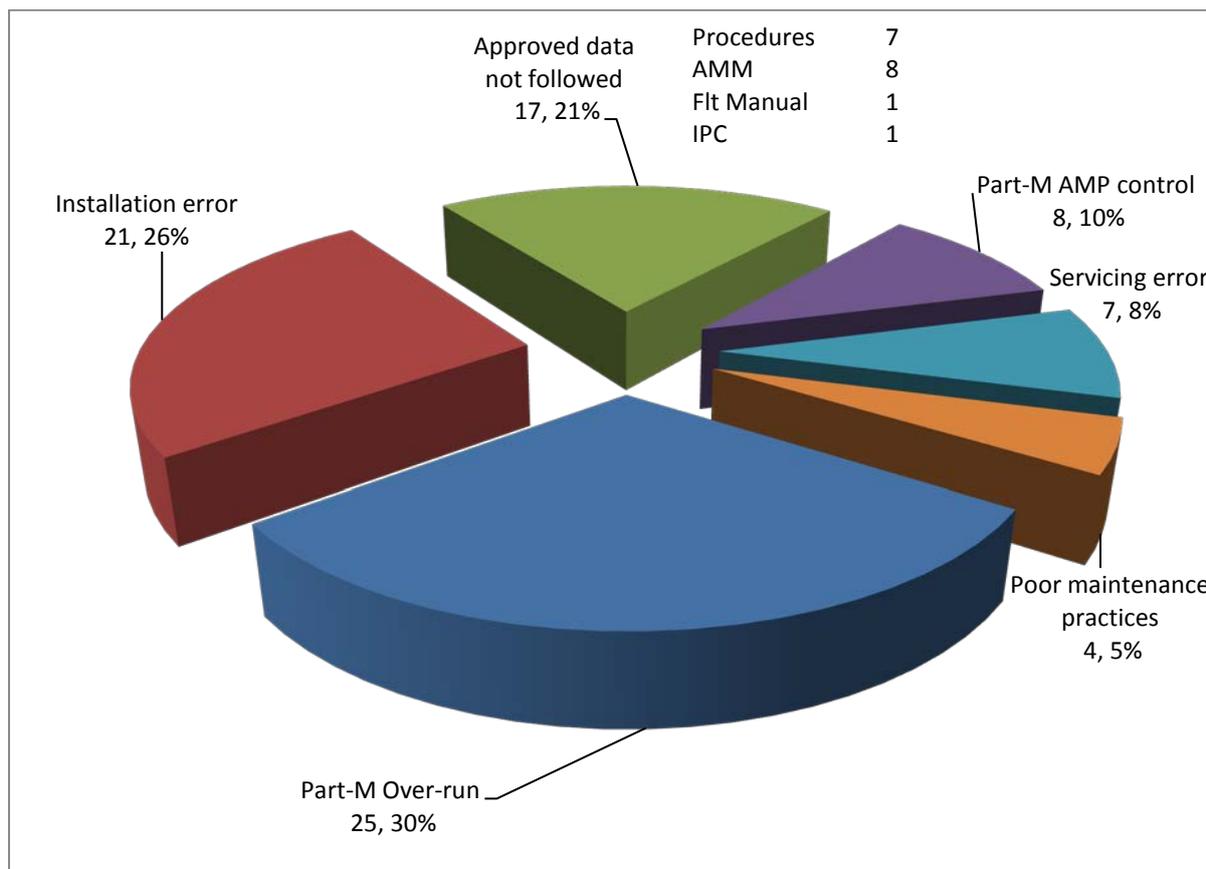
Figure F5 MOR Human Factors Errors reported in the North Sea organisations
