# Safety Alert

From the International Association of Drilling Contractors

**ALERT 06 – 21**

## **FORKLIFT CUT ELECTRICAL LINE WITH OUTRIGGER**

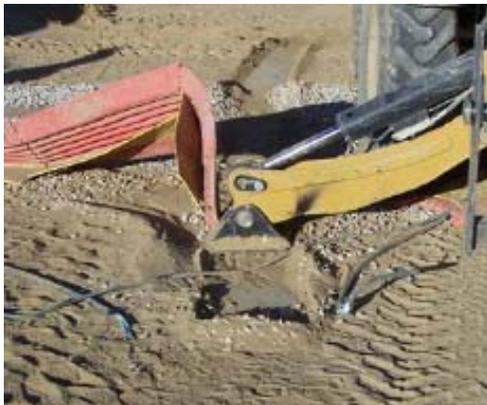
Derrickman / forklift operator entered the forklift and observed that the driver's side outrigger was up. The operator failed to notice that the off side outrigger had been placed on the ground to serve as wheel chocks. He backed the forklift up, and then moved forward towards the mud storage area when he heard a pop. The off side outrigger had struck and cut the 480 volt power supply cable to the rig camp transformer. When the power supply cable was severed, the breaker was tripped. The operator jumped from the forklift unharmed.

Employee had self imposed haste due to first day in position, and failed to perform a required walk around inspection prior to operating the forklift. In the absence of proper wheel chocks the outrigger was used as a substitute. The individual was recently trained on the forklift, but failed to follow procedures taught in the course. The "Wells" team management had made a decision not to follow the new spotter policy issued by the operator.

**Cut Electric Cable**

A check list will be developed and posted on the forklift to remind operators to conduct safety checks prior to operating. The practice using the outrigger as wheel chock will be stopped. The individual will be retrained before allowed to operate any forklift. The Operator's well site management will re-evaluate the decision of not following Operator's Spotter Policy.

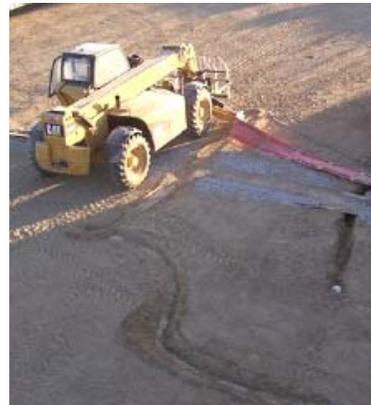
**Area that forklift traveled**
