# Safety Alert

ALERT 07 – 32

## MISCOMMUNICATION RESULTS IN A NEAR MISS

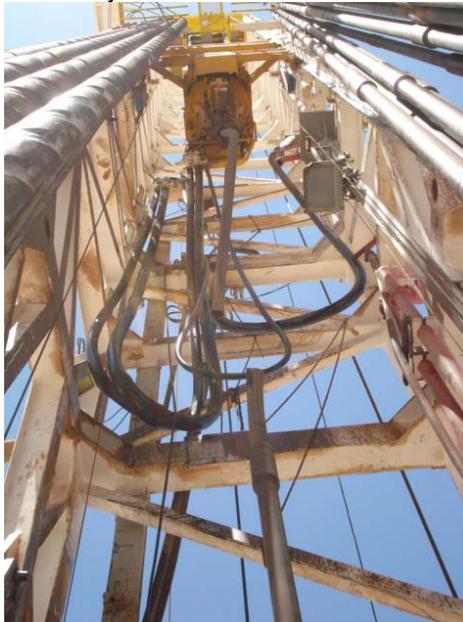
The crew was running in hole with 3 ½” cement stinger on 5” drill pipe. The number of singles to be run were calculated and laid out on the pipe racks. While verifying the amount, it was realized that one too many joints were on the rack. The joint was rolled off the rack onto the ground and the Forklift Operator was told to remove it. For some reason, the joint was not moved and the Assistant Driller thought the single had rolled off the rack on its own. The joint was put back on the rack. The Driller continued RIH and ran into bottom of the hole. The pipe buckled and broke.

- The Rig Manager and Toolpusher must both ensure proper handover and discussion of operational issues with the oncoming crews at tour changes.
- Better supervision and instruction needs to be applied by Rig Manager and TP as the crews are inexperienced and still learning.
- Although the Driller had been trained to operate the equipment, additional training is needed to ensure effective operation of the equipment at specific intervals such as, running pipe close to hole bottom or target depth. Pipe must be run slowly and with close attention paid to the weight indicator in case the pipe tally was somehow done incorrectly.
