Safety Alert

ALERT 09 – 35

DROPPED STANDS OF DRILL PIPE RESULT IN INCIDENTS

LOST PIPE RECOVERY SYSTEM

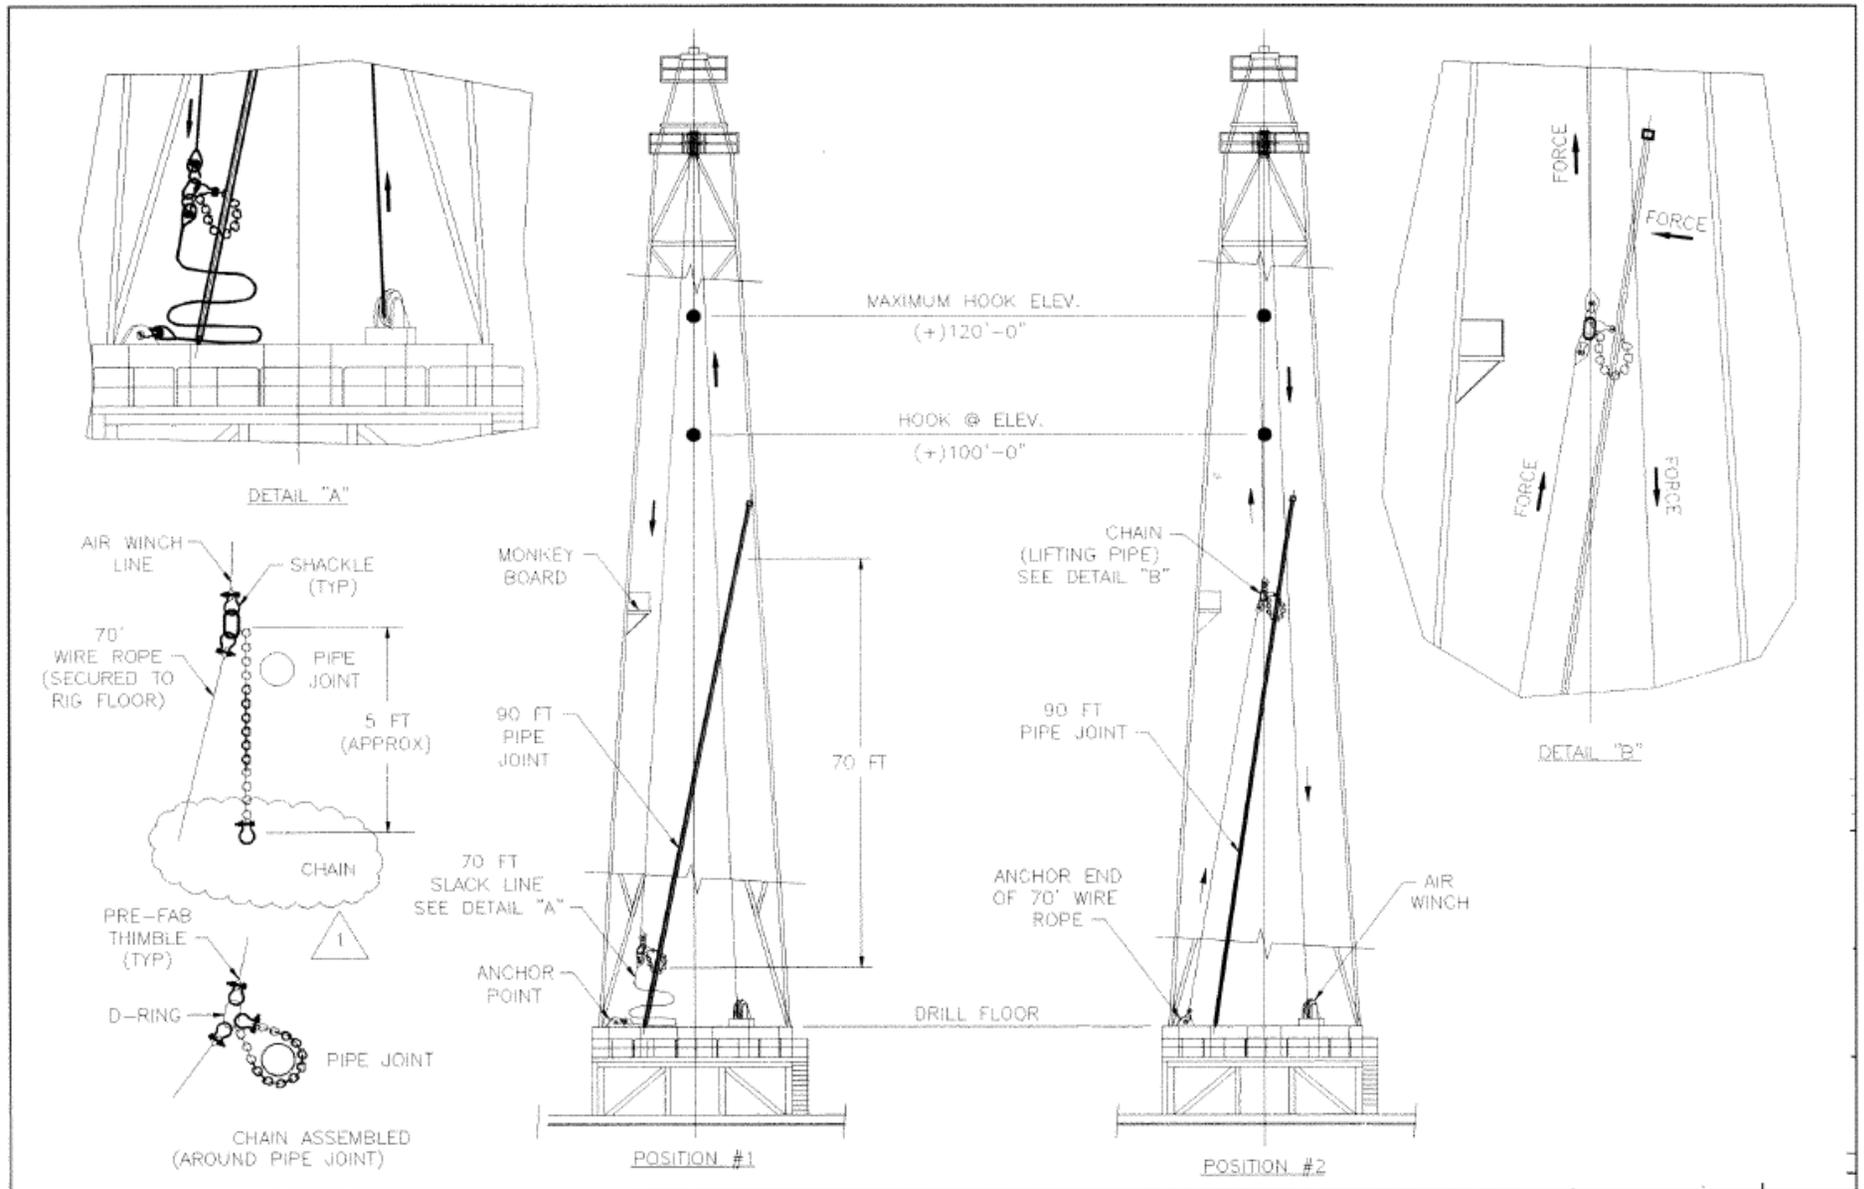
LOST PIPE RECOVERY CHAIN SEQUENCE LAYOUT

- 1.1 Refer to the attached drawing of the Lost Pipe Recovery System.
- 1.2 Use a shackle to secure the end of the 70' length of wire rope to a stationary location on the derrickman's side of the rig floor. (See detail "A")

- 1.3 Secure the live end of the rig floor winch line to the D-ring attached to the end of the 70' length of wire rope by the use of a shackle. (See detail "A")

- 1.4 Next loop the five foot length of chain which is on the D-ring assembly around the lost stand of pipe and secure it to the D-ring (the chain will now encircle the pipe and both ends of the chain will be attached to the D-ring)

- 1.5 Raise the air hoist line while making sure the chain slides up the stand (just past the second tool joint connection) until the cable is in tension. (See "Position #1")

- 1.6 Slowly increase the tension on the winch line and gently pull the stand of pipe back to the Derrickman. (See "Position #2 and Detail "B")

Note1: The seventy (70) feet length of wire rope is required when pulling back a lost stand containing three average length joints of Range Two (2) drill pipe (27 – 30 feet). Rigs operating with stands of fewer joints or Range 1 or Range 3 drill pipe will need to adjust the length of the wire rope they order.
