Safety Alert

ALERT 11 – 11

FINGER PINCHED IN CLOSING TONG GATE RESULTS IN A RESTRICTED WORK CASE

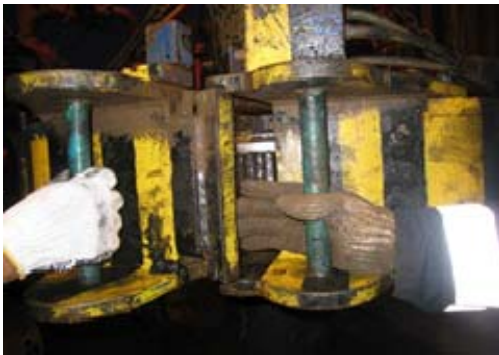
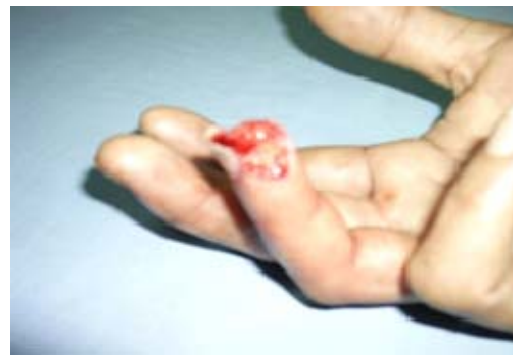
While closing the power tong gate on the rig floor the injured person's (IP's) right ring finger tip was pinched between the inner and outer power tong gates. The job was stopped immediately by the Tour pusher in charge and sent IP to see the rig medic for further treatment. IP was examined and sent to town for further medical examination and treatment.

- The power tong provider and tong type were changed and no formal risk assessment was carried out on the replacement power tong set.
- The JSA used for the job was related to other equipment and not specific to the new tongs.
- A demonstration of closing the gate was carried out while the tong was in the setback area with no swing force to close the tong gate around casing.
- No formal procedure was provided by the new tong provider on how to close the tong gates, whether one or two persons were required for safe operation.
- Handles are positioned too close to the gate edge and also too close to the outer gate path.
- There is no barrier to stop the person from extending his fingers into the outer gate path.
- No task monitoring by supervisors to detect differences between the task and JSA.

- Contacted the tong provider to modify the gate with barrier to prevent hands from entering the pinch point and to adjust the location of the handles away from pinch points.
- Conducted refresher training for "Risk Assessment / JSA" which covers review process for supervisors.
- Revised existing "Casing JSA's" after reviewing the tong and included possible points from the tong into the new JSA.
- Established clear understanding of what is best practice for operating the tong gates and communicated these to affected parties.
- Provided refresher training for "Hand and Finger Safety" for all crew members.
