Safety Alert

ALERT 12 – 24

MISUSE OF HIGH PRESSURE CLEANER RESULTS IN INJURY

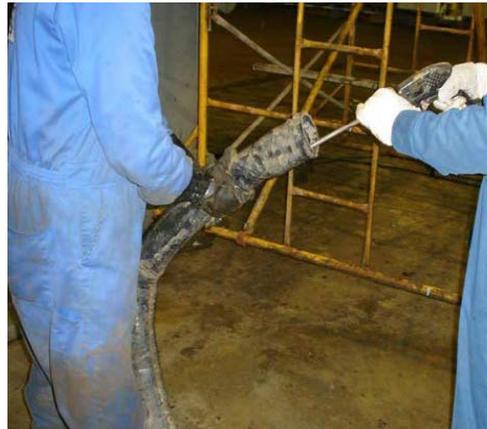
The injured person (IP) was assisting the Night Mechanic in attempting to clear the cellar pump suction line which is used to empty the cellar. The IP, who was a short-service employee with only three (3) days on the rig, held the hose while the Night Mechanic used the high pressure wash down gun inside the hose. When the Night Mechanic activated the gun, the high pressure spray from the gun took him by surprise. The high pressure wash down gun kicked up and the nozzle swiped the IP across his face from his chin to his right ear.

- The IP was a short-service employee who had only worked three (3) days on the rig.
- Clearing the hose in such a manner using a high pressure wash down gun when one man is in the line of fire was hazardous.
- The job was uncontrolled.
- The person using the high pressure wash down gun did not understand the risks the IP was being exposed to.
- The high pressure wash down gun has a regulator which can be adjusted to change the pressure and should have been regulated down to suit the needs of the job.
- The high pressure gun pressure regulator had been adjusted to its maximum pressure setting, causing the unexpected kickback.

- The rig personnel were instructed to order the correct ball valve / filter for use with the pump suction line to reduce the risk of foreign objects blocking the suction line.
- Supervisors were reminded that they are to hold mandatory Pre-job safety meeting prior to any task requiring the use of the high pressure wash down gun.
- The rig personnel were reminded that only authorized personnel are to adjust the pressure regulator of the high pressure wash down gun.
- Maintenance personnel were instructed that a pressure gauge is to be fitted on the pump.
- The company policy on short service employees regarding, induction, training and how they are supervised at the rig site was re-enforced with all employees.
