# Safety Alert

ALERT 12 – 28

## DRILLER INATTENTION RESULTS IN DROPPED BLOCKS

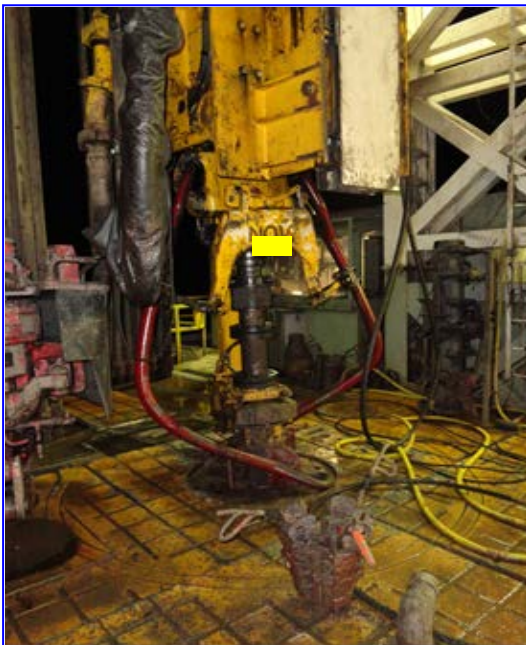
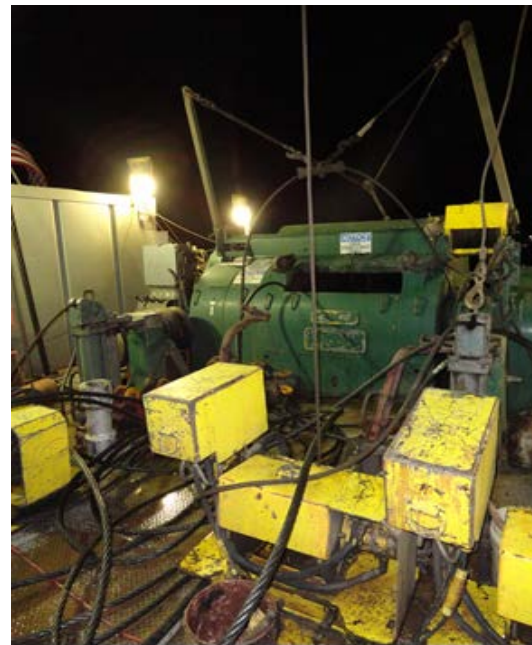
While tripping in the hole, the driller was washing and reaming due to a tight hole. After raising a full stand past the derrick board, the driller started to lower the stand back down when they hit a bridge causing the blocks to lay over the top drive which allowed the drill line to acquire slack above the blocks. As the blocks were falling towards the V-door the driller clutched the draw works and at the same time the bit broke through the bridge allowing the blocks and top drive to free fall and hit the end of the slack drill line. The sudden increase of weight parted the drill line 228 feet (69 meters) from the drum of the draw works. The blocks, top drive, and the drilling line fell to the rig floor.

- An excess amount of slack in the drill line allowed the blocks and top drive to free fall once the bit broke through the bridge.
- Due to simultaneous operations the driller was not paying full attention to the weight indicator and was distracted by other operations going on at the same time.

- The crew was reminded that a JSA for washing and reaming shall be reviewed and/or updated to point out possible hazard scenarios and the information shall be shared among all crews throughout the fleet.
- The company installed a new block dolly system that will stay in the mast at all times. This will prevent the blocks from hanging out over the top drive creating slack in the drilling line during similar operations or events.
- The rig manager and driller were instructed that if the driller is distracted in any way during simultaneous operations he shall stop the job to regain focus on the task and keep constant attention on the weight indicator.
