Safety Alert

From the International Association of Drilling Contractors

ALERT 01-44

FALL FROM HEIGHT, FATALITY

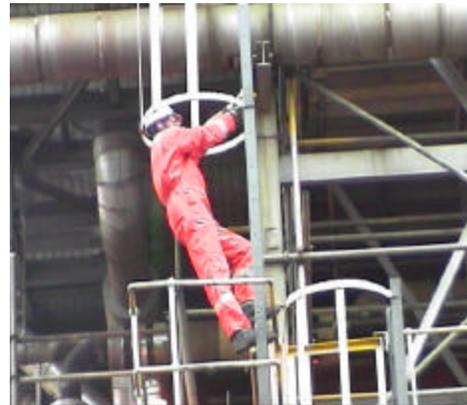
Although this incident did not occur on a drilling rig, many rigs have similar ladders and landings. A welding supervisor fell over 9 meters (30 feet) to ground while descending from a fixed vertical hooped ladder. The welding supervisor had been carrying out routine weld inspections in preparation for a plant turnaround, prior to descending the ladder to return to grade. An eyewitness reported that the supervisor lost 3 point contact with the ladder and fell backwards through an unprotected section of ladder, hitting the handrail, pivoting over it and falling to grade. This vulnerable section of ladder between the top of the handrail and bottom of ladder guard hoops is highlighted in the photograph below.

- The supervisor for reasons not determined did not maintain 3 point contact with the ladder.
- There was no fall protection located between the bottom of the ladder guard hoops and the top of the handrails.
- The platform landing was of insufficient breadth to contain an individual in the event of a backwards fall from height
- The potential of a fall from the unprotected area between the bottom of the ladder guard hoop and the top of the handrail had not been foreseen for this location during more than 30 years of service.

CORRECTIVE ACTIONS: To address this incident, this company did the following:

- Even when guards are in place they may not be sufficient to prevent injury.
- Height is not the only consideration when assessing risk.
- Design standards do not always reduce risk to an acceptable standard (as low as reasonably practicable).

- Risk can arise through even the most routine of activities.
- Other related ladder incidents have occurred at the complex but lessons have not been applied consistently. After this accident, the site is even more committed to improve consistency of remedial actions across all operating areas in the complex.

- Safety rules for safe use of ladders have not been institutionalized across the complex. Greater emphasis, awareness and training will be given to everyday hazards, such as those identified in the use of ladders.

- Even the most routine of activities involve hazards.
- Basic occupational safety standards for older equipment should be equivalent to those expected on new plant
