ALERT 15-07

POOR SITUATION AWARENESS/LINE OF FIRE INCIDENT RESULTS IN OSHA RECORDABLE

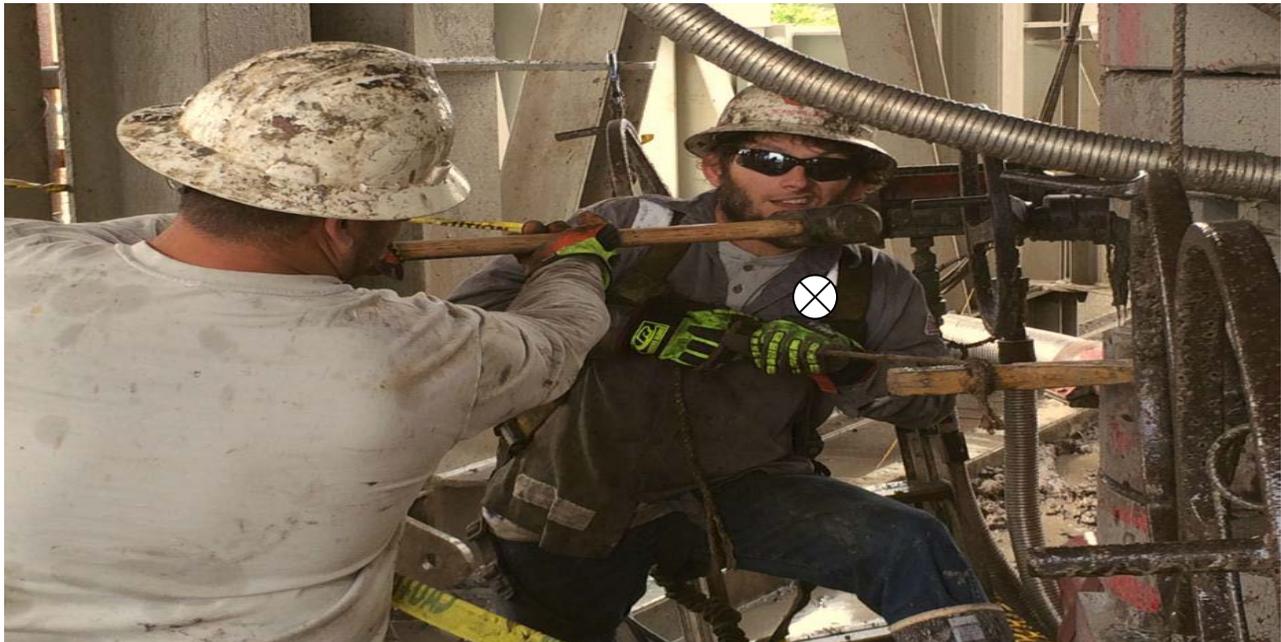
This is a re-enactment and not a picture from the actual incident or rig! This picture is strictly a visual aid to show the line of fire one may find himself in during nipple up.

Culture/Process: Although having a good pre-job meeting and several Error-Likely Situations were anticipated and defenses were put in place this incident still occurred, we didn't maintain good situation awareness while working our way around the stack. Employees should always be using situation awareness and have a questioning attitude. By doing so one or both of the men should have noticed that the short rope coupled with the angle that the man was pulling it placed him directly in the line of fire.

Engineering: Management is currently looking for a practical engineering defense that we can use to hold hammer wrenches and other tools correctly while keeping other employees out of the line of fire.
